Aladdin Environmental LLC

October 28, 2008

Re: 115 Villa Arboles, San Antonio, TX

Aladdin Environmental is pleased to submit this environmental evaluation on the above residence located at 115 Villa Arboles, San Antonio, TX. This limited evaluation was performed on October 24th, 2008. We have observed the standard of care generally exercised by the profession under similar circumstances and conditions to complete this report.

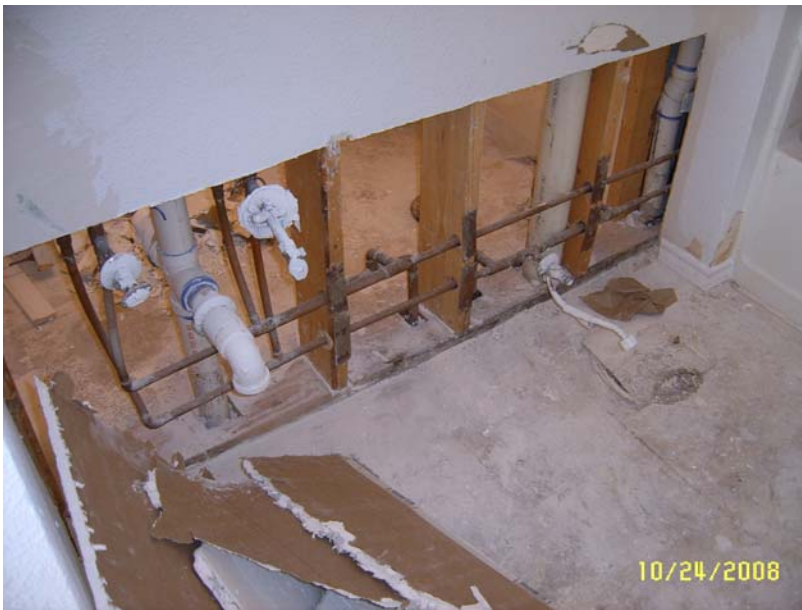
Master Bath - baseplate

S1 – Master Bath – baseplate

- A swab sample was taken of a discoloration on the baseplate between the two bathrooms. Lab results indicate a “medium” spore count of *Aspergillus/Penicillium* and *Cladosporium* type spores.

- Inspected areas throughout the house. The house was vacant and undergoing reconstruction.
- Walls were checked around plumbing fixtures, windows and other possible moisture sources using a moisture meter and all readings were normal, with the exception of the baseplate between the two bathrooms.
- The lower portion of sheetrock wall was open between the two bathrooms. A fan was in place to expedite drying.
 - Recommend the baseplate be cleaned & sanitized.

The area can be retested once the recommended work is accomplished.

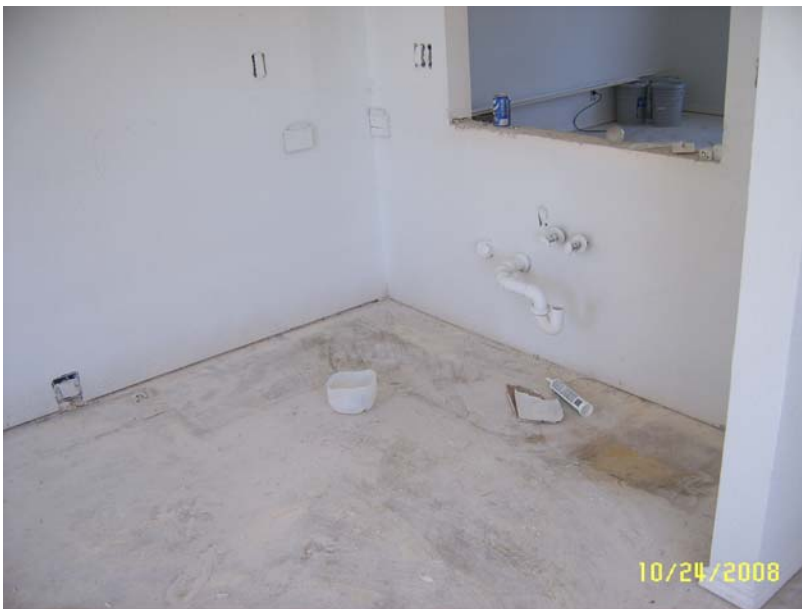
A2 – Living @ Kitchen

- Lab results show counts of several types of mold, all lower than the outside counts with the exception of *Aspergillus/Penicillium*, which is higher than the outside sample. The overall count is much lower than the outside count.
