Project No. ASR08-059-00
November 10, 2008

**RE: Consulting Engineering Services
Residential Study
138 Villa Arboles
San Antonio, Texas**

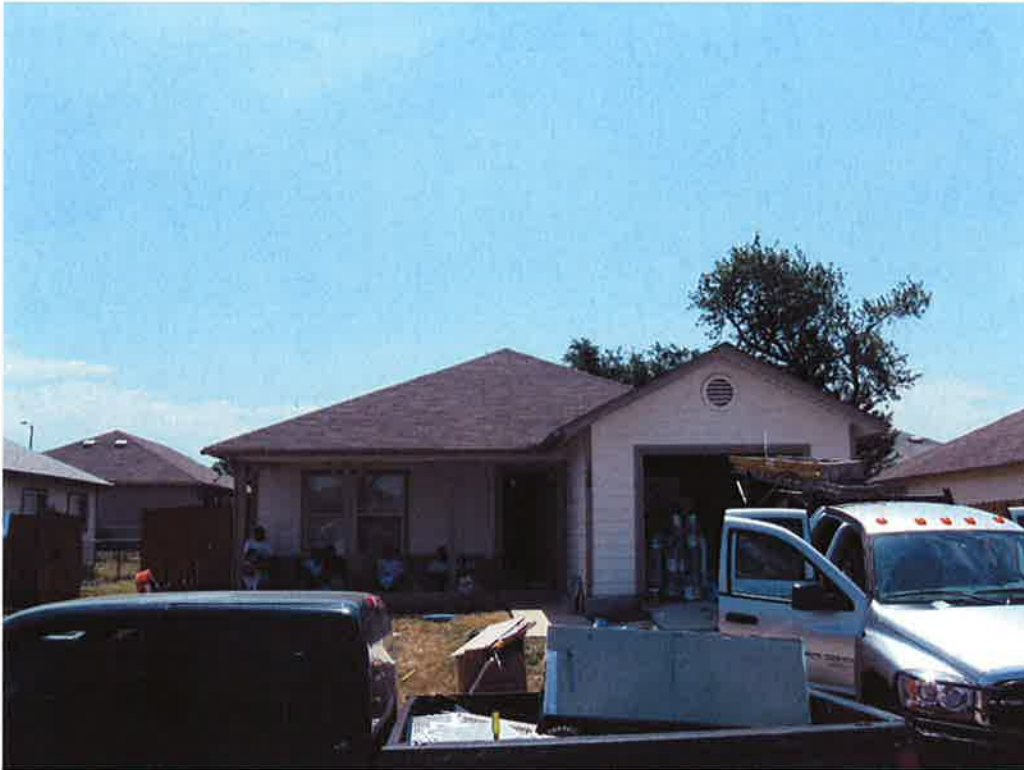
PHOTOGRAPH 1

- The surface drainage is considered to be good along the front of the home as shown on Photograph 1.
- A portion of the concrete driveway slab has been replaced as shown on Photograph 5.
- The expansion joint between the front concrete sidewalk and the grade beam along the left side of the garage has been previously resealed.
- There is some drying of the soils along the perimeter beam as shown on Photograph 6.
- There is a slight sag in the gutter where it extends along the right side garage eave as shown on Photograph 7.

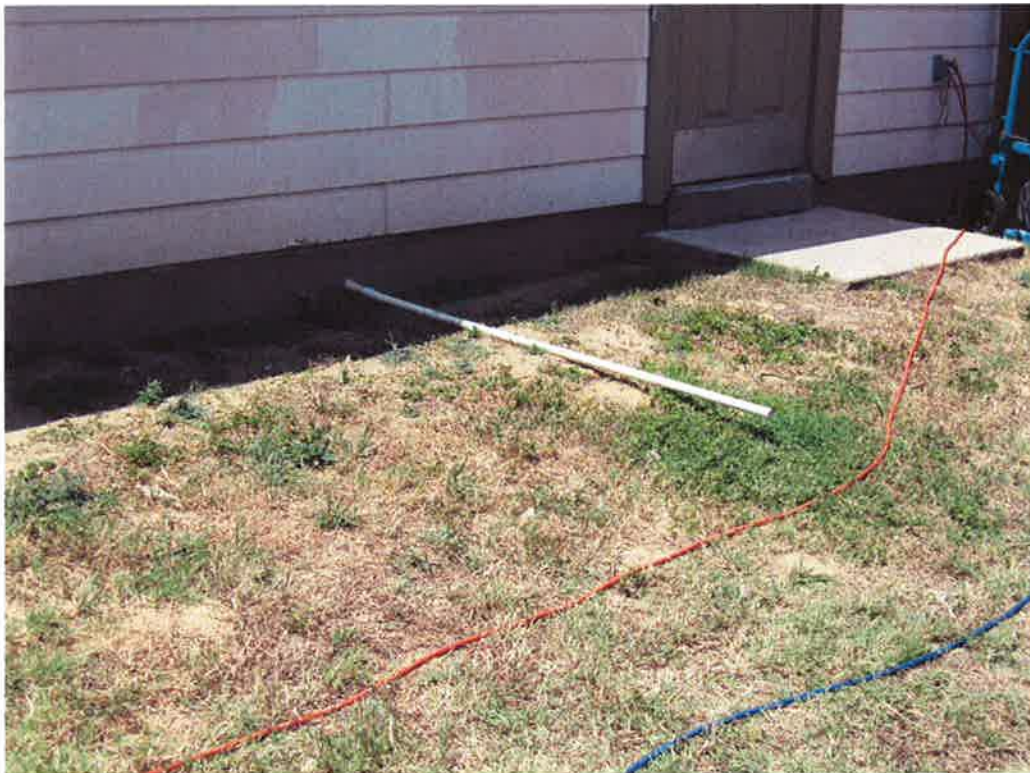
PHOTOGRAPH 8

- The former temperature/pressure relief drain is located about 4-1/2 feet from the back edge of the stoop as shown on Photograph 8.
- The PVC condensate drain line exits the foundation about 4 feet from the back edge of the concrete stoop and extends about 5-ft into the right yard as shown on Photograph 8.
- There is some drying of the soils along the perimeter beam as shown on Photograph 9.
- The surface drainage is considered to be good along the right side of the home as shown on Photograph 2, with the exception of a low spot between the grade beam and the front edge of the concrete stoop as shown on Photograph 10.
- A drip line has formed on the ground surface below the edge of the roof eave.
- The fiber board between the grade beam and the concrete stoop has collapsed into the joint.

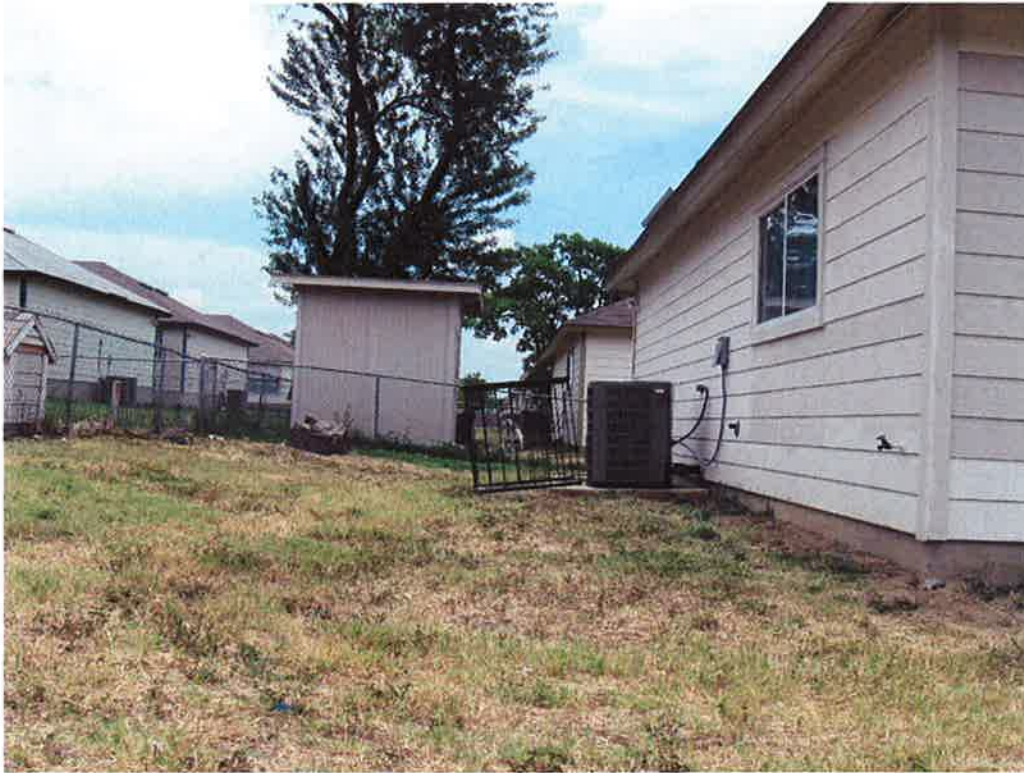
PHOTOGRAPH 11

- The surface drainage is considered to be poor with the ground surface sloping toward the foundation as shown on Photograph 11. There is a slight swale that extends from left to right across the yard; however it is not well defined.
- The coil and fan unit is located adjacent to the perimeter grade beam.
- There is some drying of the soils along the perimeter beam as shown on Photographs 12 and 13.
- There is a 2-ft diameter tree stump located about 15-ft to the rear of the right-rear corner of the home as shown on Photograph 14.
- A drip line has formed on the ground surface below the edge of the roof eave.

- Irrigation should be controlled within a 10-foot zone around the perimeter of the home. The moisture content of the surface clay soils should be maintained at a uniform condition year round. The ground within this area should not be allowed to become dry to the point where the ground cracks and pulls away from the foundation. These conditions were noted along the back, left, and right sides of the foundation. Water should also not be allowed to pond in these areas or near the foundation.

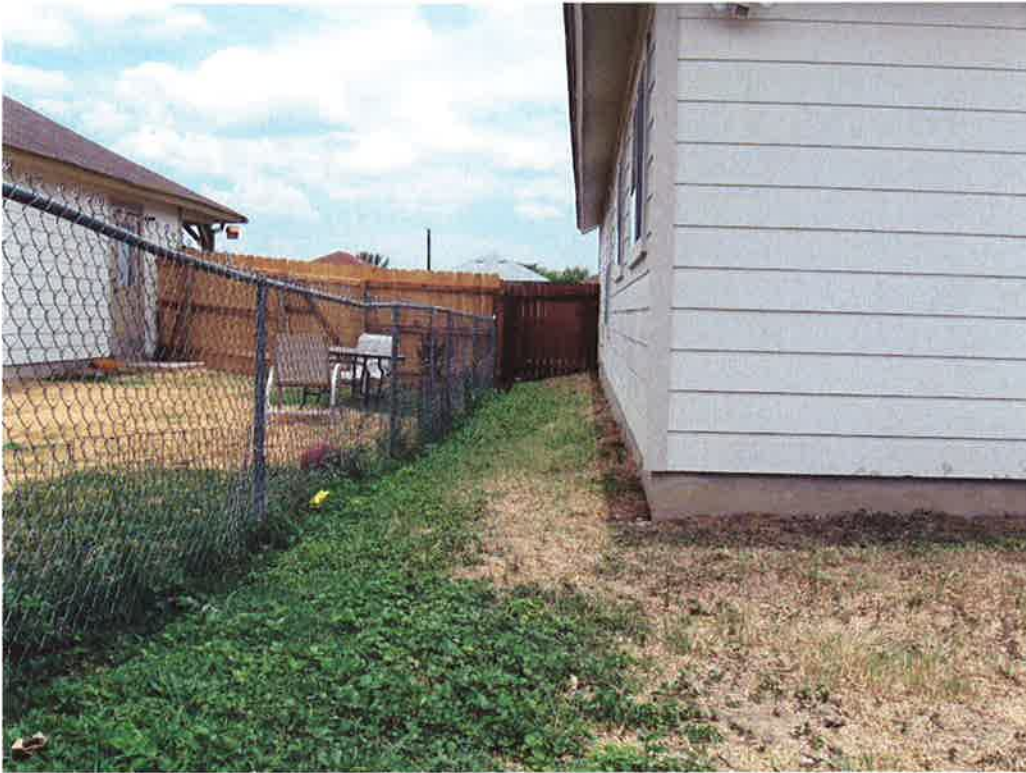
PHOTOGRAPH 15

- The surface drainage is considered to be good along the right side of the home as shown on Photograph 15.
- There are no signs of cracking along the perimeter grade beam.
- There is some drying of the soils along the perimeter beam as shown on Photograph 16.

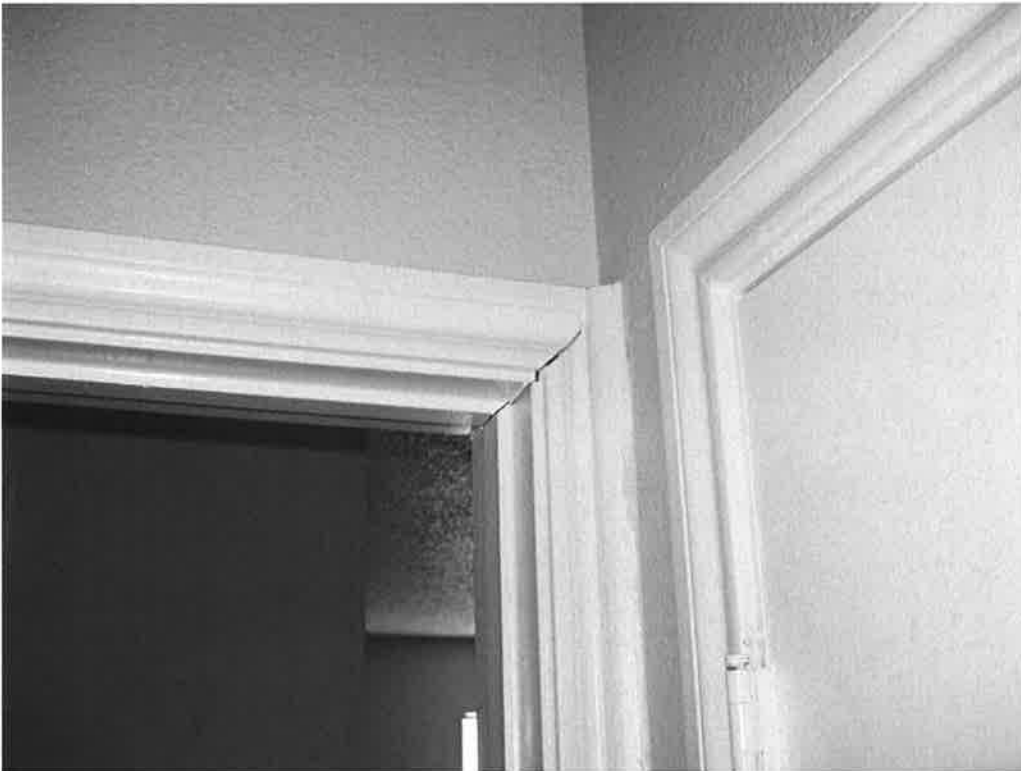
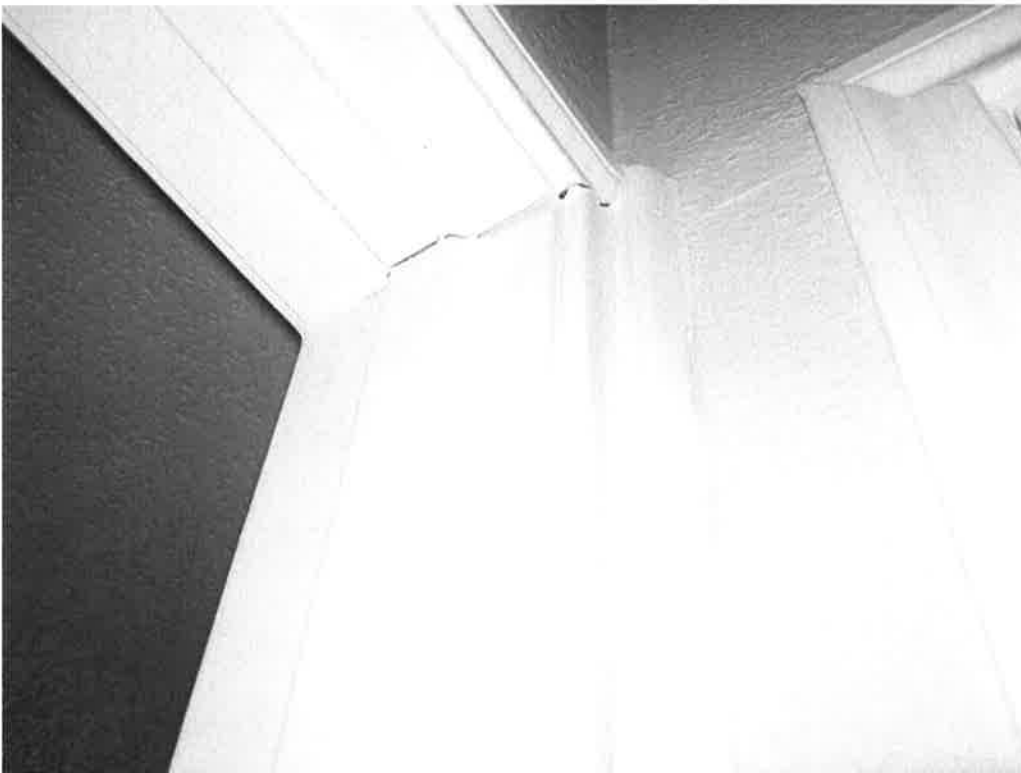
- There is a separation at the top front corner of the doorway trim that varies up to about 0.06-inch in width as shown on Photographs 17 and 18.

- The separation at the wood trim along the hallway bathroom doorway may be a result of some soil-related movements; however, it can be corrected by filling the opening with standard color matching caulking material.
- The cracks in the garage floor slab are plastic shrinkage and dry shrinkage cracking and crack widths are related to normal soil movements supporting the foundation and are not a structural deficiency.
- The monolithic beam and slab on ground reinforced concrete foundation supporting the home and the wood frame is considered to be structurally adequate.
