Aladdin Environmental LLC

August 14, 2008

Re: 139 Villa Grande, San Antonio, TX

Aladdin Environmental is pleased to submit this limited environmental evaluation on the above residence located at 139 Villa Grande, San Antonio, TX. This limited evaluation was performed on August 12th, 2008. We have observed the standard of care generally exercised by the profession under similar circumstances and conditions to complete this report.

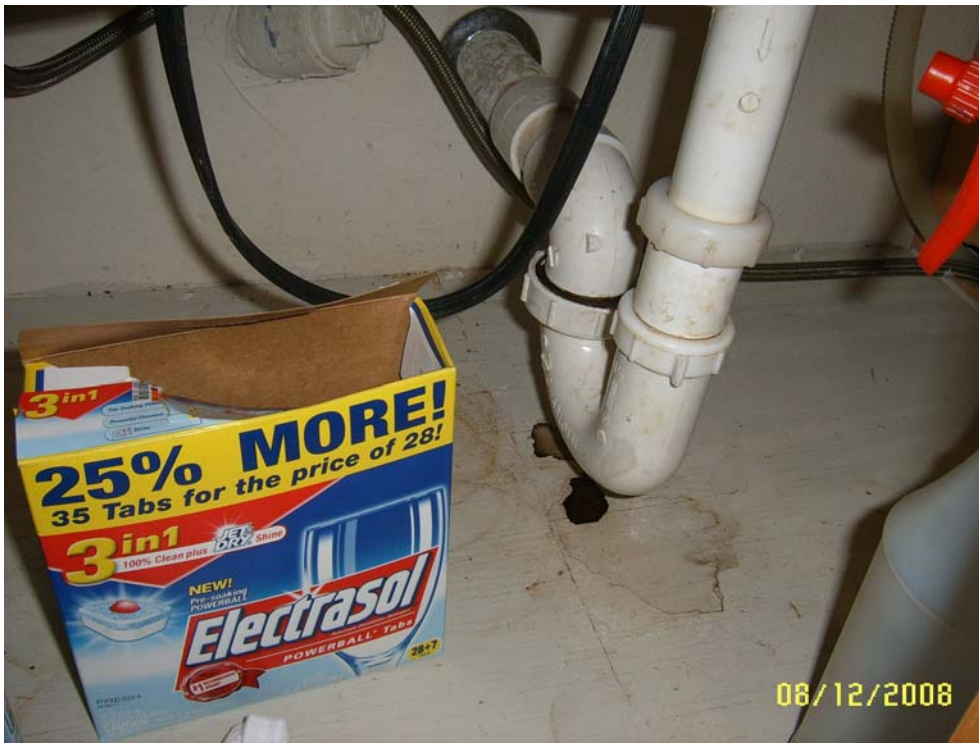
- Kitchen – The shelf below the sink showed indications of water spots. There was water presently on the drain connection. There was no visible microbial growth.

Kitchen - shelf below sink with water present on drain connection

- Recommend repairing the leak to prevent further damage.
 - Recommend cleaning the sink shelf.
- Living – It appears the HVAC unit is new with new ductwork throughout. The A/C return had some dust buildup.

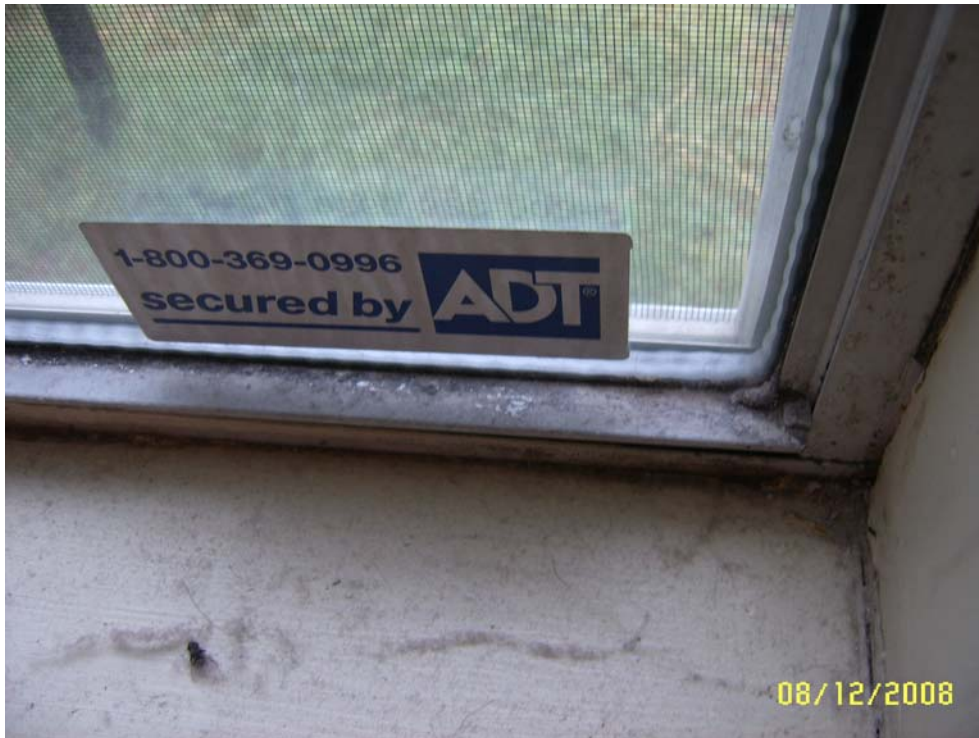
Master Bedroom window

- Recommend the window & sill be part of a regular cleaning routine.
- Master Bedroom – The windows had a build-up of dirt/debris.
 - Recommend the window & sill be part of regular cleaning routine.

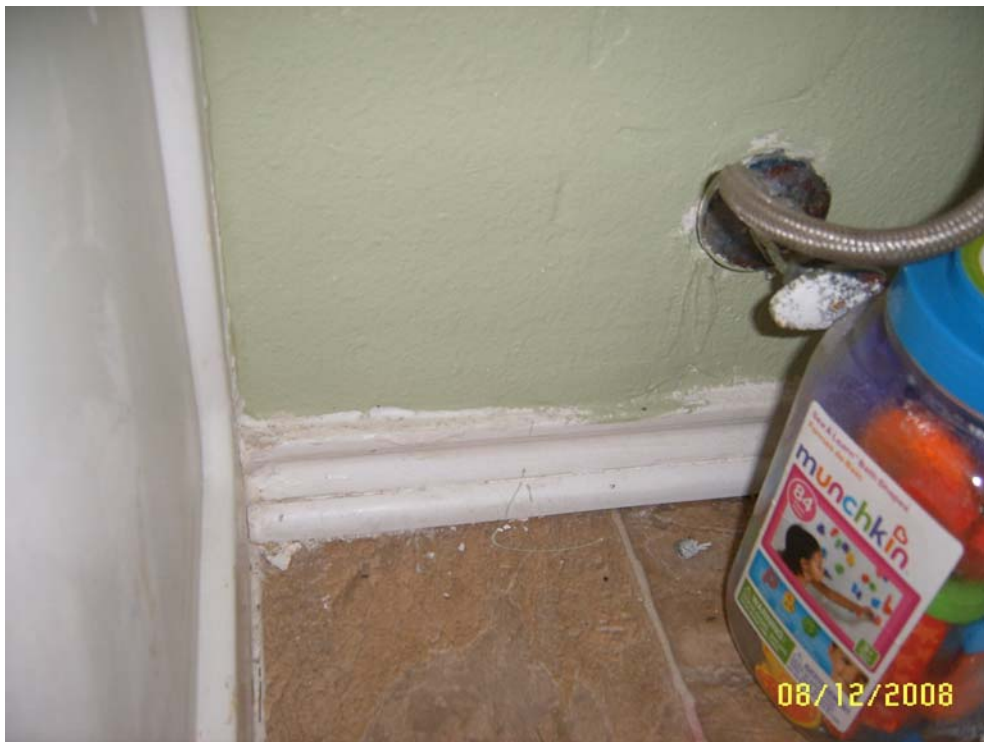
- Hall Bath – Sheetrock behind toilet appears to have had some repairs, but no apparent damage. Moisture readings were normal.
- Bedrooms – The 2 bedrooms appear to have had the windows recently replaced. The window sills had a normal amount dirt/debris.

Hall Bath - sheetrock behind toilet

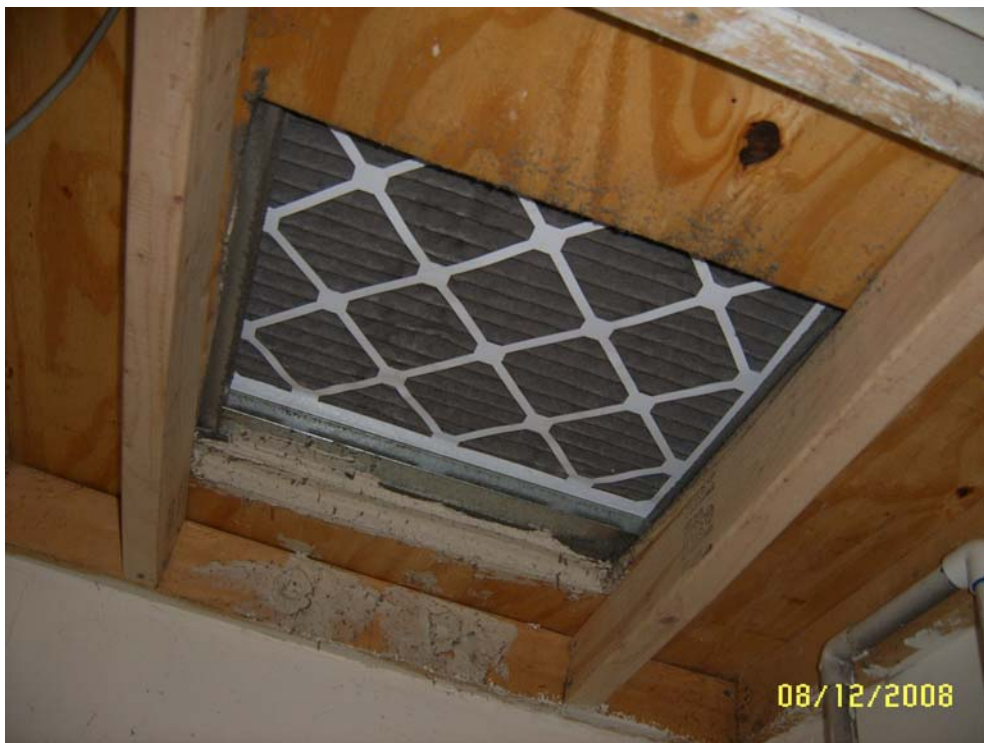
A/C return

- Recommend the A/C return be vacuumed when the A/C filter is changed as part of a regular cleaning routine.
 - Recommend the window & sill be part of regular cleaning routine.
