Project No. ASR08-061-00  
September 18, 2008

**Raba-Kistner Consultants, Inc.**  
12821 W. Golden Lane  
P.O. Box 690287, San Antonio, TX 78269-0287  
(210) 699-9090 • FAX (210) 699-6426  
www.rkci.com

**RE: Consulting Engineering Services  
Residential Study  
142 Villa Grande  
San Antonio, Texas**

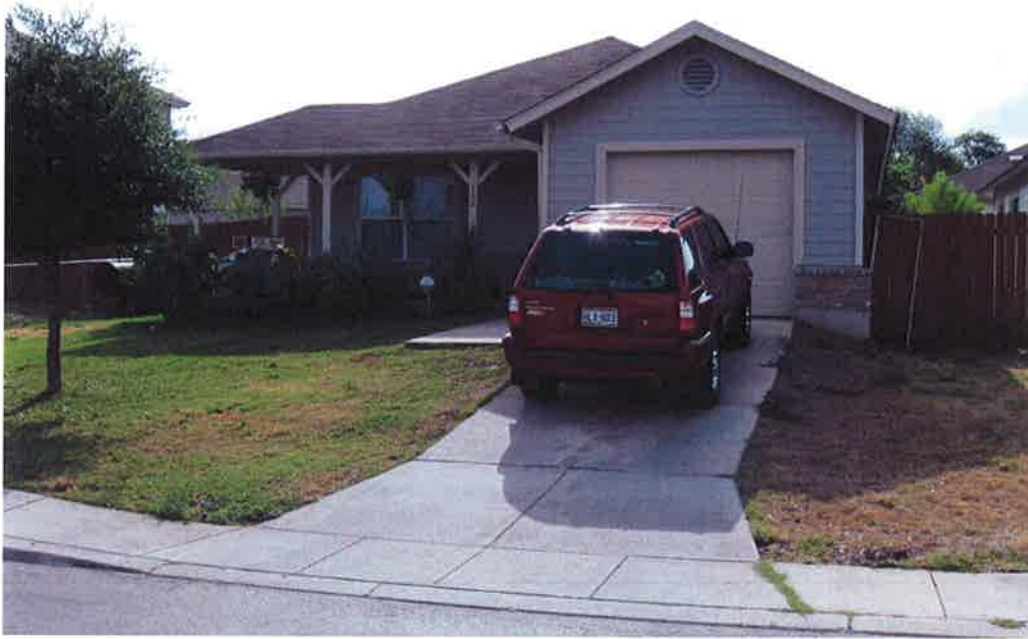
**PHOTOGRAPH 1**

- With the exception of the planter bed located along the front porch, the surface grading is considered good with the ground sloping away from the foundation as shown on Photograph 1 in Attachment B.

- There is a gutter located along the left garage roof eave and along the porch roof eave as shown on Photograph 1 in Attachment B. The gutter empties into two downspouts located at the left-front corner of the garage and at the left-front corner of the porch.

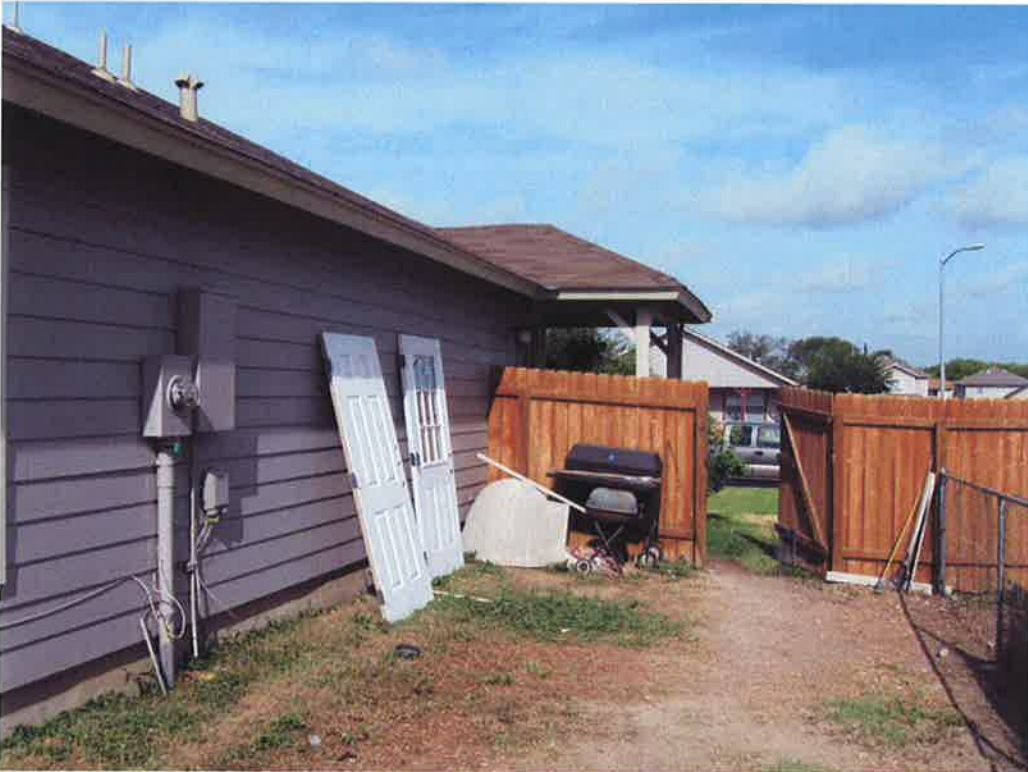
**PHOTOGRAPH 2**

- The ground surface grading is considered fair to poor with a relatively flat surface, sparse ground cover, and several low spots along the foundation as shown on Photographs 2 and 18 in Attachment B.
- Dry soil conditions were observed along the perimeter grade beam where a horizontal separation has developed between the soil and the grade beam as shown on Photographs 18 and 19 in Attachment B.

- Surface grading is considered good with the ground sloping away from the foundation as shown on Photograph 2 in Attachment B.
- Dry soil conditions were observed along the perimeter grade beam where a horizontal separation has developed between the soil and the grade beam as shown on Photographs 20 and 21 in Attachment B. The separation varies up to about 1-1/4 inches in width and as much as 6 inches in depth.
- Vertical cracks were observed along the exposed portion of the concrete grade beam as shown on Photograph 22 in Attachment B. In general, these cracks vary up to about 0.016 inches in width.

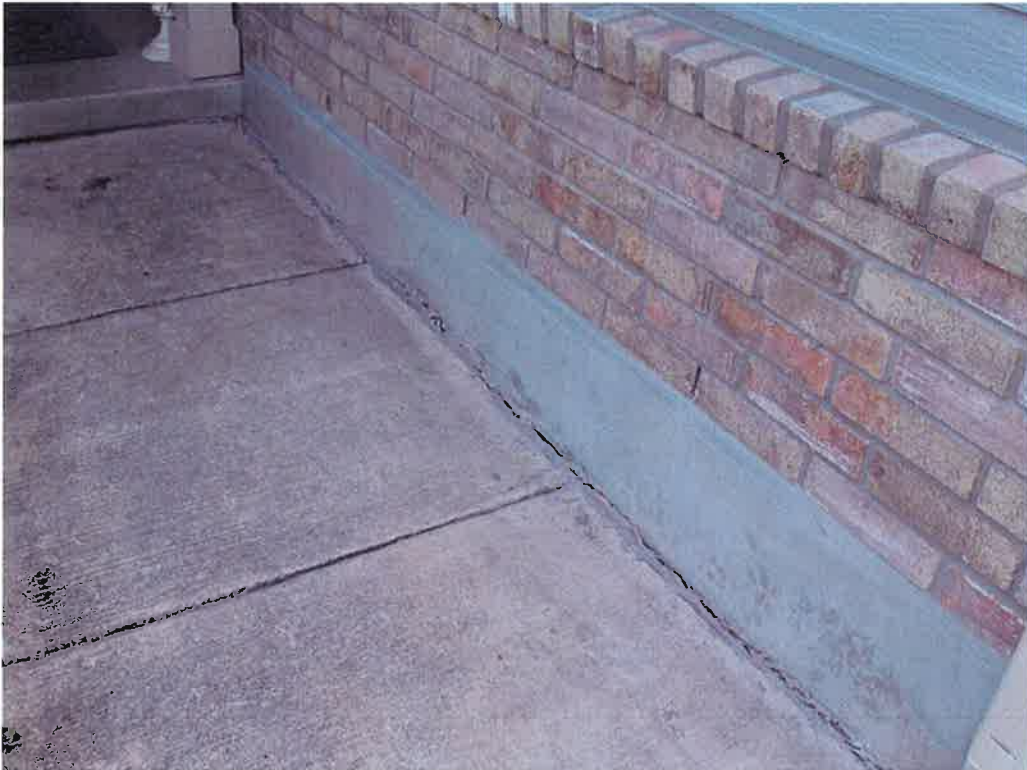
**PHOTOGRAPH 7**

- The concrete walkway has moved away from the grade beam along the left side of the garage as shown on Photographs 7 and 8 in Attachment B. It appears that the walkway has settled approximately 3/4-inch along the joint. This has torn the elastomeric sealant along the joint.

- The expansion joint between the front concrete walkway and the grade beam along the left side of the garage should be corrected using a reputable experienced sealant contractor using standard joint filling materials and methods.

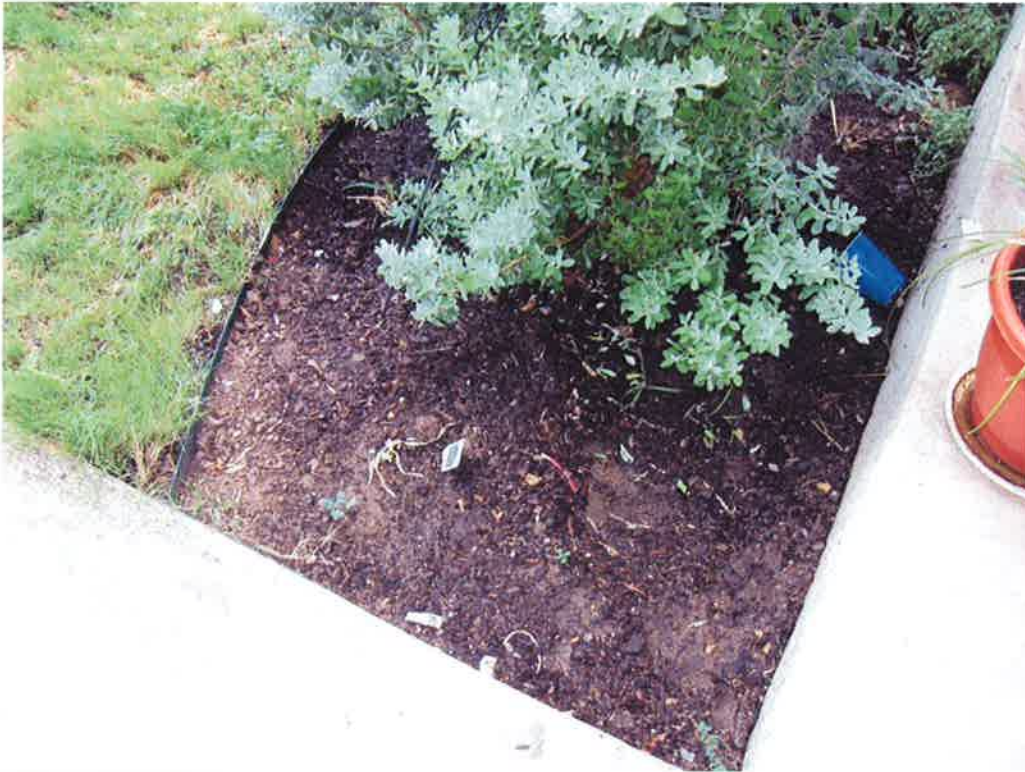
**PHOTOGRAPH 9**

- The metal border edging located along the planter bed traps water against the porch foundation as shown on Photograph 9 in Attachment B.
- There are some isolated spots in the front yard where the soil has settled as shown on Photograph 10 in Attachment B.

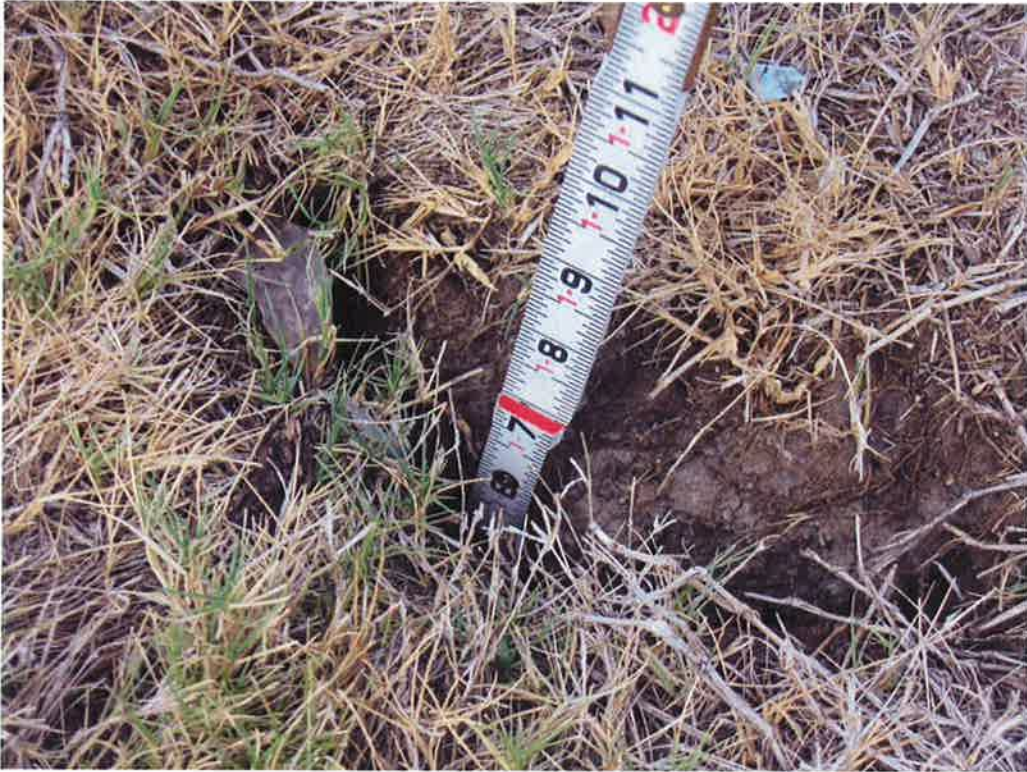
**PHOTOGRAPH 11**

- Dry soil conditions were observed in the yard along where cracks in the ground surface varying up to about 1-1/4 inches in width and as much as 20 inches in depth as shown on Photographs 11 and 12 in Attachment B.
- The wood porch columns are twisted as shown on Photograph 13 in Attachment B.

- Irrigation should be controlled within a 10-foot zone around the perimeter of the home. The moisture content of the surface clay soils should be maintained at a uniform water content condition year round. The ground within this area should not be allowed to become dry to the point where the ground cracks and pulls away from the foundation. This is particularly true of this residence where these conditions were noted along the left and right sides of the foundation. Water should also not be allowed to pond near the foundation.

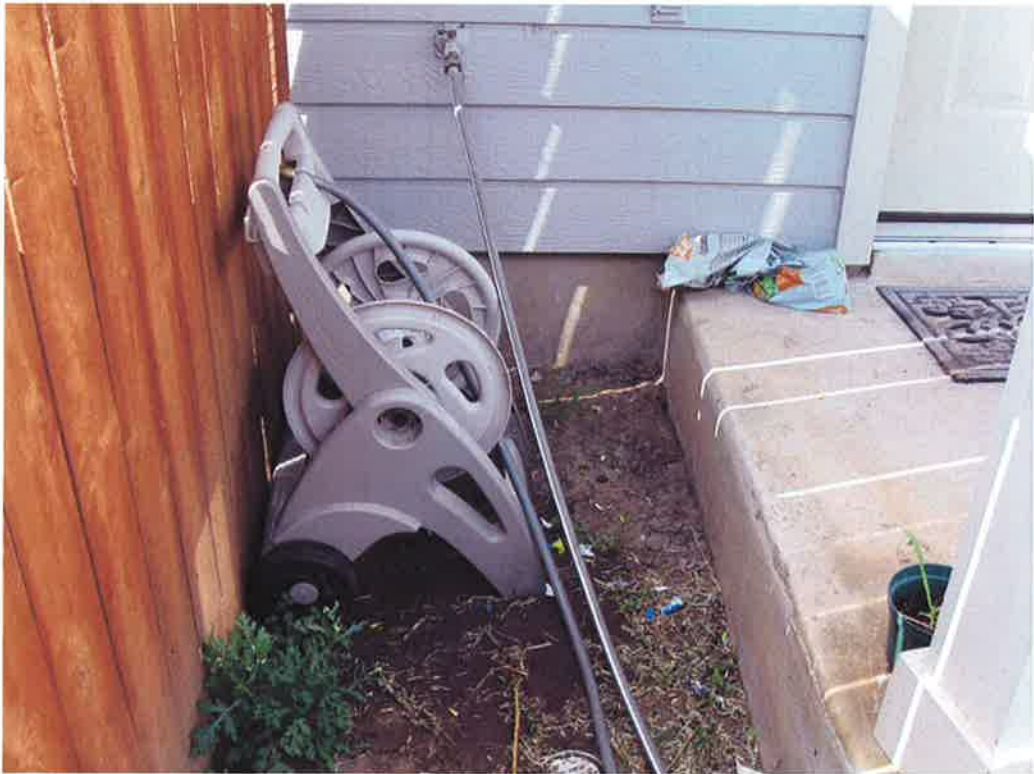
**PHOTOGRAPH 14**

- There is a low spot in between the cedar fence and the porch slab as shown on Photograph 14 in Attachment B.
- There polyvinyl chloride (PVC) condensate drain line extends approximately 4-ft from the perimeter grade beam as shown on Photograph 15 in Attachment B.
- There is a vertical separation between the electric meter box and the conduit pipe that varies up to about 1-inch as shown on Photograph 16 in Attachment B.
- Dry soil conditions were observed along the perimeter grade beam where a horizontal separation has developed between the soil and the grade beam as shown on Photograph 17 in Attachment B.

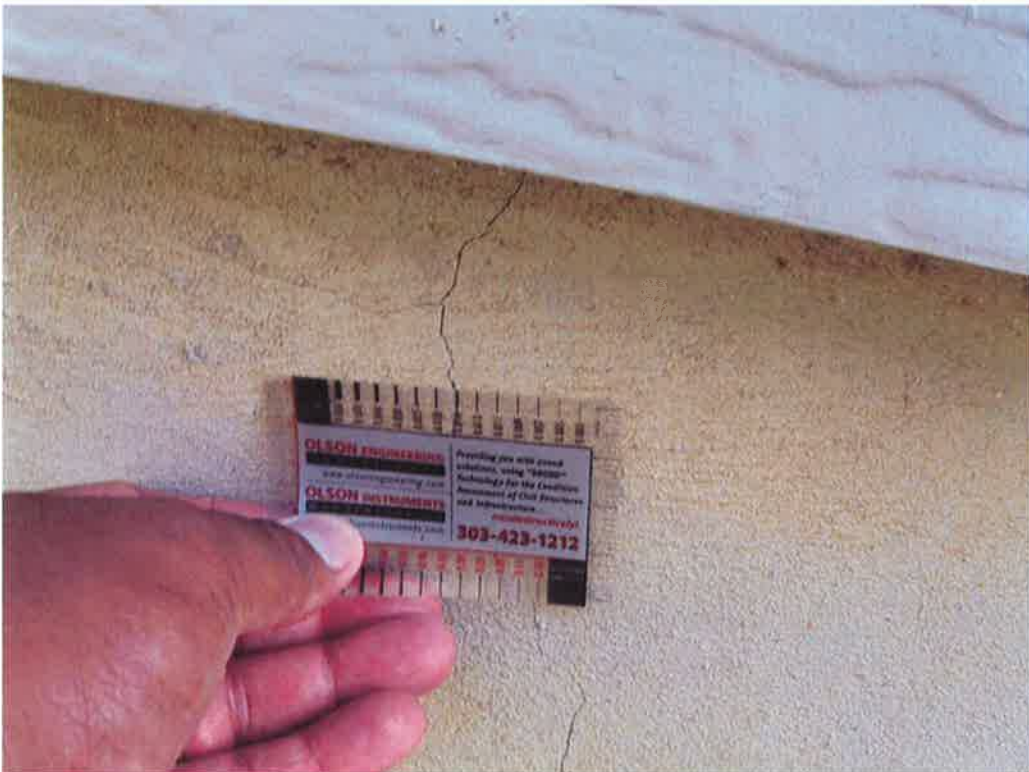
**PHOTOGRAPH 22**

- The cracks in the concrete grade beams are plastic shrinkage and dry shrinkage cracking and crack widths are related to soil movements supporting the foundation.
- The movements are not associated with plumbing leaks; however, this should be confirmed by performing plumbing leak testing.
- The sheetrock butt joint separations can be corrected using standard repair materials and methods as required.
- The beam depths measured by Fugro, Inc., at two particular locations did not achieve the specified beam depth. It is our judgment that this has not adversely affected the performance of the foundation.
- The concrete foundation supporting the home and the wood frame is considered structurally adequate.
