Project No. ASR08-055-00
October 8, 2008

**RE: Consulting Engineering Services
Residential Study
1503 NW 26th Street
San Antonio, Texas**

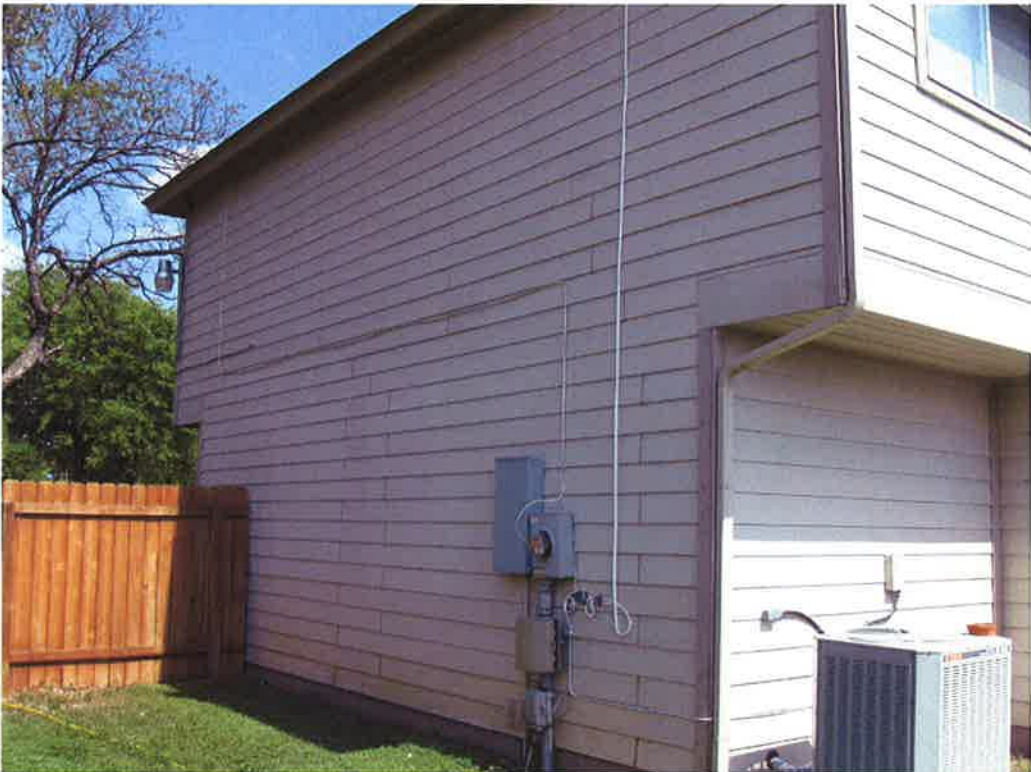
PHOTOGRAPH 2

- The ground surface along the right side of the home is relatively flat.
- Butt joints between the fiber cement board siding have been re-caulked as shown on Photograph 2 of Attachment B.
- There is a horizontal separation between the soil and the perimeter grade beam along the right side of the home that varies up to about 5/8-inch in width, as shown on Photograph 10 in Attachment B.

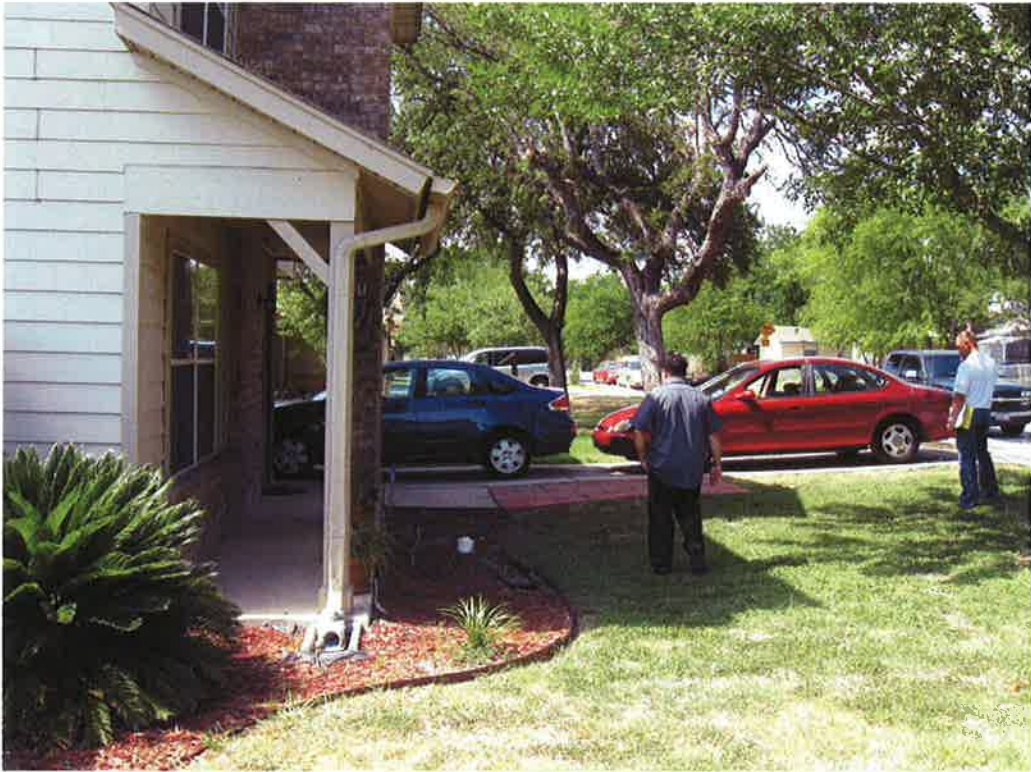
PHOTOGRAPH 5

- Surface grading is considered poor with the ground sloping toward the foundation as shown on Photograph 5 of Attachment B.
- The metal edging located along the front planter bed traps runoff water within the planter and against the foundation as shown on Photograph 5 of Attachment B.

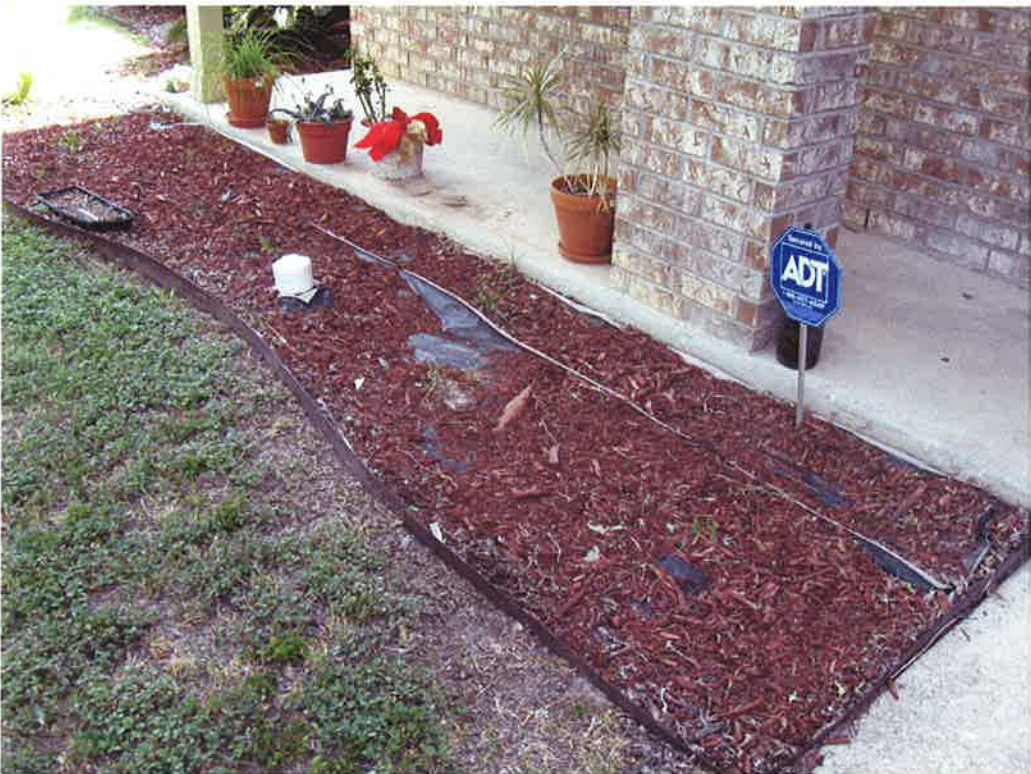
PHOTOGRAPH 6

- The downspout located at the left-front corner of the porch exits onto a splash block located within the planter bed as shown on Photograph 6 of Attachment B.

- In order to help control the effects of surface water around the home, all water draining off the roof eaves should be collected and redirected to drain to the street located along the front of the residence.
- Thoroughly clean the cracks in the garage floor slab and seal them with a urethane crack sealant.
- Patch and re-paint the Sheetrock crack in the partition wall between the master bedroom and closet.
- Adjust the doors to open and close correctly.

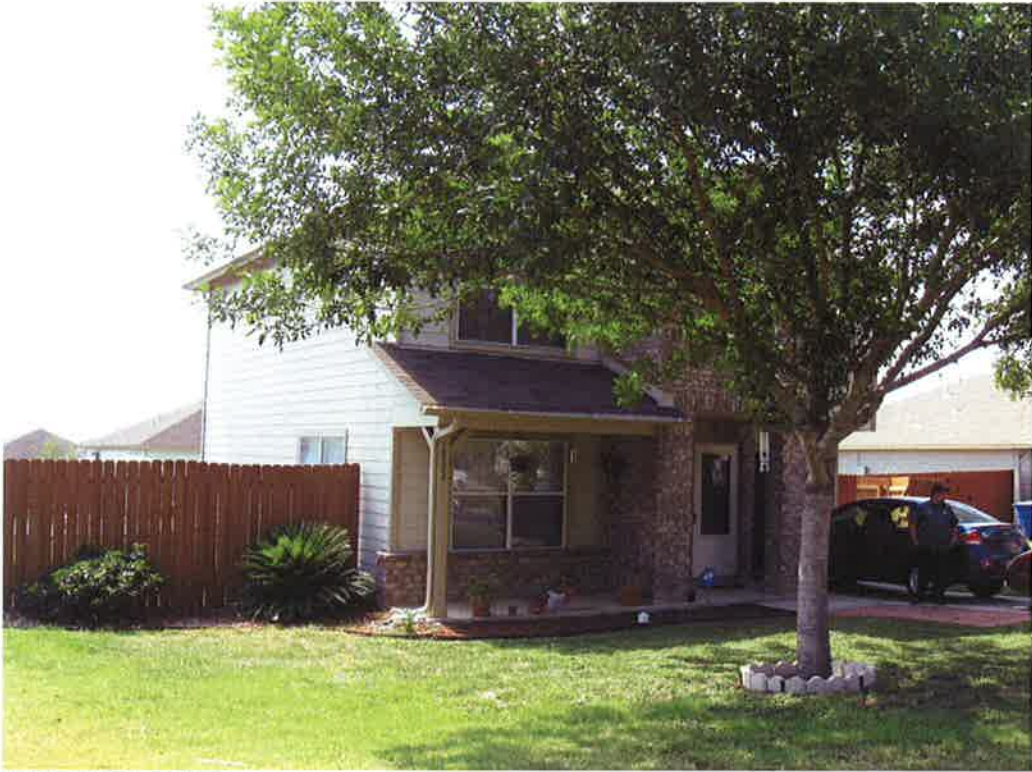
PHOTOGRAPH 7

- There are two large trees located in the front yard. The tree located closest to the foundation is approximately 15-ft in front of the porch as shown on Photograph 7 of Attachment B.

As stated earlier, there are two large size trees located in the front yard, with the closest tree located about 15 feet from the porch foundation. Additionally, there is a planter bed located along the front of the porch and at the right-front corner of the garage. Trees and other large plants can remove water from the soils beneath the foundation via their root systems. The reduction of water content in expansive clay soils can cause shrinkage in the soils resulting in reduced support and downward movement of the foundation in the vicinity of the tree(s). The roots of trees generally extend past the extents of their drip lines (canopies). It is believed that some species of trees growing closer to the foundation that 1-1/2 times their ultimate height can affect the building foundation. We believe that this tree may be contributing to movement of the foundation near the front of the home.

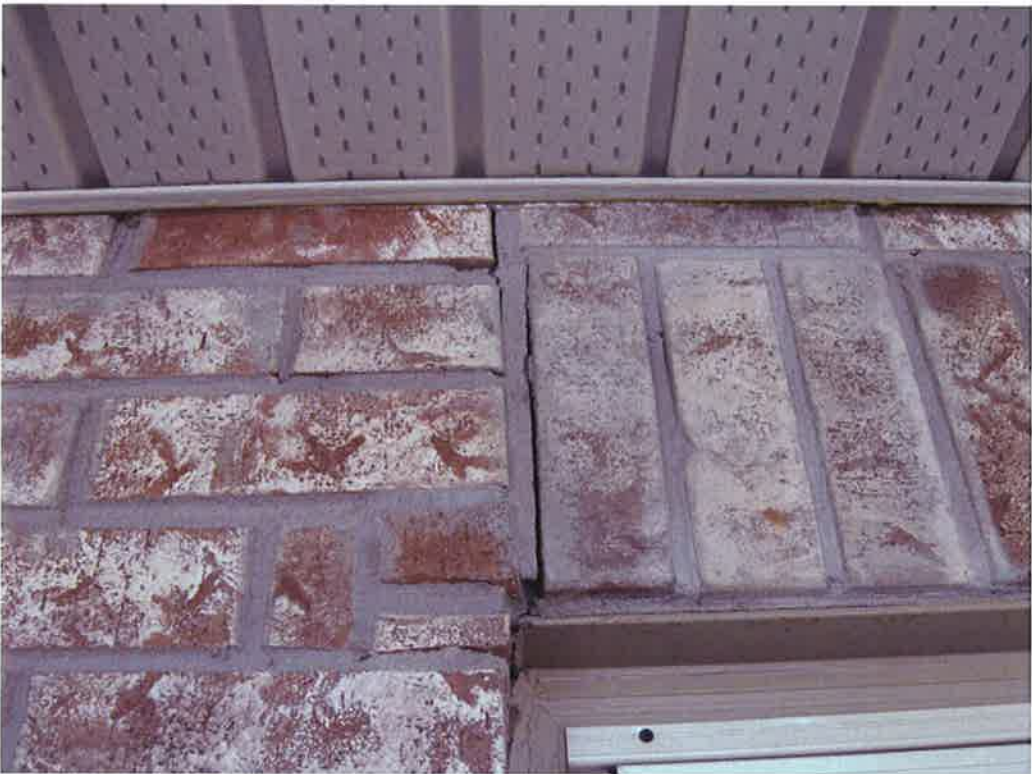
PHOTOGRAPH 8

- There is about a 1/8-inch wide vertical mortar joint separation within the brick veneer located above the front door as shown on Photograph 8 of Attachment B.

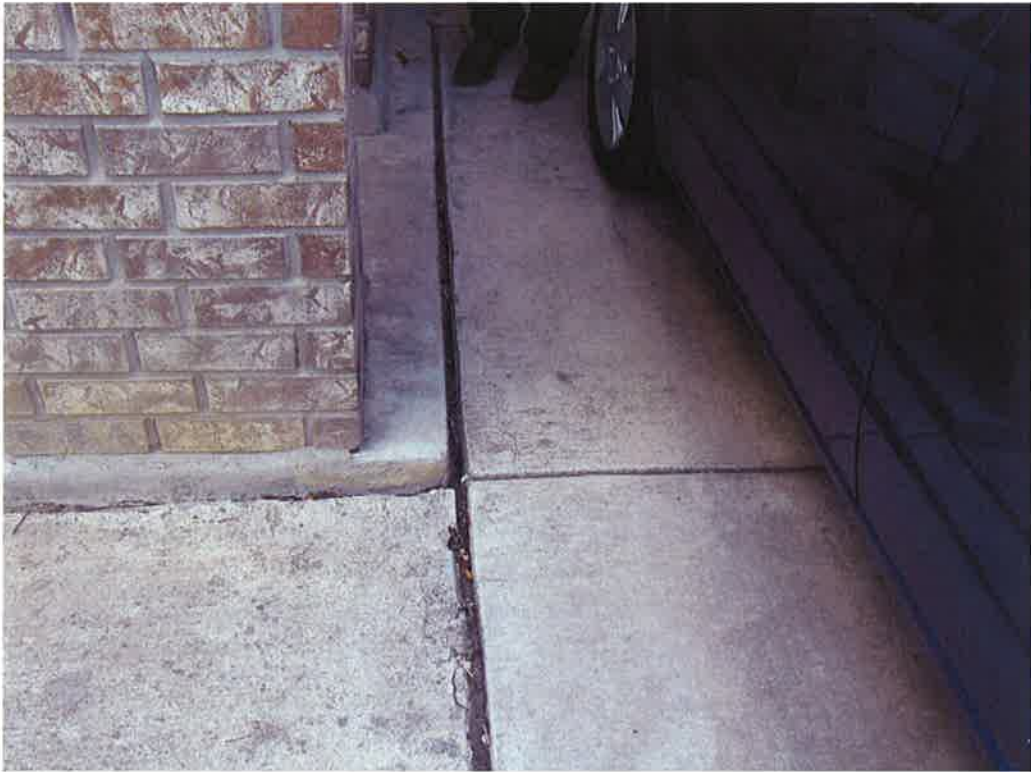
PHOTOGRAPH 9

- There is about a 3/4-inch wide horizontal separation at the joint between the porch foundation and the driveway slab and the fiberboard joint filler has collapsed within the joint as shown on Photograph 9 of Attachment B.

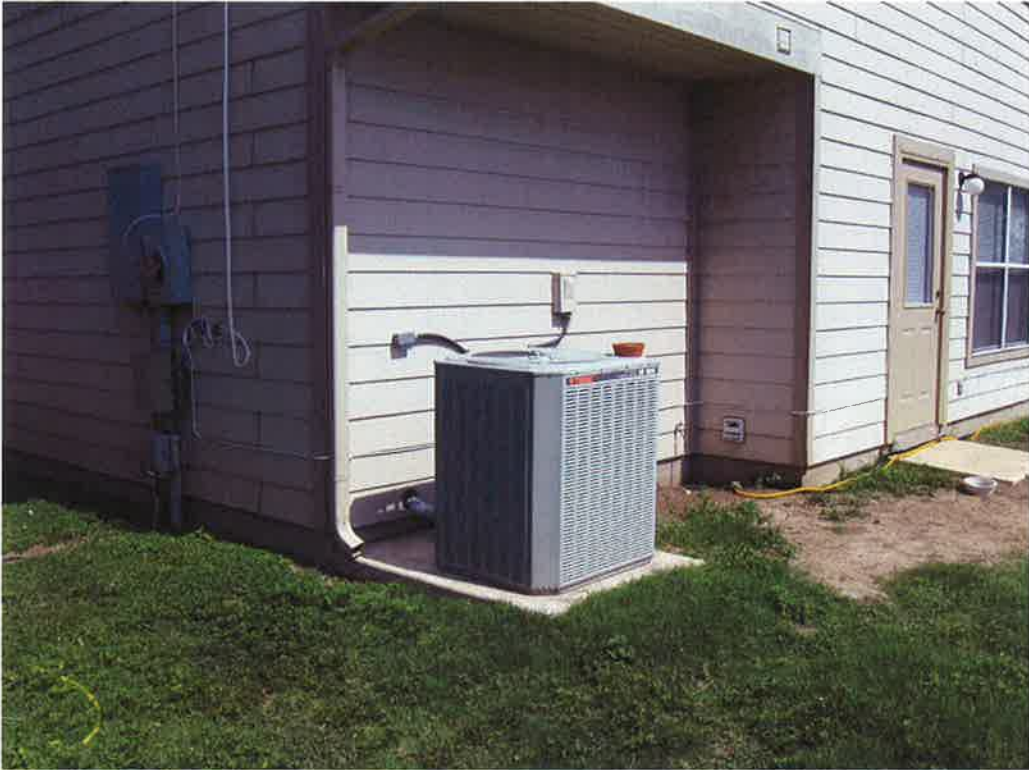
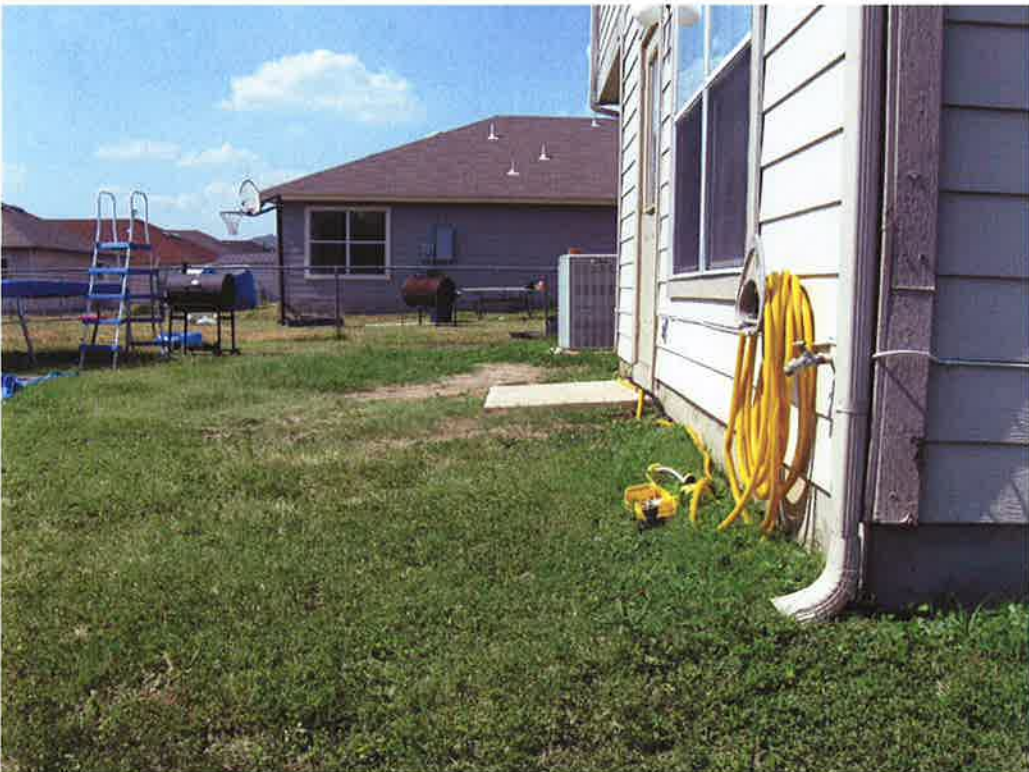
- The downspouts located at the right-rear and left-rear corners of the home exit adjacent to the foundation as shown on Photographs 11 and 12, respectively, of Attachment B.
- The ground surface has a gentle slope away from the foundation. However, there are several low spots in the yard located adjacent to the foundation where runoff water can pond as shown on Photographs 12 and 13, respectively, of Attachment B.
- There is a diagonal crack in the left-front corner of the concrete back door stoop slab that varies up to about 1/16-inch in width.
- There is a previously repaired crack in the vertical face of the perimeter grade beam where the back door stoop slab ties into the foundation as shown on Photograph 14 of Attachment B.

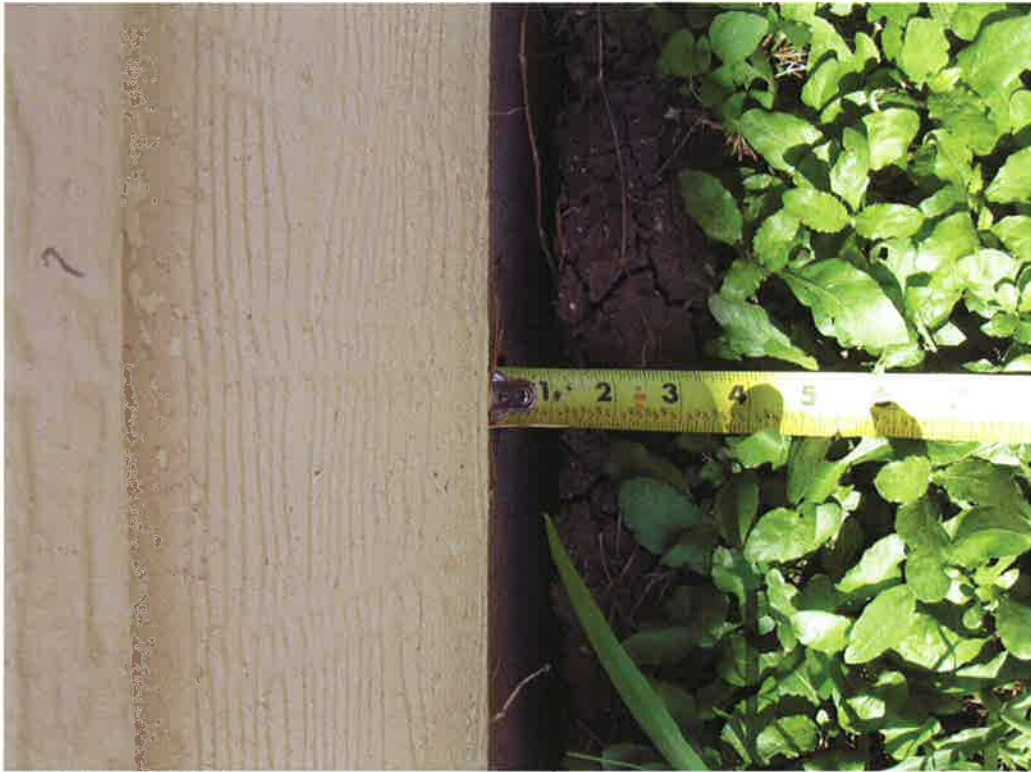
PHOTOGRAPH 15

- The ground surface has a gentle slope away from the foundation.
- There is a horizontal separation between the soil and the perimeter grade beam along the left side of the home that varies from about 3/4-inch to 1-1/4-inches in width, as shown on Photograph 15 of Attachment B. The depth of the separation was measured to be at least 4-inches.
- The HVAC condensate drain pipe exits adjacent to the left exterior grade beam as shown on Photograph 16 of Attachment B. The ground surface was wet and higher in elevation where the drain pipe is located than the rest of the ground surface along this side of the home. In addition, algae staining is on the siding beneath the drain line.

- Irrigation should be controlled within a 10-foot zone around the perimeter of the home. The moisture content of the surface clay soils should be maintained at a uniform condition year round. The ground within this area should not be allowed to become dry to the point where the ground cracks and pulls away from the foundation. This is particularly true of this residence where these conditions were noted along the left and right sides of the foundation. Water should also not be allowed to pond in these areas or near the foundation.

- The soils in the yard need to be maintained adjacent to the foundation year round. This can be managed by watering along the perimeter of the foundation with soaker hoses connected to 12-foot long garden hoses that are attached to the hose bibbs along the exterior of the home. The soaker hoses can be laid out in an "S" pattern extending preferably five feet, if property lines allow, away from the foundation as shown on Figure 3 of Attachment A of this document. Generally, slow soaking watering for a maximum of about 4 hours per week will provide a uniform water content in the yards surface soils during dry weather conditions. The flow rate of the water through the soaker hoses should be

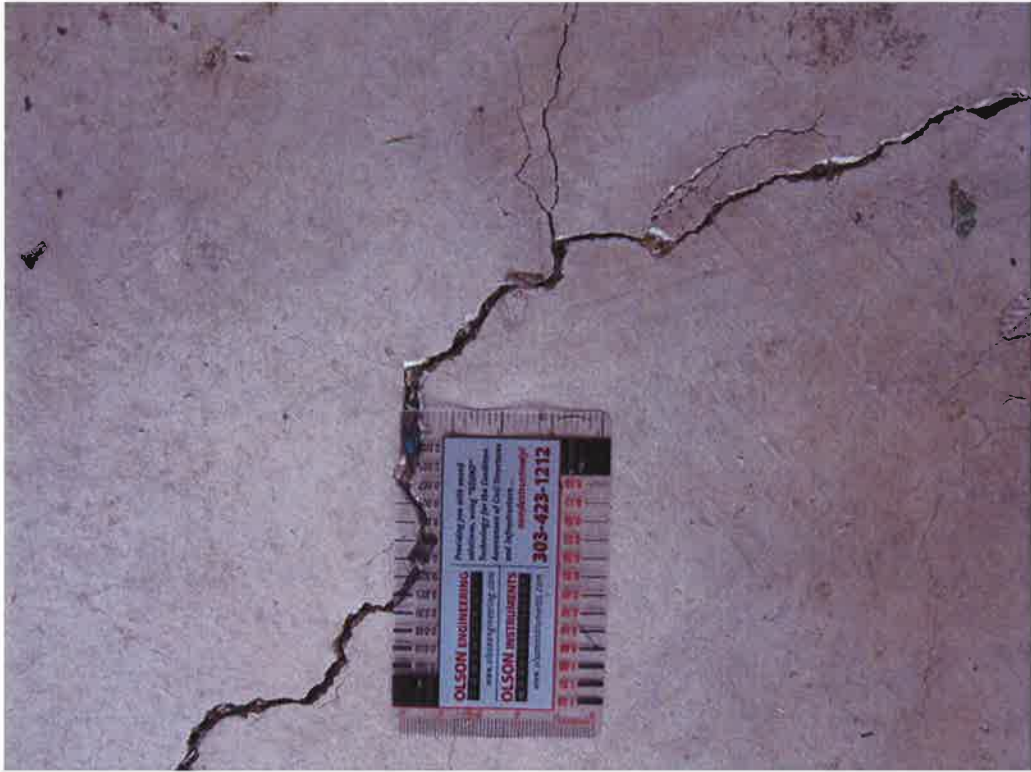
PHOTOGRAPH 17

- Cracks were observed in the concrete floor slab and were measured to range from hairline up to about 1/8-inch in width as shown on Photograph 17 of Attachment B.

With the exception of some localized movements that have occurred between the kitchen and the left-front corner of the living room, the floor slab is relatively flat and is performing within the boundaries for floor slab elevation differentials in the San Antonio locale. In general, the random cracking conditions observed in the floor slab at the time of our site visits are considered to be minor and is not a structural deficiency.

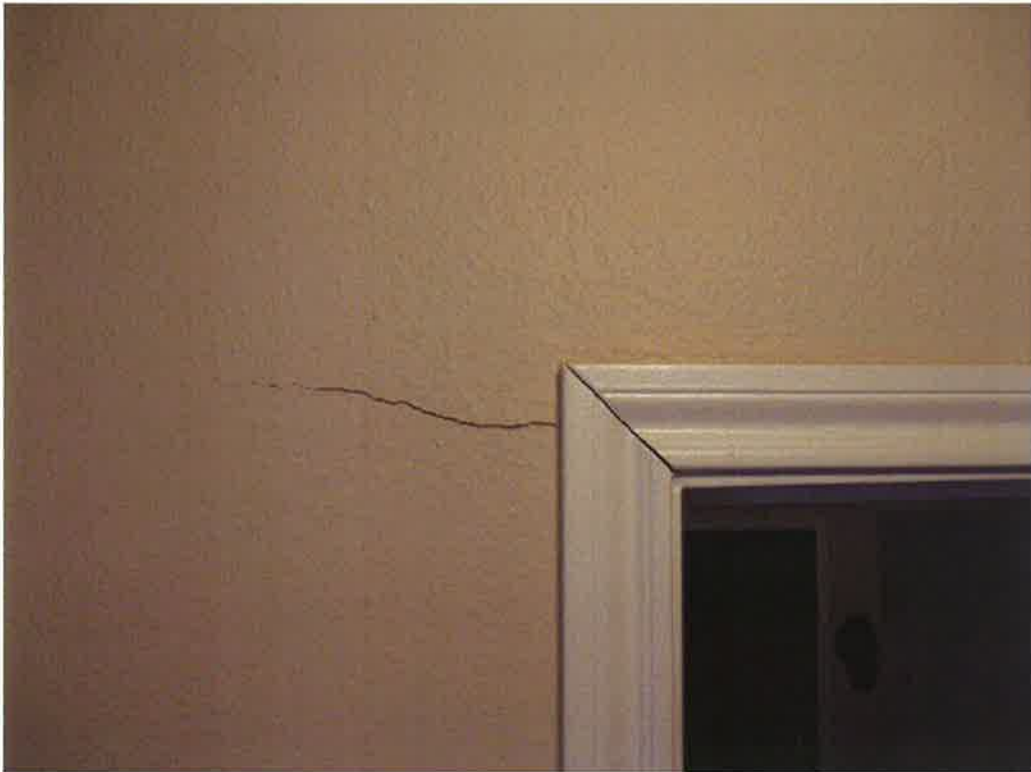
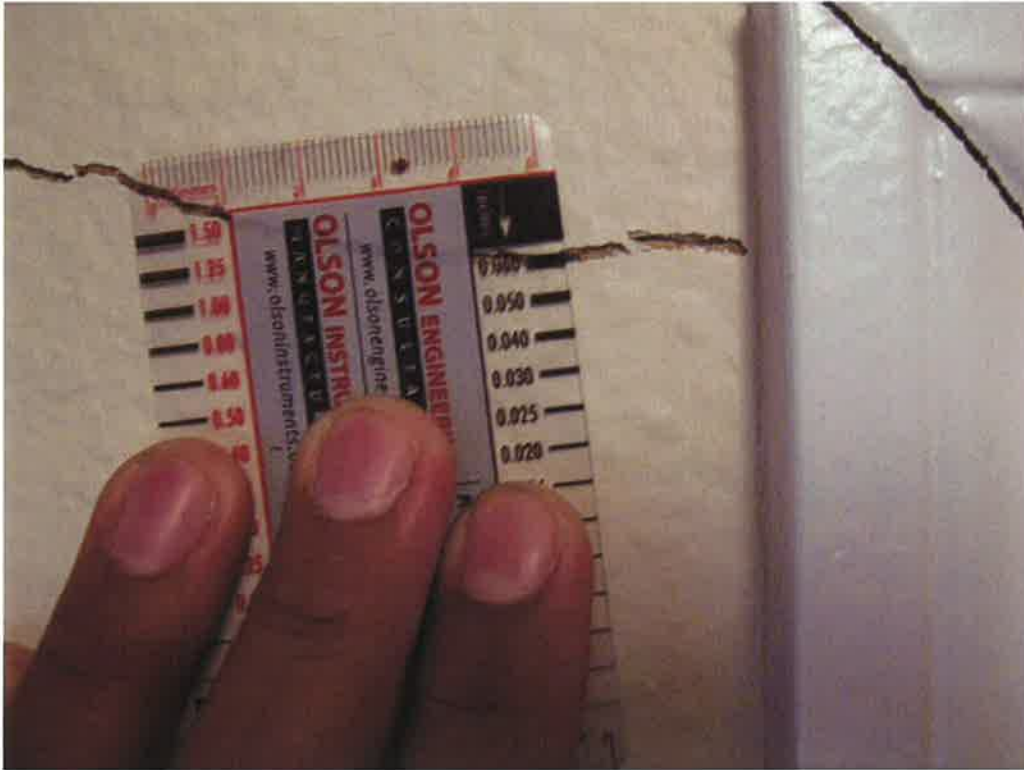
- There is a horizontal sheetrock crack near the top-front corner of the closet doorframe that telegraphs through the partition wall, into the closet, and varies up to about 1/16-inch in width as shown on Photographs 18 and 19 of Attachment B. This crack is reflected through the wall.
- Inside the closet, there is a separation at the top-front corner of the wood trim located along the doorframe that varies up to about 0.05-inch in width.
- The closet door does not close completely.

- The Sheetrock crack in the partition wall between the master bedroom and closet, the cracking conditions observed at this home appear to be a result of some soil-related movements. These movements are likely a result of a combination of variations in climatic conditions, vegetation effects, and surface grading conditions around the home.
- The cracks in the concrete foundation are plastic shrinkage and dry shrinkage cracking and crack widths are related to soil movements supporting the foundation and are not a structural deficiency.
- The monolithic beam and slab on ground reinforced concrete foundation supporting the home and the wood frame are considered structurally adequate.

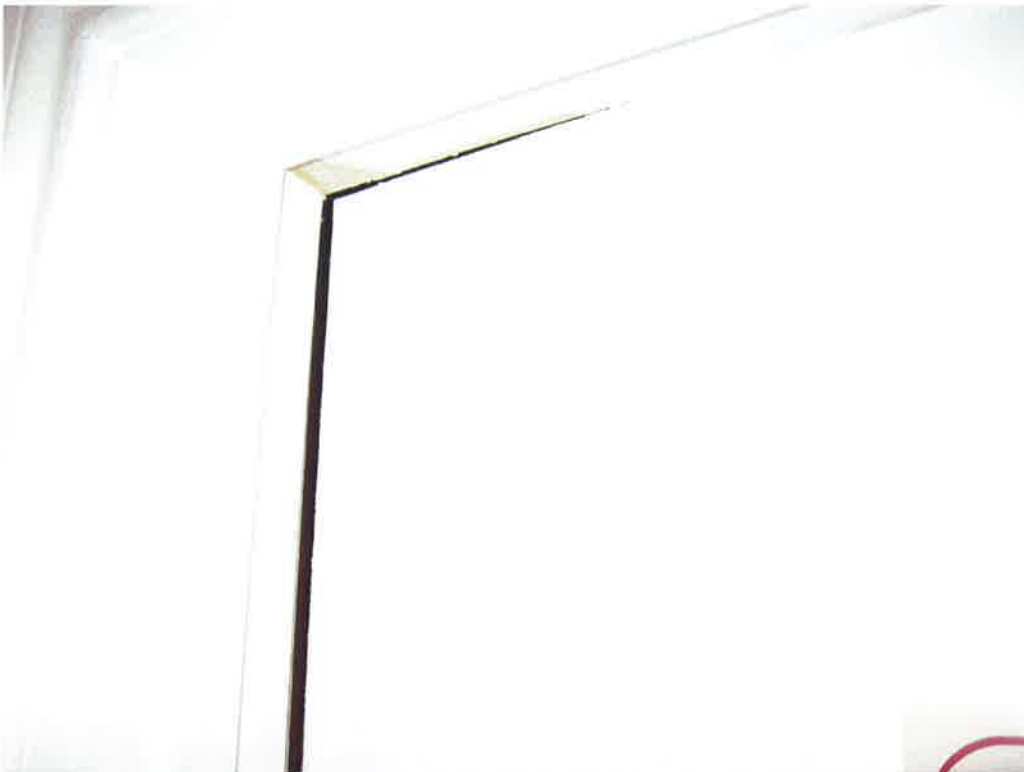
PHOTOGRAPH 20

- The bedroom door does not close completely as shown on Photograph 20 of Attachment B.
