FIELD REPORT 0806 - 07

JUNE 11, 2008

PROJECT Testing of windows and structural wall area at the perimeter of the window unit for verification of resistance to water penetration. Exterior wall material had been removed and new flashing material installed between the window frame and structural wall material. Some of the existing sliding window units had been removed and new units installed. Exterior finish wall materials reinstalled, sealed and repainted.

June 11, 2008
 TEST LOCATION No 11
 1603 NW 26th Street

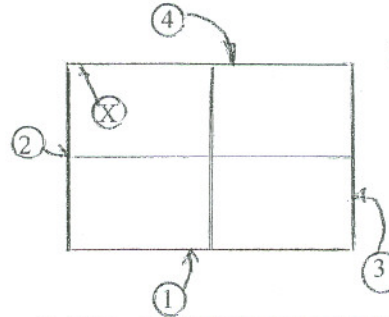
WINDOW NUMBER 1

No water penetration to the interior
 Between window frame and wall observed

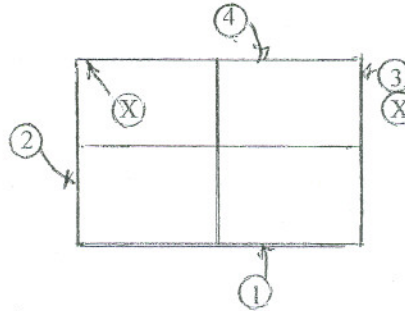
WINDOW NUMBER 5

No water penetration to the interior
between window frame and wall observed

- Application 3
Water on interior of
glass 1" from jamb
flows down to top of
vent panel.
- Application 4 no
water penetration

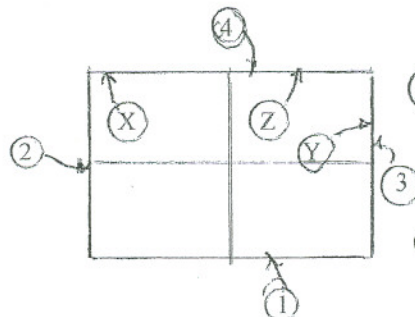
WINDOW NUMBER 6

No water penetration to the interior
between window frame and wall observed

- Application 2
Water on glass.
No water during
application 4
- Water between glass
and frame at bottom
half of glass
- Water on interior
of glass 10 inches
from jamb.
Top of glass can
be moved by
pushing on glass
