Aladdin Environmental LLC

Re: 315 Villa Rosa, San Antonio, TX

Aladdin Environmental is pleased to submit this environmental evaluation on the above residence located at 315 Villa Rosa, San Antonio, TX. This limited evaluation was performed on June 5th, 2008. We have observed the standard of care generally exercised by the profession under similar circumstances and conditions to complete this report.

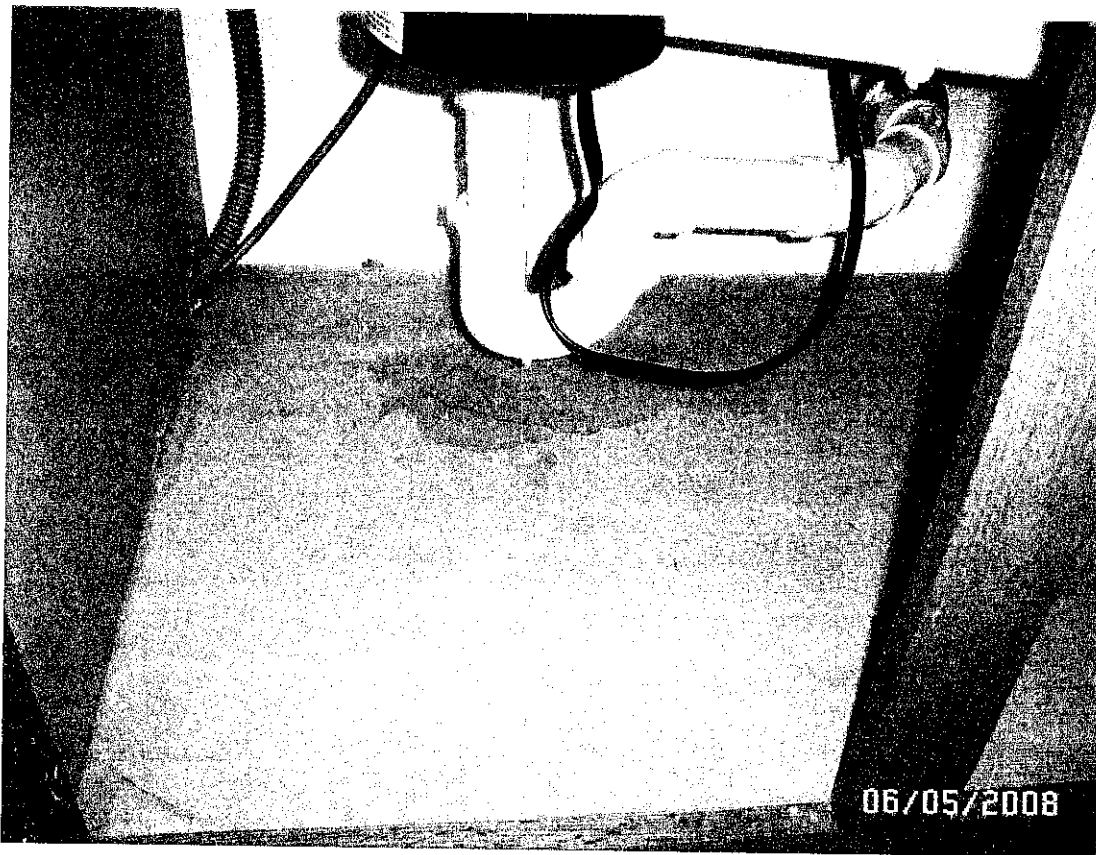
- Kitchen – There is a minor discolored area on the shelf below the sink from a previous drip. There was sheetrock damage next to the back door from what appears to be from a pet.

water spots below kitchen sink

- Recommend cleaning the shelf below the sink and confirming there is no plumbing leak present.
 - Recommend removing & replacing the caulk around the window and cleaning the window sill.

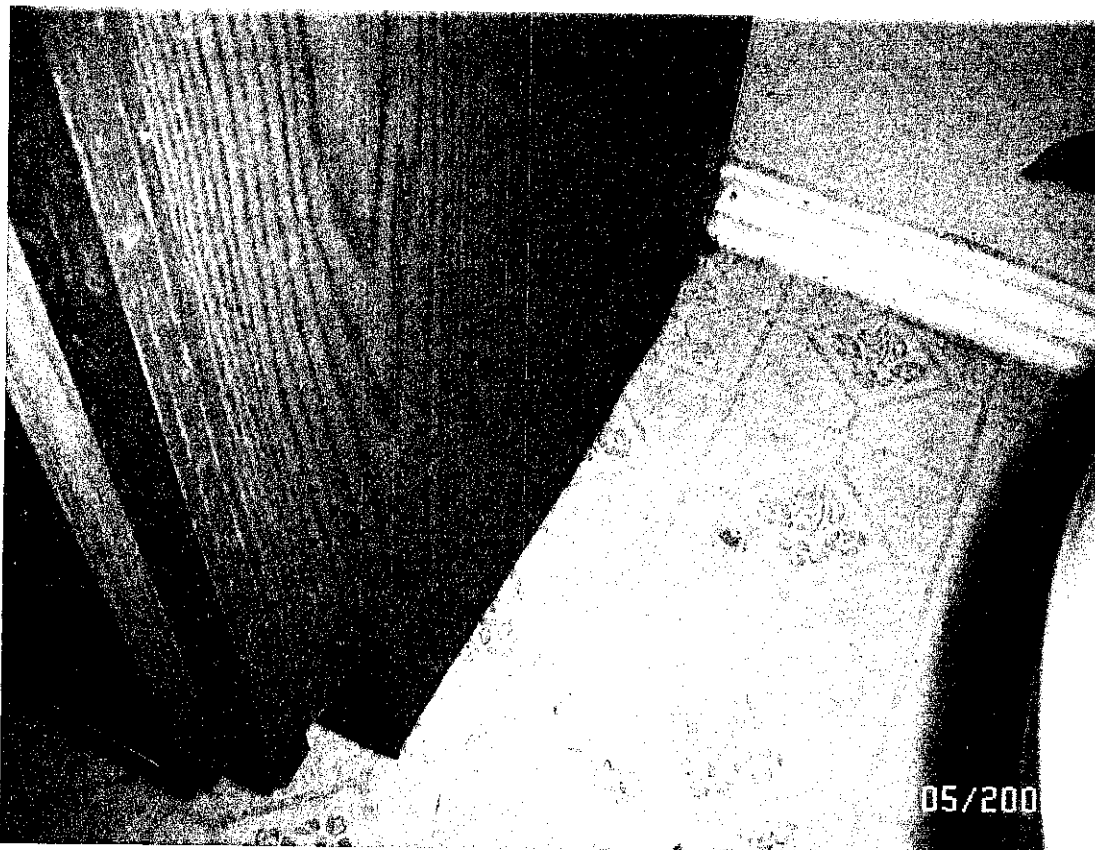
- Hall Bathroom – There is water damage on the base of the vanity.
 - Recommend removing & replacing the vanity. If any sheetrock damage is found during removal, the assessment consultant should be notified

Hall Bath - water damage to base of vanity
