FIELD REPORT 0806 - 07

JUNE 11, 2008

PROJECT Testing of windows and structural wall area at the perimeter of the window unit for verification of resistance to water penetration. Exterior wall material had been removed and new flashing material installed between the window frame and structural wall material. Some of the existing sliding window units had been removed and new units installed. Exterior finish wall materials reinstalled, sealed and repainted.

TEST LOCATION No 7
4019 San Luis

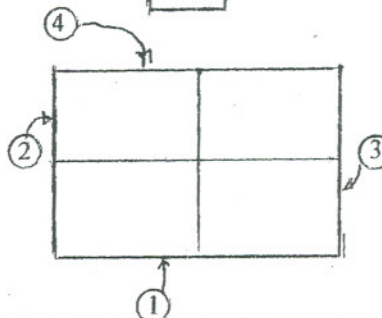
WINDOW NUMBER 1

No water penetration to the interior
between window frame and wall observed.

TWO 3'-0" x 5'-0" SINGLE HUNG UNITS

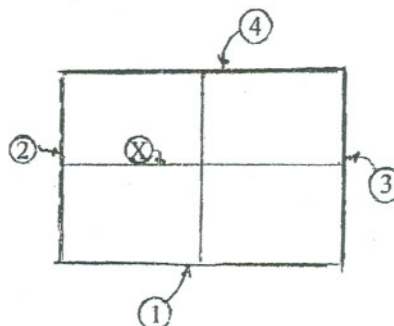
WINDOW NUMBER

No water penetration to the interior
between window frame and wall observed

(X) Water between glass and seal.
Bottom of glass not tight at frame.

TWO 3'-0" x 5'-0" SINGLE HUNG UNITS
