FIELD REPORT 0806 - 02

JUNE 4, 2008

PROJECT Testing of windows and structural wall area at the perimeter of the window unit for verification of resistance to water penetration. Exterior wall material had been removed and new flashing material installed between the window frame and structural wall material. Some of the existing sliding window units had been removed and new units installed. Exterior finish wall materials reinstalled, sealed and repainted.

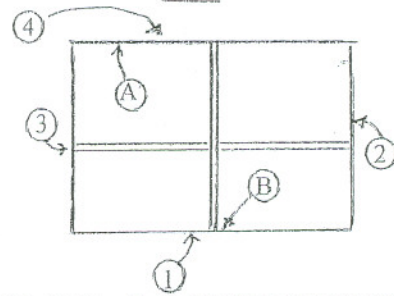
WINDOW NUMBER 1

No water penetration to the interior between window frame and wall observed.

- (A) Water entered between glass and seal at top of glass flowed down interior surface of glass.
- (B) Water on wood sill. Appeared to have penetrated corner joint of window frame.

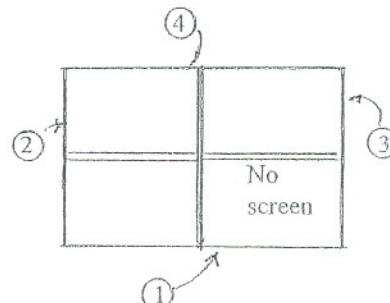
WINDOW NUMBER 5

No water penetration to the interior observed.
