Project No. ASR08-044-00  
September 22, 2008

**RE: Consulting Engineering Services  
Residential Study  
402 Precious Drive  
San Antonio, Texas**

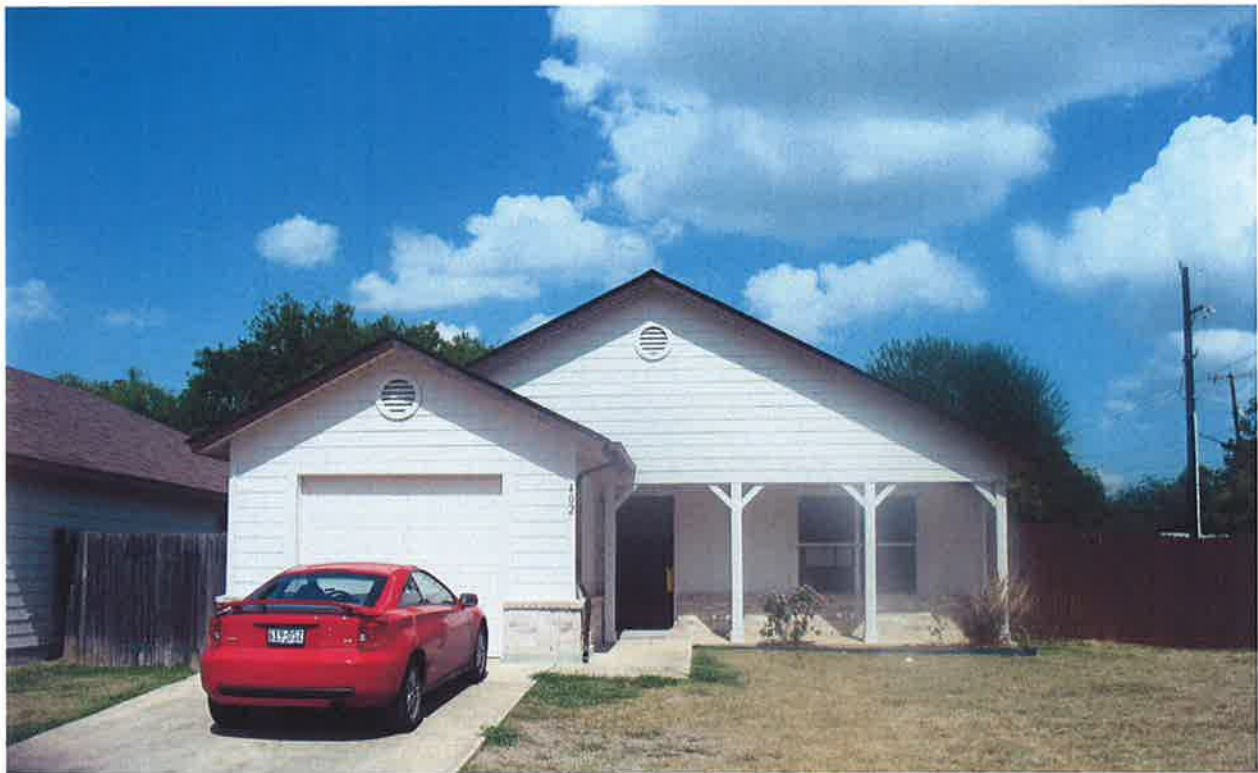
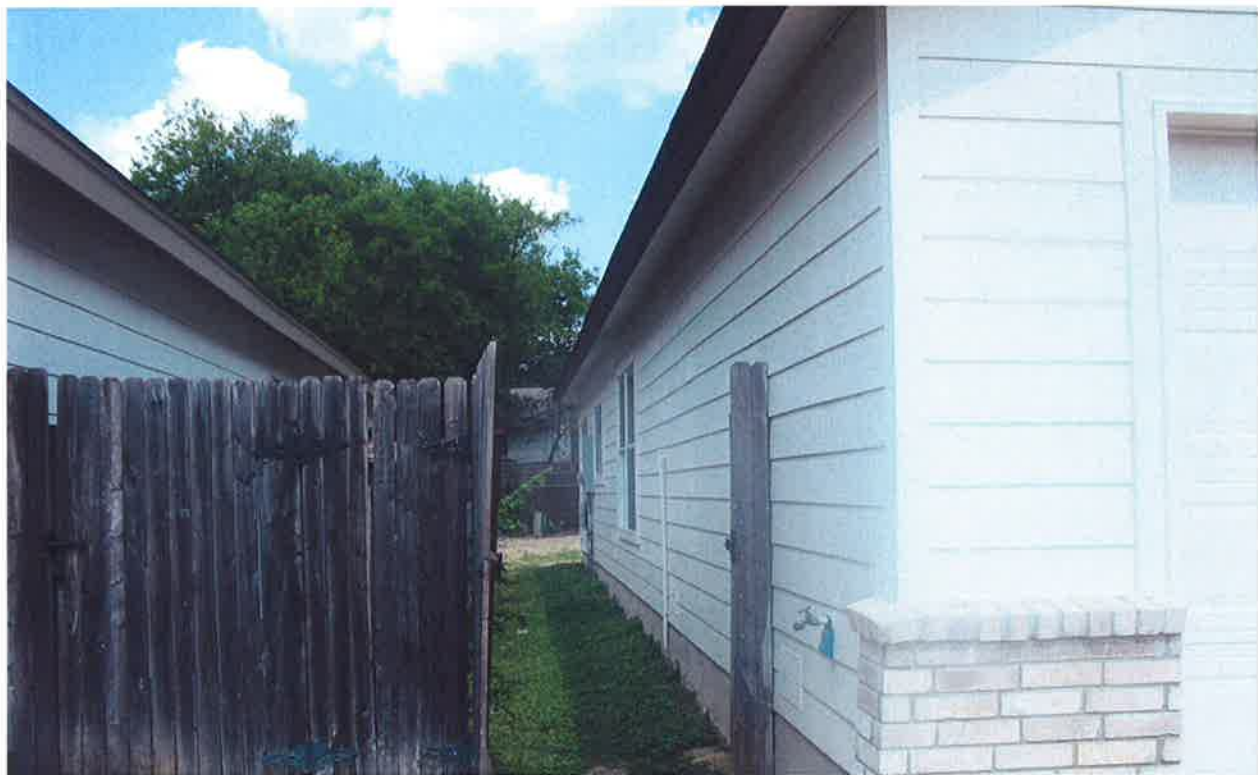
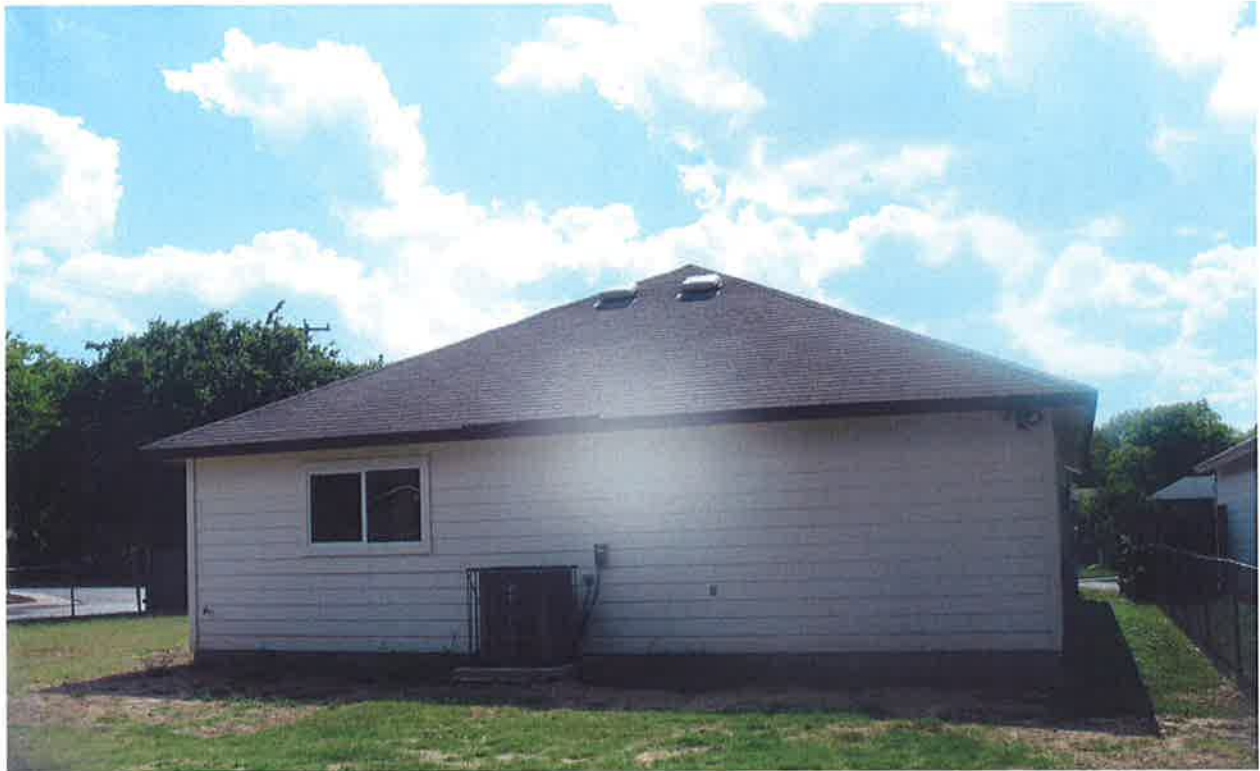
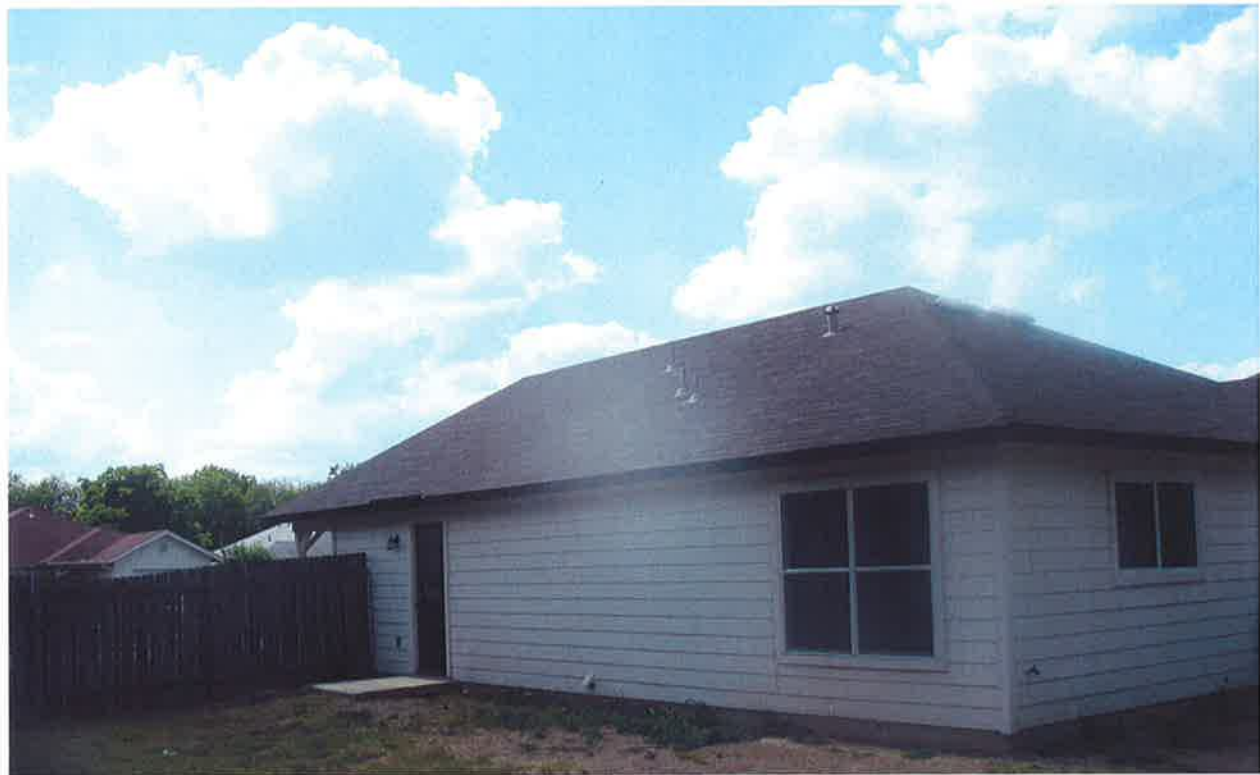
16-inches on center. The roof framing system consists of prefabricated wood trusses, with galvanized metal connections, spaced about 24-inches on center. At present, the slab-on-ground is covered with wall-to-wall carpet, with the exception of the kitchen, laundry room, and bathrooms, where it is covered with vinyl tile floor covering. The garage is exposed concrete located on the left side of the home. Views of the outside of the residence as it exists today are shown on Photographs 1 through 4 included in Attachment B in this document.

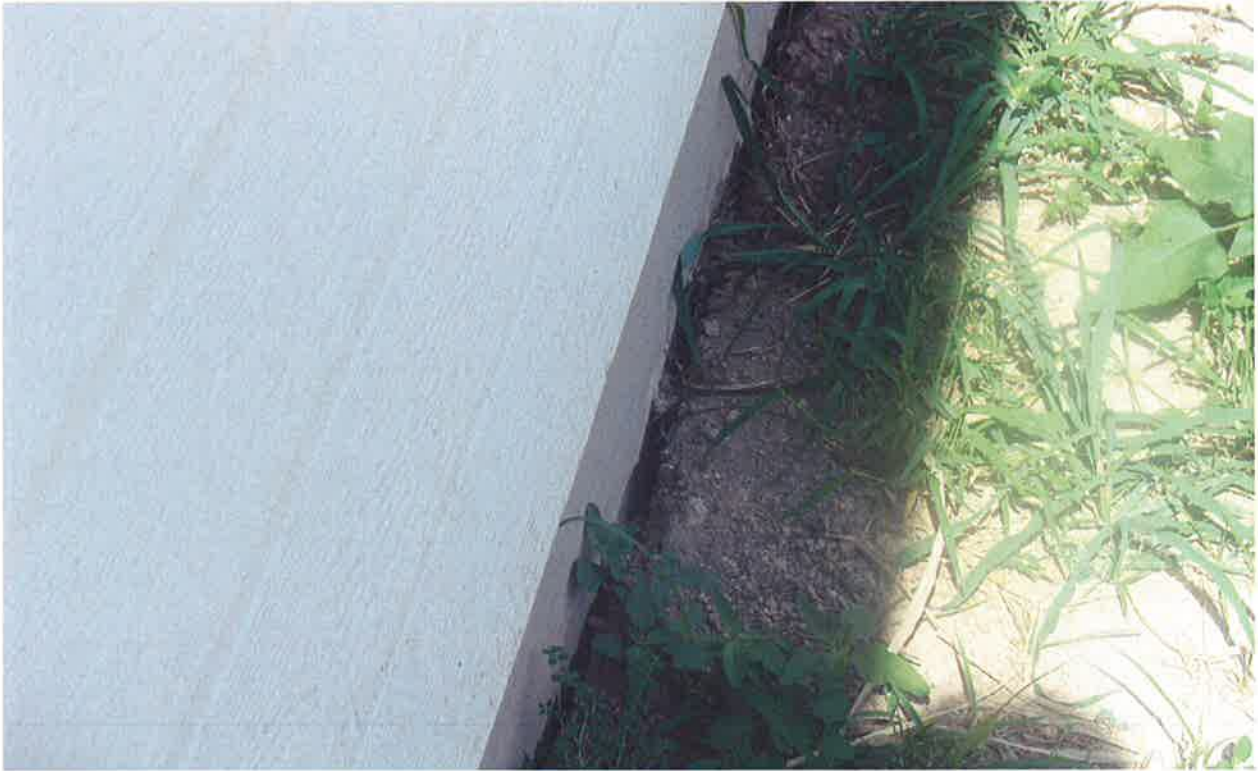
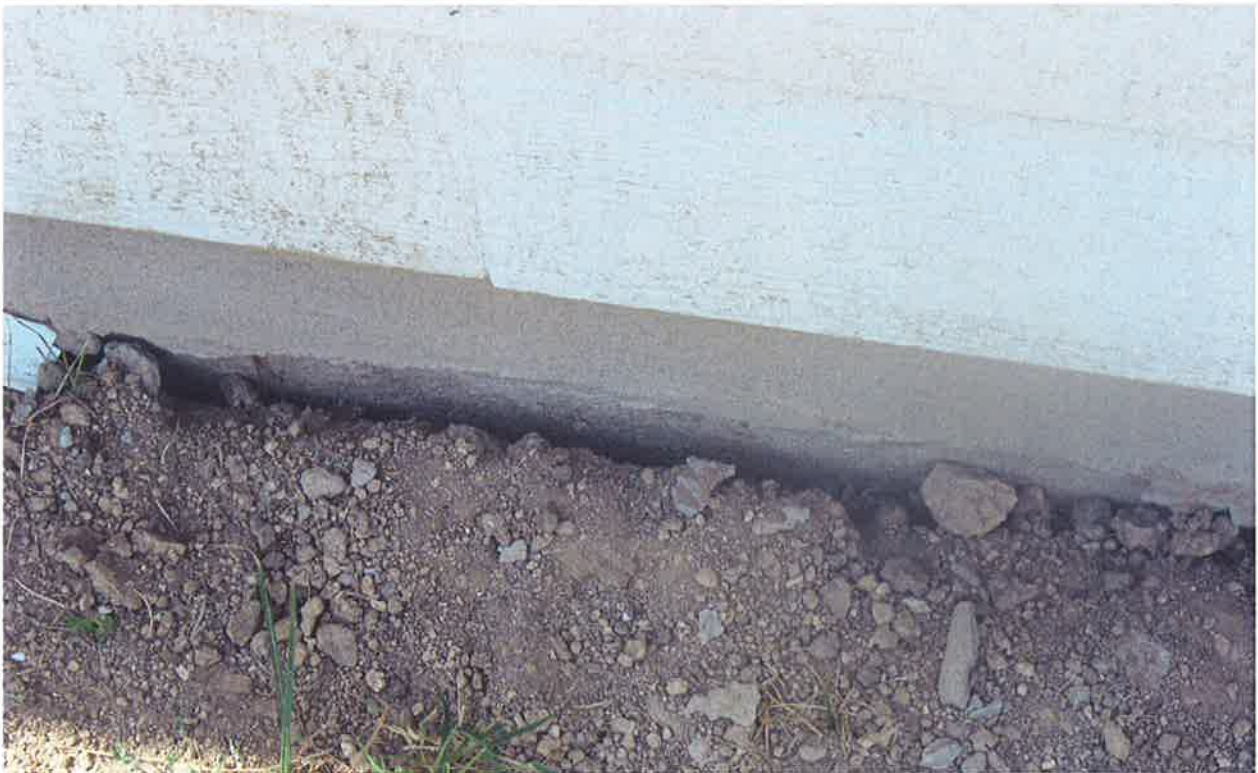
- A layer of neat cement coating was applied to the exposed portion of the concrete perimeter beams.
- A horizontal separation between the soil and the perimeter grade beam along the right side of the home near the kitchen side door as shown on Photographs 5 and 6, and at the left-front corner of the garage, as shown on Photograph 7 in Attachment B.

- Irrigation should be controlled within a 10-foot zone around the perimeter of the home. The moisture content of the surface clay soils should be maintained at a uniform water content condition year round. The ground within this area should not be allowed to become dry to the point where the ground cracks and pulls away from the foundation. This is particularly true of this residence where these conditions were noted along the right side of the foundation and at the left-front corner of the garage. Water should also not be allowed to pond near the foundation.

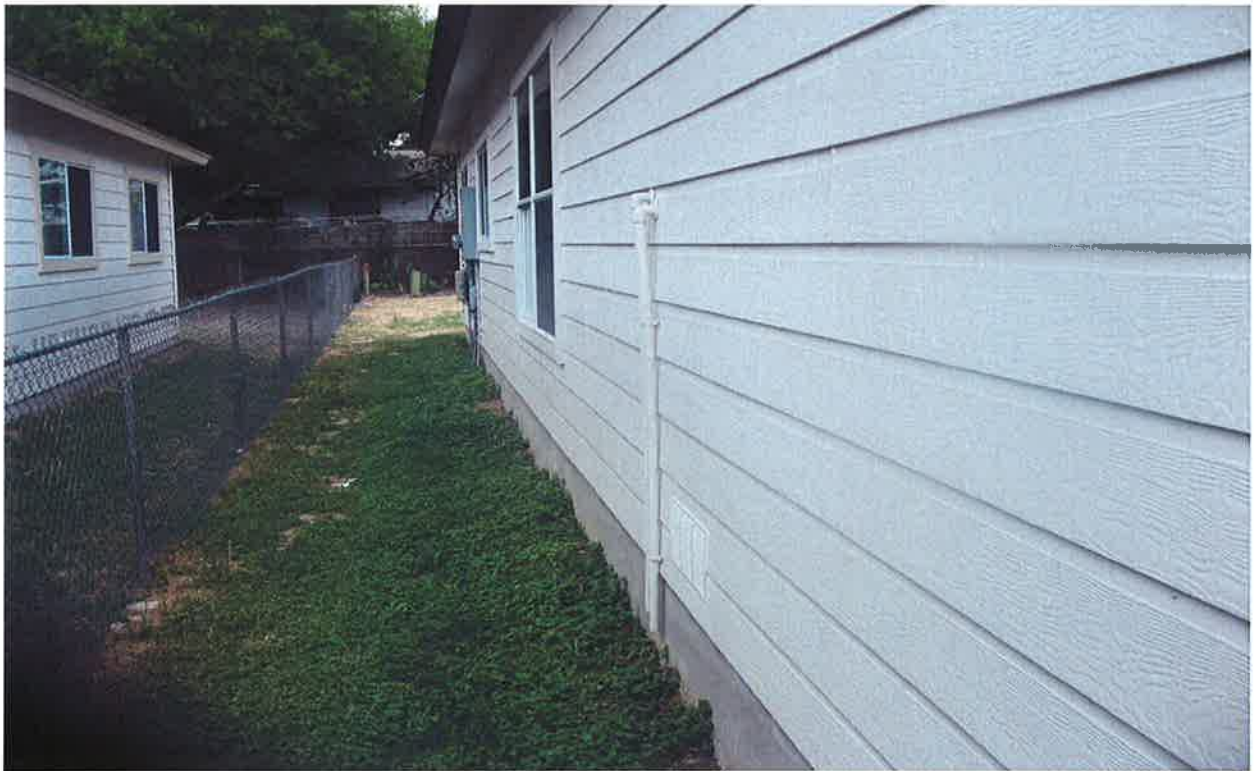
**PHOTOGRAPH 8**

- The polyvinyl chloride (PVC) water heater temperature/pressure relief (T/P R) drain pipe exits adjacent to the left exterior concrete grade beam as shown on Photograph 8 in Attachment B. The copper drain line, located along the right perimeter grade beam was abandoned once the hot water heater was replaced and two new PVC drain lines were installed.

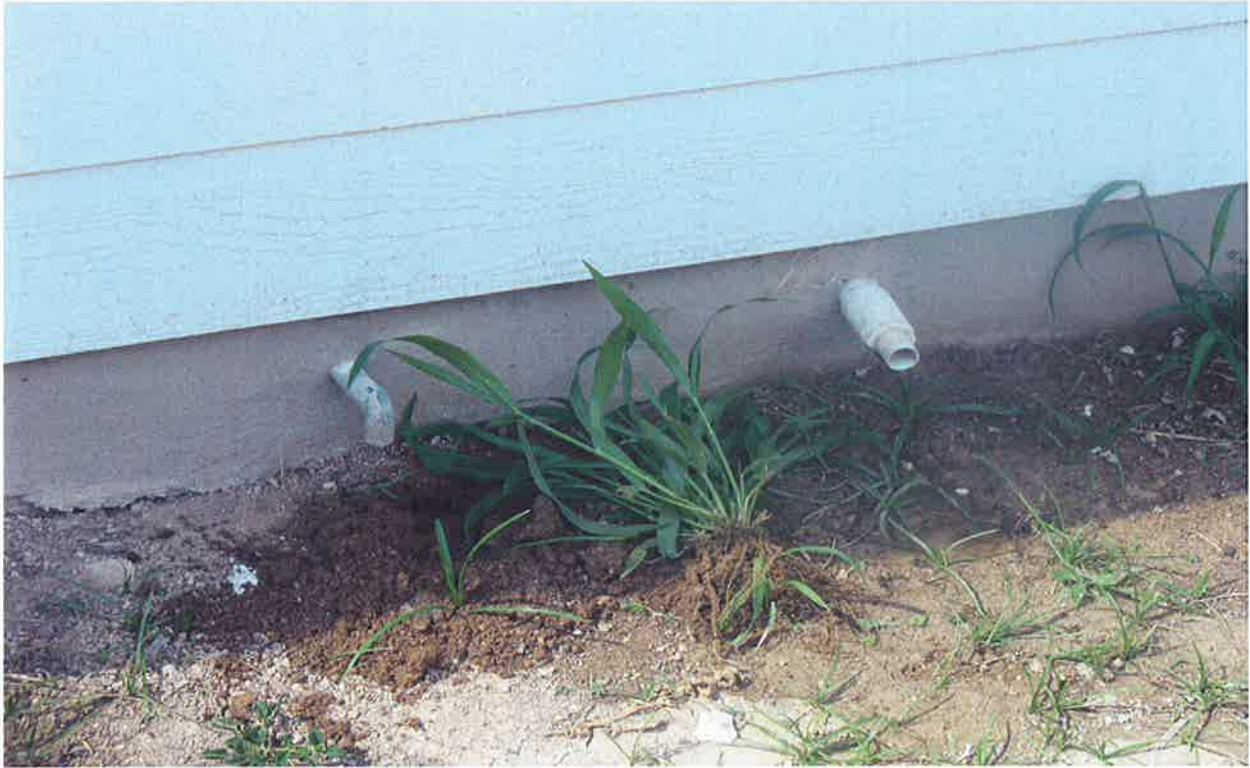
**PHOTOGRAPH 9**

- The HVAC condensate drain line empties adjacent to the right exterior concrete grade beam as shown on Photograph 9 in Attachment B. We encountered water directly underneath this line.

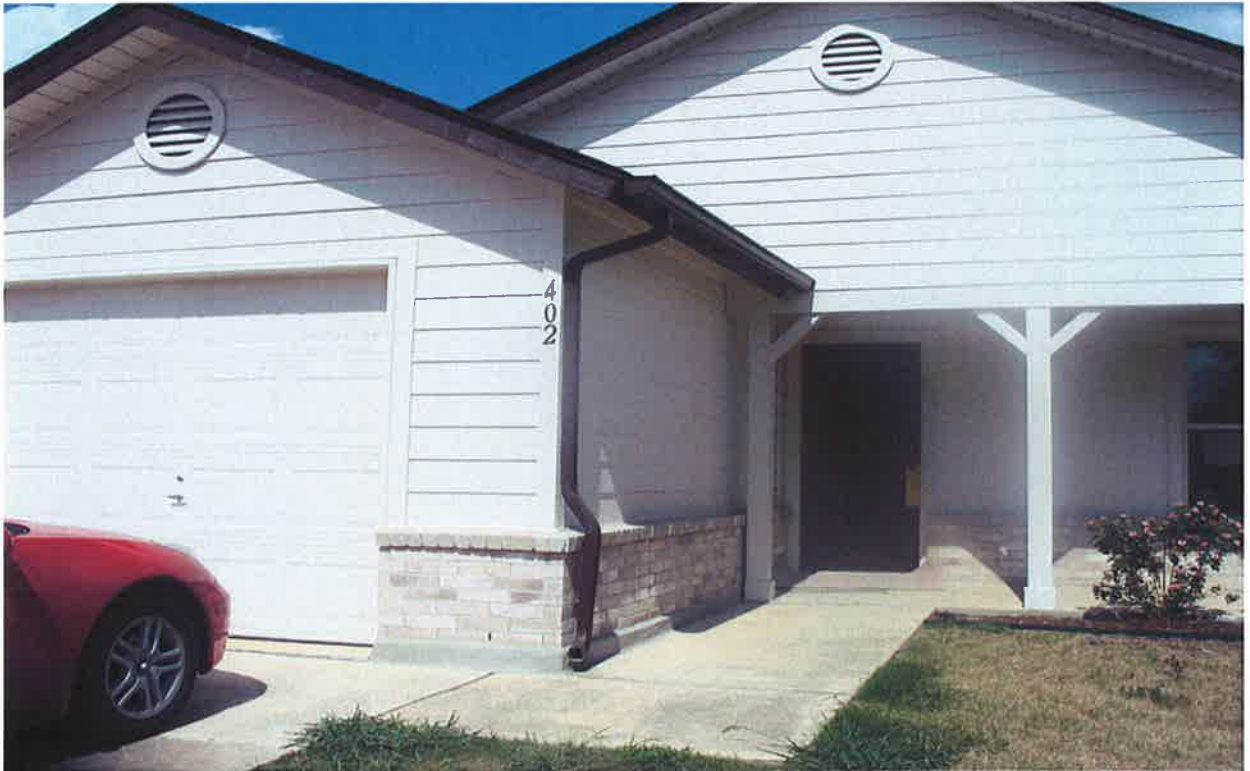
**PHOTOGRAPH 10**

- There is only one gutter and one downspout along the roof eaves of this residence. This gutter collects rainwater from the right portion of the garage roof and redirects the runoff to a downspout located on the right-front corner of the garage. The downspout, in turn, drains the rainwater directly onto the concrete walkway as shown on Photograph 10 in Attachment B.

Poor drainage conditions observed along the exterior of the home's foundation represents that there is an increased potential for soil-related differential movements that may affect the performance of the foundation and frame. With the exception of the gutter and downspout, located along the roof eave on the right side of the garage, runoff from the rooftop falls onto the ground surface adjacent to the foundation where the ground surface grading is not sufficient to drain this water away from the perimeter of the foundation in an efficient manner. Water that ponds adjacent to the foundation will likely soak into the soils located along the perimeter grade beam and could possibly wet the soils around the home's foundation. Inconsistent watering of the yard near and along the perimeter of the foundation and changes in seasonal moisture content can also contribute to soil-related differential movements.

- In order to help control the effects of surface water around the home, all water draining off the roof eaves should be collected in gutters and downspouts and redirected to drain to the street located along the front of the residence.

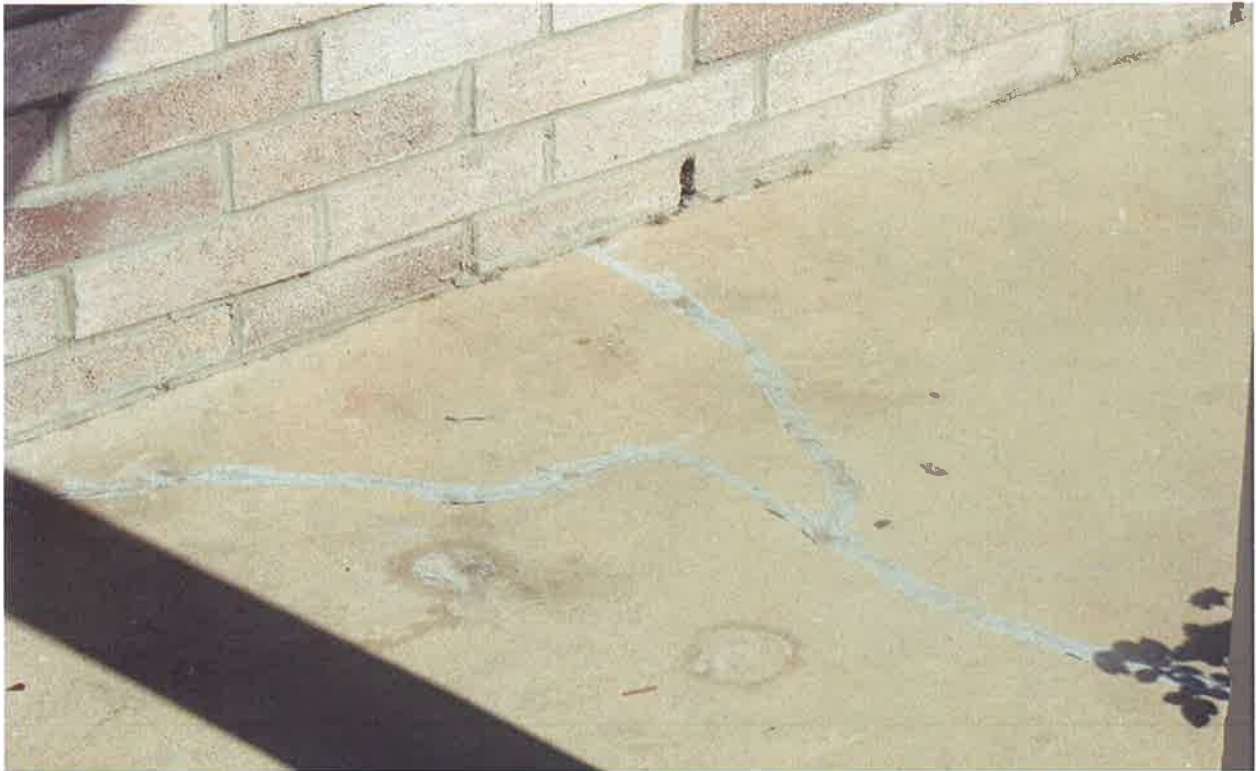
**PHOTOGRAPH 11**

- The sanitary sewer cleanout is located in the front yard, approximately 4 feet from the front covered porch.
- There is previously patched random concrete cracking on the porch slab as shown on Photograph 11 in Attachment B.

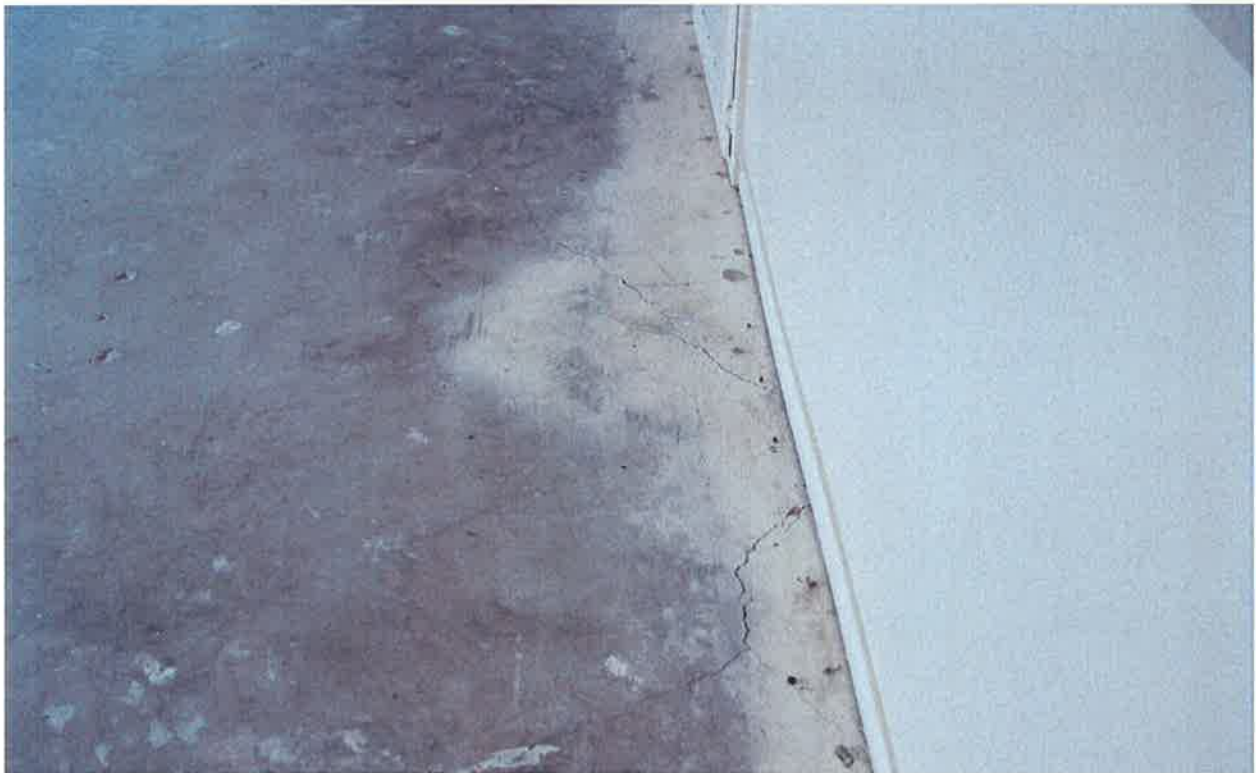
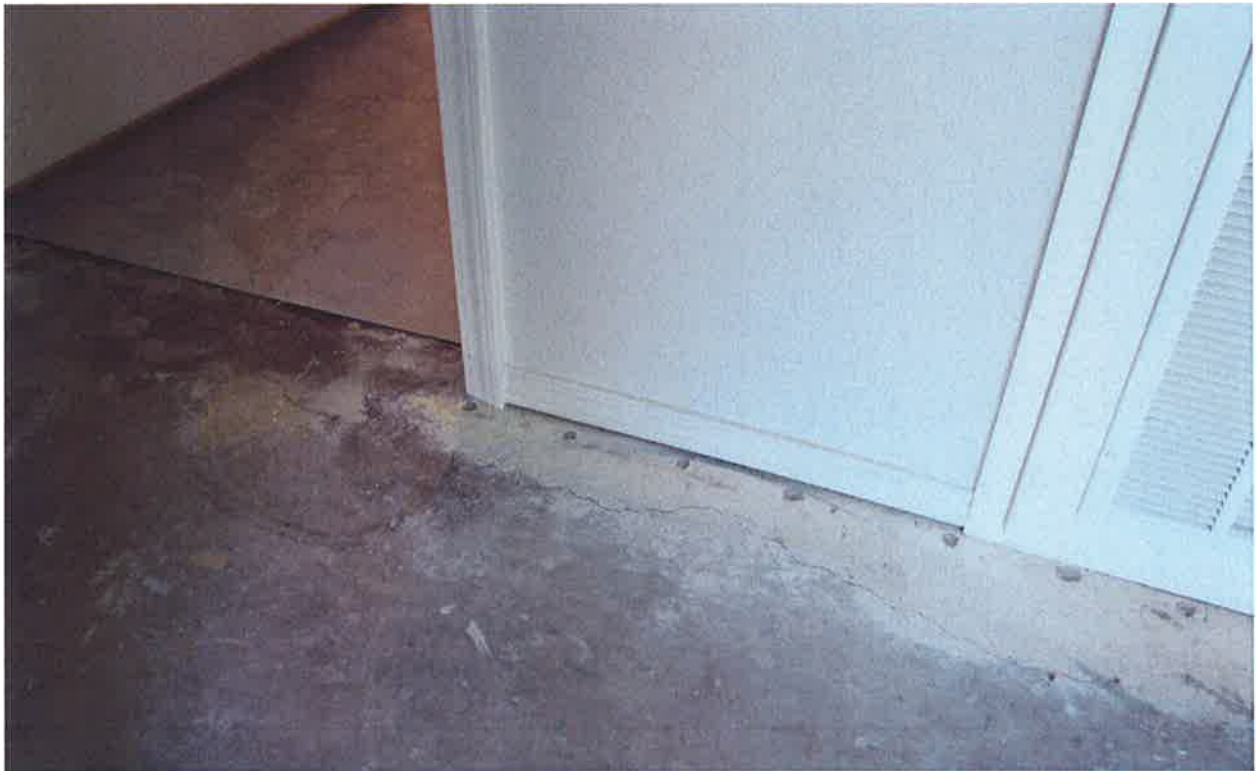
- We noted cracks in the concrete floor slab along the right side of the hallway, as shown on Photographs 12 and 13 in Attachment B.
- Several random plastic shrinkage cracks were observed on the surface of the living room floor slab as shown on Photographs 14, 15, and 16 in Attachment B.
- We also noticed a concrete crack near the hallway bathroom as shown on Photograph 17 in Attachment B. Since there is vinyl floor covering within the bathroom, we do not know where this crack extends in the bathroom.
- Within the master bedroom, there are several random cracks in the floor slab as shown on Photograph 18 in Attachment B.
- We did not note any cracks in the sheetrock covered walls or ceilings throughout the home.

- The cracks in the concrete foundation are plastic shrinkage and dry shrinkage cracking and crack widths are related to soil movements supporting the foundation and will not impact good long term performance of the foundation.
