TEST LOCATION No .9
4026 El Paso

FIELD REPORT 0806 - 07

JUNE 11, 2008

PROJECT Testing of windows and structural wall area at the perimeter of the window unit for verification of resistance to water penetration. Exterior wall material had been removed and new flashing material installed between the window frame and structural wall material. Some of the existing sliding window units had been removed and new units installed. Exterior finish wall materials reinstalled, sealed and repainted.

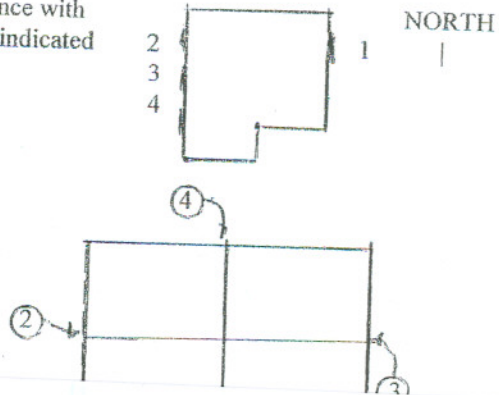
June 10, 2008
SCHEMATIC plan of residence with
location of windows tested indicated

Water pressure at test unit inlet 15 psi.

WINDOW NUMBER 1
Water Applied

1	1:26 PM - 1:32 PM - 6 minutes
2	1:32 PM - 1:37 PM - 5 minutes
3	1:37 PM - 1:42 PM - 5 minutes
4	1:42 PM - 1:48 PM - 5 minutes
