Aladdin Environmental LLC

Re: SAHA, Mirasol Task Force, 4128 El Paso, San Antonio, TX

Aladdin Environmental LLC is pleased to submit this report for the Post Remediation Assessment for the above house on September 30th, 2008. This report applies to the Utility Room as detailed in the Mold Remediation Protocol dated September 24th, 2008. We have observed the standard of care generally exercised by the profession under similar circumstances and conditions to complete this report.

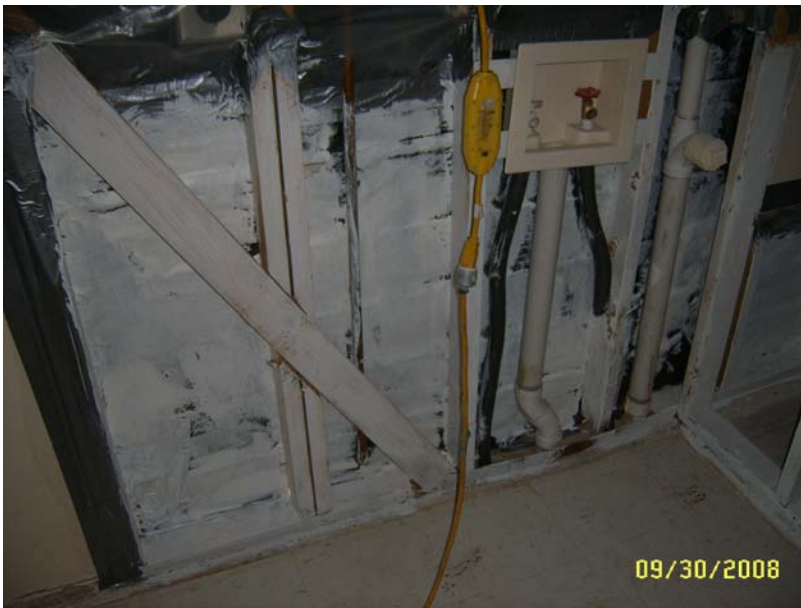
Test results indicate the mold levels in the house are similar to or lower, or within normal variances, when compared to the sample taken outdoors. This report is based on the source or sources of elevated moisture levels at the site have been identified and eliminated. In addition, visual signs or other evidence to suggest possible mold growth were not observed during the inspection. It is my understanding the moisture issues have been corrected based on the leak at the washer connection being fixed.

Utility wall at washer connection

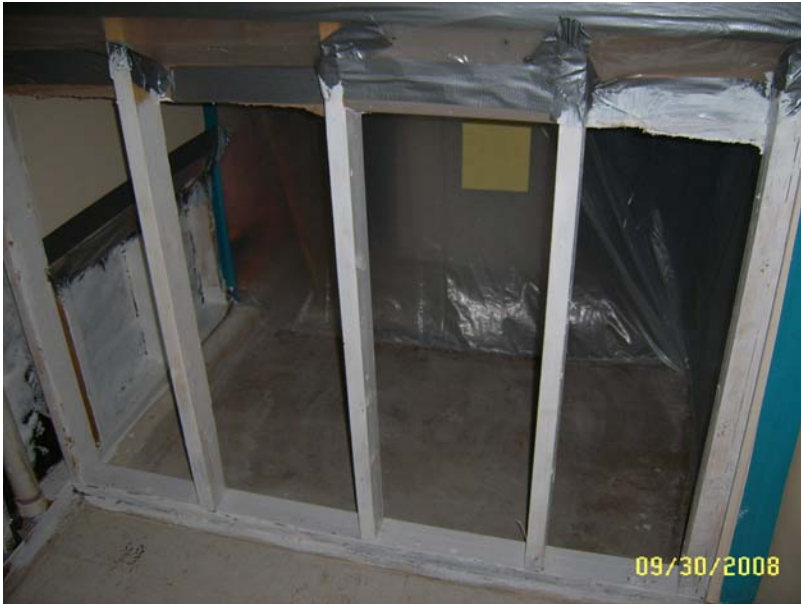
Utility wall backing garage
