FIELD REPORT 0806 - 07

JUNE 11, 2008

PROJECT Testing of windows and structural wall area at the perimeter of the window unit for verification of resistance to water penetration. Exterior wall material had been removed and new flashing material installed between the window frame and structural wall material. Some of the existing sliding window units had been removed and new units installed. Exterior finish wall materials reinstalled, sealed and repainted.

June 10, 2008
 TEST LOCATION No 10
 4136 El Paso

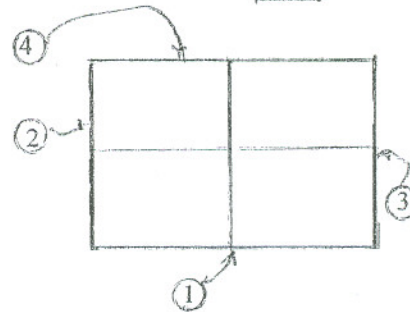
WINDOW NUMBER 1

No water penetration to the interior
 Between window frame and wall observed

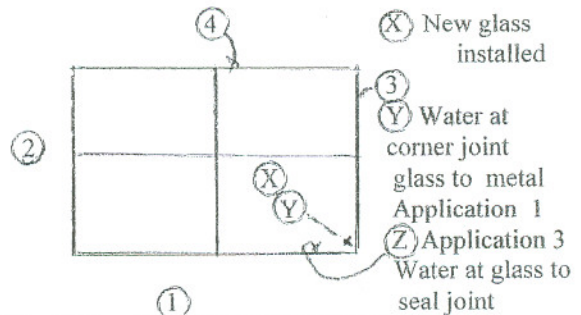
WINDOW NUMBER 4

No water penetration to the interior
 between window frame and wall observed

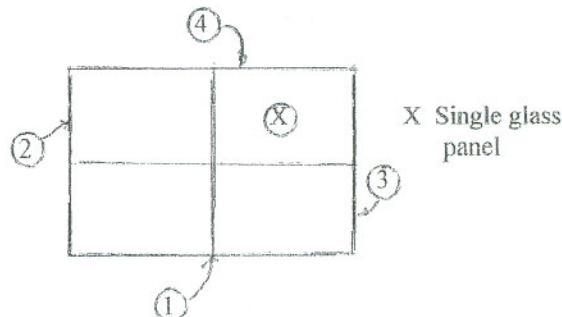
WINDOW NUMBER 5

No water penetration to the interior
 between window frame and wall observed
