RESIDENTIAL DISTRESS STUDY

**432 PRECIOUS DRIVE
SAN ANTONIO, TEXAS**

Project No. ASR08-043-00
June 12, 2008

**RE: Consulting Engineering Services
Residential Distress Study
432 Precious Drive
San Antonio, Texas**

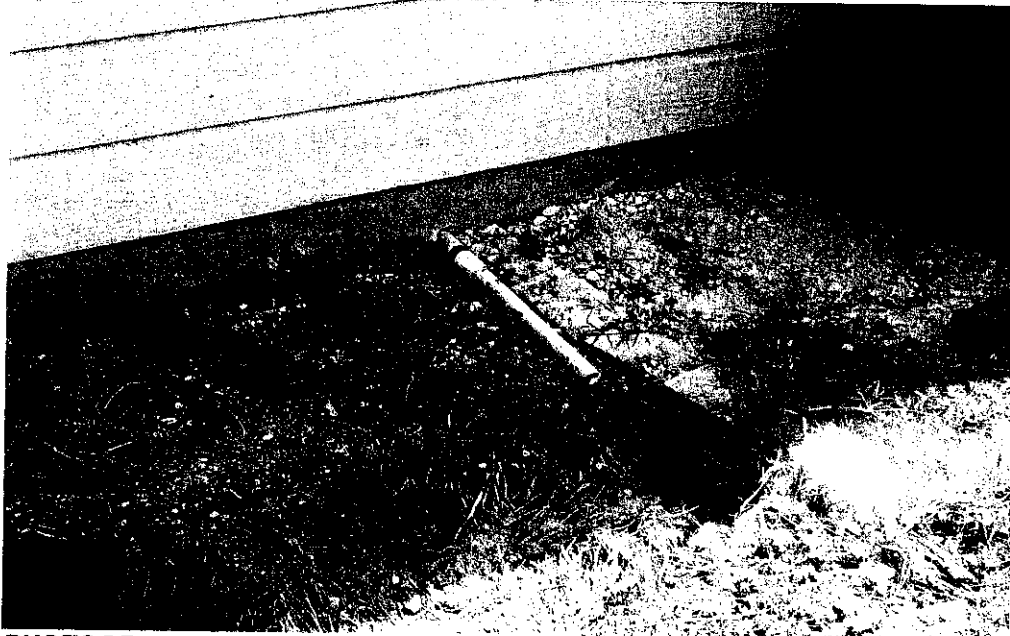
- There are two medium size trees in the front yard, located about 15-feet from the front, exterior kitchen wall.
- The water heater temperature/pressure relief (T/P R) drain line and the heating, ventilation, and air-conditioning (HVAC) condensate drain line empty adjacent to the left exterior concrete grade beam as shown on Photographs 8 and 9 in Attachment B. We encountered some standing water in this area.

PHOTOGRAPH 8
GENERAL VIEW OF THE CONDENSATE DRAIN LINE AND T/P R DRAIN PIPING LOCATED AT THE PERIMETER GRADE BEAM ALONG THE LEFT SIDE OF THE HOME.

- Discharge from the HVAC condensate drain line should also be routed to drain at least 10 feet from the perimeter of the foundation.
- A geotechnical investigation should be performed for this home to assess the conditions of the underlying soils beneath and along the perimeter of the home and to gain a better understanding of how these soils are influencing the performance of the foundation. This should include performing one interior and two exterior exploratory soil borings down to depths of about 15-feet or refusal, whichever occurs first, as well as conducting laboratory tests on the soil samples recovered from the borings to assess the moisture content, plasticity, and

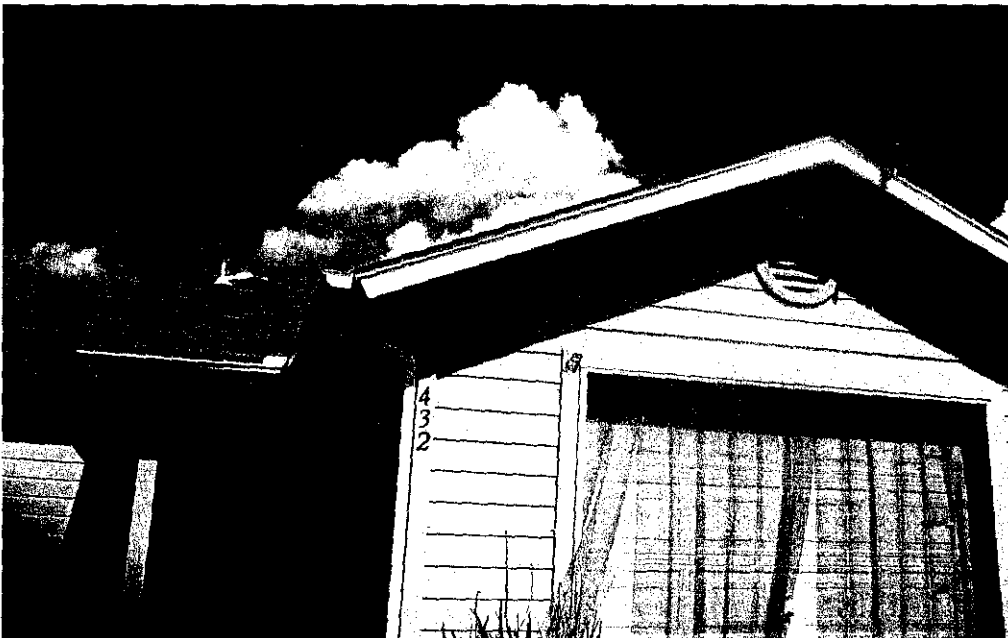
- We noted only one gutter and one downspout along the roof eaves of this residence. This gutter collects rainwater from the left half of the garage roof and the front porch, and redirects the runoff to the downspout located on the left-front corner of the garage. The downspout, in turn drains the rainwater directly onto the concrete walkway as shown on Photograph 10 of Attachment B.

With the exception of the gutter and downspout, located along the roof eave on the left side of the garage, runoff from the roof valley and the roof eaves falls onto the ground surface and may tend to pond on this low lying area. Water that ponds within this area will likely soak into the soils located adjacent to the perimeter grade beam and could possibly gain access to soils beneath the home.

PHOTOGRAPH 10
CLOSE-UP VIEW OF THE GUTTER AND DOWNSPOUT LOCATED ALONG THE FRONT WALKWAY.

- In order to help control the effects of surface water around the home, all roof drain water should be collected and redirected to drain to the street located along the front of the house. Roof gutters and downspouts should be installed and connected to buried drain piping. We recommend using Schedule 40 PVC drain piping because it is more durable and less susceptible to cracking and damage. All connections should be water tight. Care should be taken to install enough downspouts so the gutters do not overflow during heavy rainfall. The gutter subcontractor will design the gutters to handle the roof runoff. Additional runs of drain line should be installed as needed to carry the water from the downspouts to the front of the home.

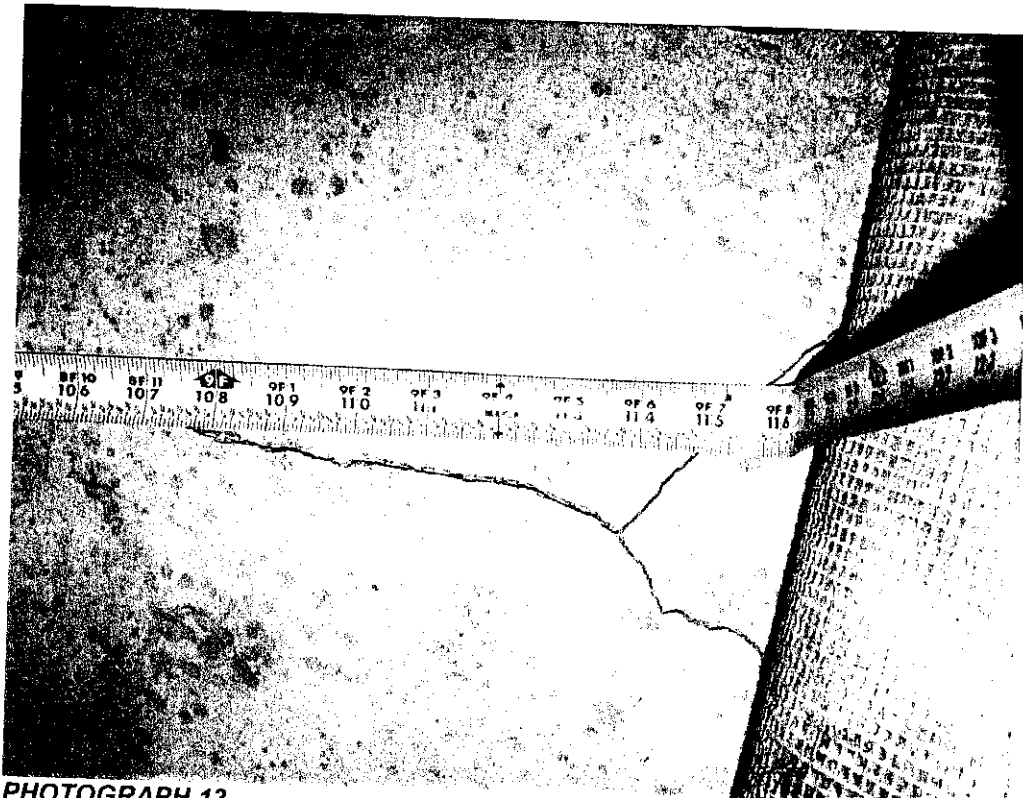
- We noted a significant transverse crack in the concrete floor slab, located in the living room. This crack, extends from left-to-right across the floor slab, and was measured to be approximately 9-1/2 ft long (where visible) and approximately 1/8-inch wide in some locations as shown on Photographs 11, 12, and 13 of Attachment B. For ease of reference, this crack is also shown in red on Figures 1, 2, and 3 of Attachment A.
- Other cracks were noted in the concrete floor slab within bedrooms 2 and 3, as well as along the hallway. In general, these cracks varied in thickness from hairline to about 1/16-inch wide as shown on Photographs 14 through 16 of Attachment B.
- We did not note any cracks on the sheetrock covered partition walls or ceilings.

PHOTOGRAPH 13
CLOSE-UP VIEW OF THE LIVING ROOM CRACK SHOWN IN PHOTOGRAPHS 11 AND 12.

- A concrete core sample should be obtained from the significant crack located in the living room floor slab to assess the depth of the crack and the condition of the concrete.
- Excavations along the perimeter of the exterior grade beam should also be performed to observe and document the depth of the grade beam and its condition. At this time, we recommend that a minimum of two excavations be performed. Once the excavations and soil borings have been completed and the results of the field and laboratory tests analyzed, additional recommendations may need to be provided.

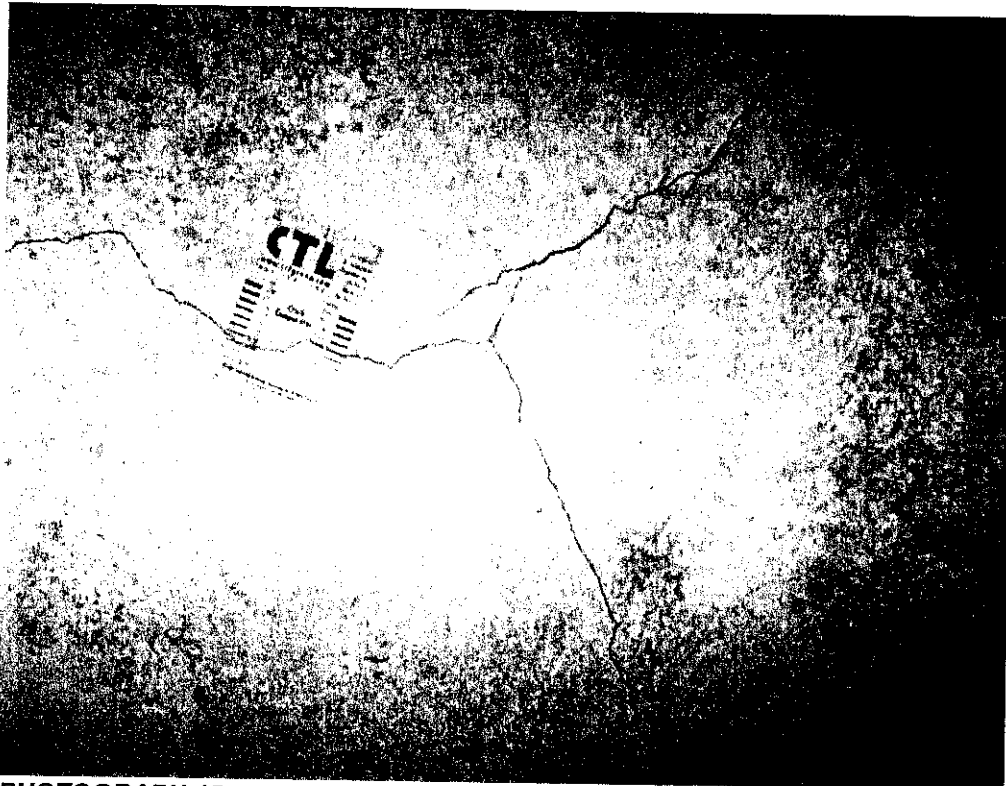
PHOTOGRAPH 15
CLOSE-UP VIEW OF A CRACK WITHIN THE CONCRETE FLOOR SLAB.
