Project No. ASR08-058-00  
October 6, 2008

**RE: Consulting Engineering Services  
Residential Study  
440 Precious Drive  
San Antonio, Texas**

**Raba-Kistner Consultants, Inc. (R-K)** is pleased to submit this document of our engineering services provided for the above referenced residence. It is our understanding that this work is being performed to assess the general physical condition of the above referenced residence and to identify specific items that maybe influencing the performance of this monolithic concrete foundation and wood frame. To accomplish this objective we conducted visual observations of the structural condition of the building frame and foundation along with relative floor elevation measurements and some non-destructive testing of the reinforced concrete beam and slab-on-ground foundation. This document presents our observations and opinions in accordance with our approved scope of work presented in **R-K** proposal No. PSR08-099-00, dated June 16, 2008.

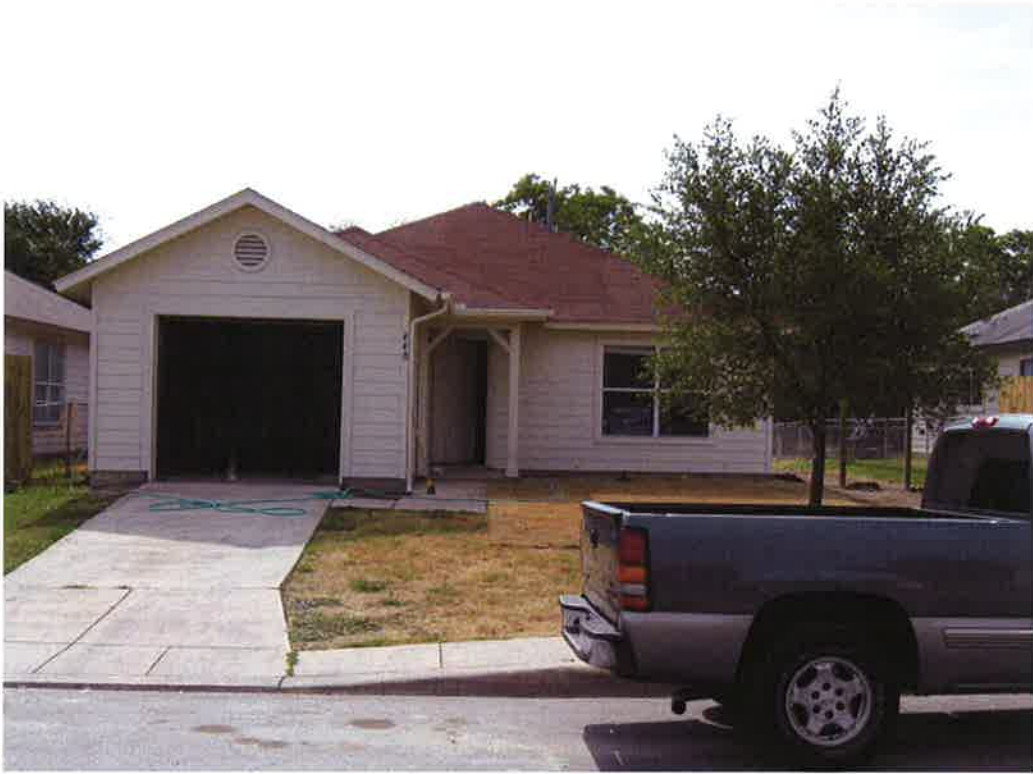
**PHOTOGRAPH 1**

- Surface grading is considered good with the ground sloping away from the foundation as shown on Photograph 1 in Attachment B.
- The downspout located at the right-front corner of the garage exits onto the concrete walkway located along the right side of the garage as shown on Photographs 5 and 6 in Attachment B.
- New sod was noted within the front yard.
- There is one medium size tree located approximately 27 ft from the foundation.
- No vertical or horizontal movements existed between the concrete foundation and driveway slab or the entrance sidewalk slab.
- No foundation cracks were noted from the soil line up to the cement board siding.

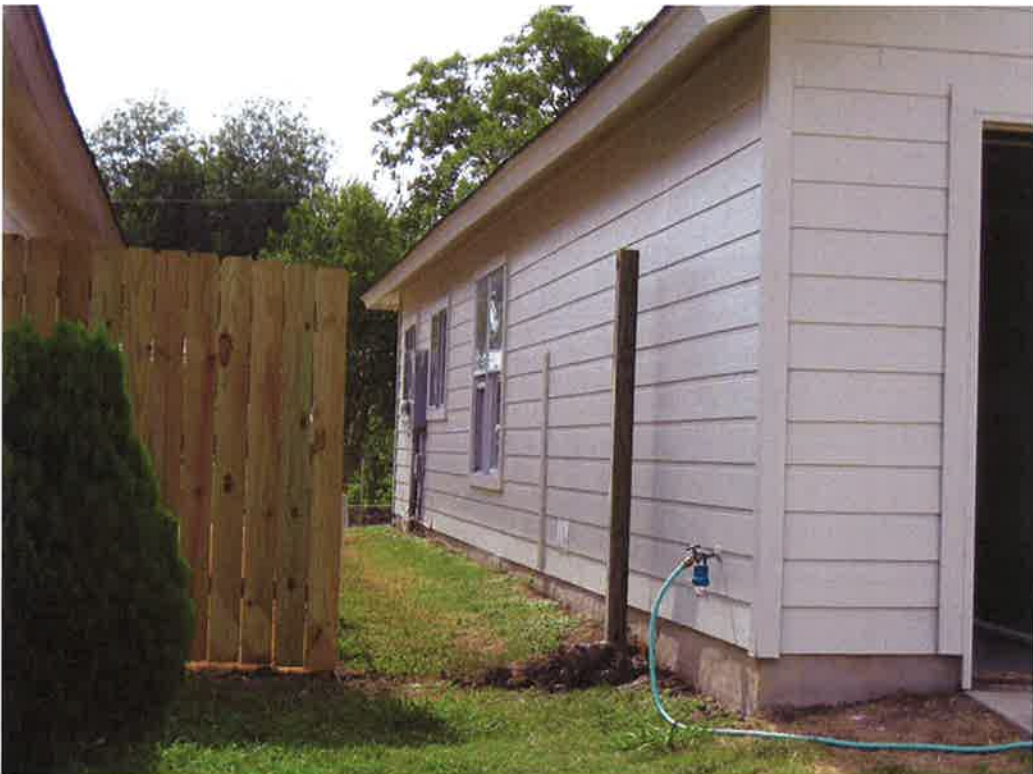
**PHOTOGRAPH 2**

- Surface grading is considered good with the ground sloping away from the foundation as shown on Photograph 2 in Attachment B.
- There is a horizontal separation between the soil and the perimeter grade beam along the left side of the home as shown on Photograph 7 in Attachment B.
- The new polyvinyl chloride (PVC) temperature/pressure relief (T/P R) valve drain lines are located on this side of the home.
- Installing fence posts for privacy wood fence.
- No foundation cracks were noted from the soil line up to the cement board siding.

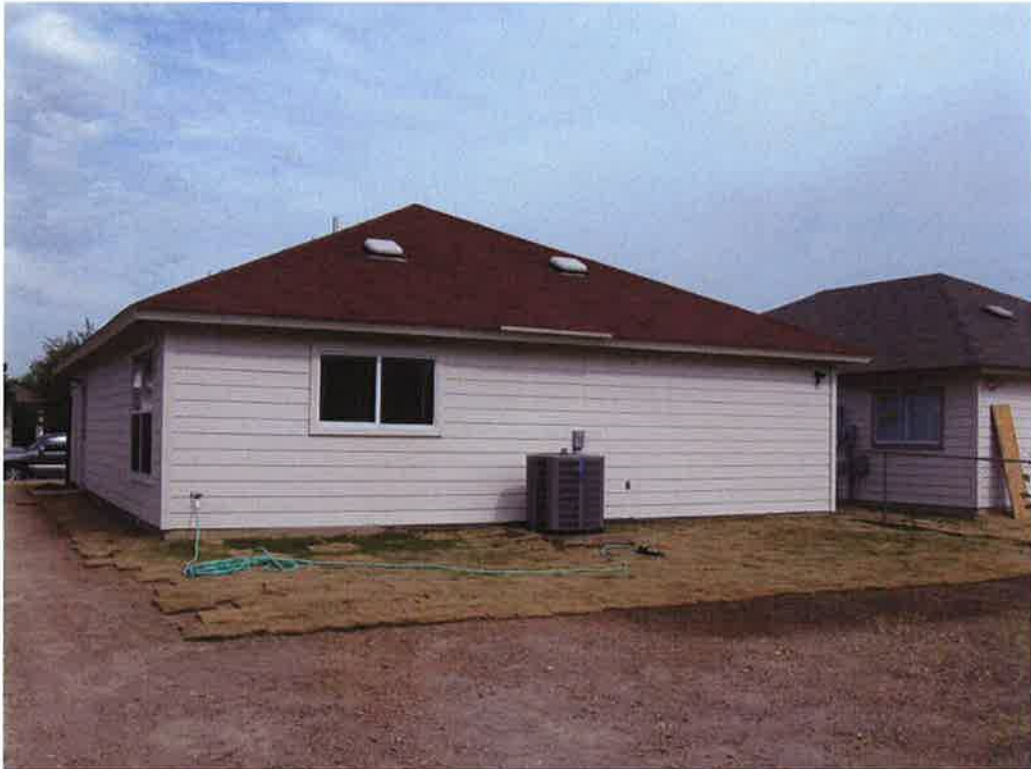
**PHOTOGRAPH 3**

- Surface grading is considered good with the ground sloping away from the foundation as shown on Photograph 3 in Attachment B.
- The new sod, located along the perimeter grade beam, is placed high up against the grade beam as shown on Photograph 8 in Attachment B.
- Dry soil conditions were observed in the yard where shrinkage cracks have formed in the ground surface as shown on Photograph 9 in Attachment B.
- No foundation cracks were noted from the soil line up to the cement board siding.

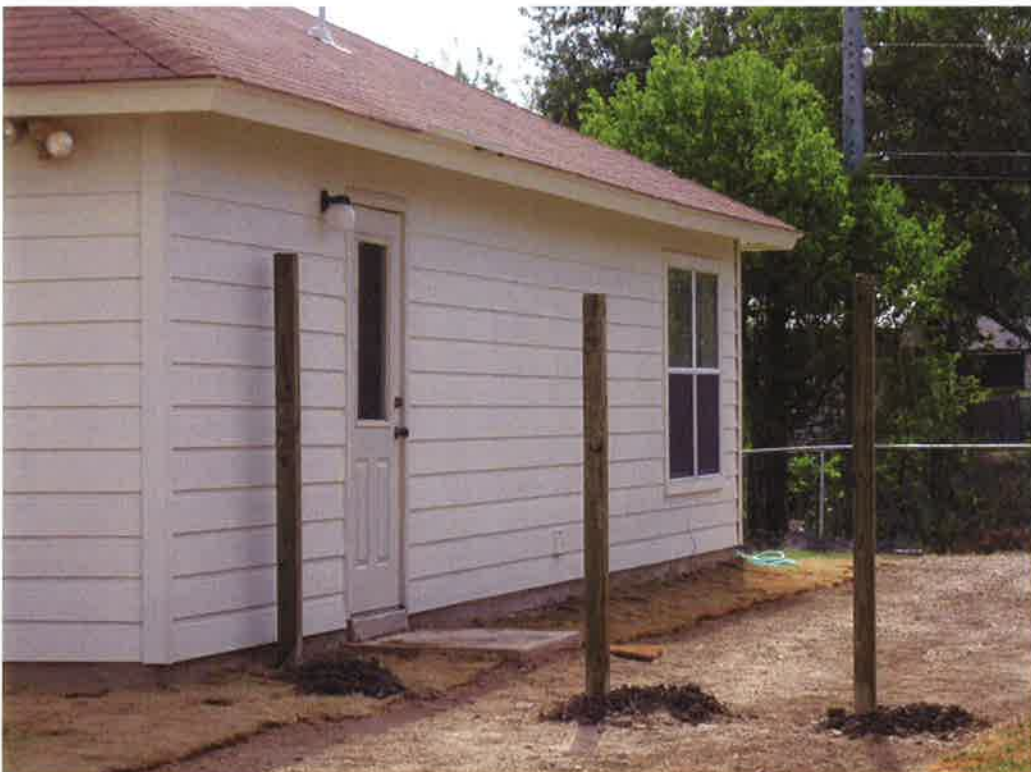
**PHOTOGRAPH 4**

- The ground surface grading along the right side of the home is relatively flat as shown on Photograph 4 in Attachment B.
- New sod has been installed along the right side of the home and extends about 3-ft away from the grade beam.
- The PVC condensate drain line, located approximately 6-ft to the rear of the kitchen side door, has been cut off where it exits the perimeter grade beam as shown on Photograph 10 in Attachment B.
- A hairline crack in the concrete beam was observed adjacent to the PVC condensate drain line.
- Installing new wood fencing.
- No relative movements between the foundation and the small concrete slab.

Poor drainage conditions observed along the right side of the home's foundation represents that there is an increased potential for soil-related differential movements that may affect the performance of the foundation. With the exception of the gutter and downspout, located along the roof eave on the right side of the garage, runoff from the rooftop falls onto the ground surface and may pond adjacent to the foundation where the ground surface grading is not sufficient to drain this water away from the perimeter of the foundation in an efficient manner. Rain water that ponds adjacent to the foundation may soak into the soils located along the perimeter grade beam and could possibly wet the soils beneath the home's foundation. Inconsistent watering of the yard near and along the perimeter of the foundation and changes in seasonal moisture content can also contribute to soil-related differential movements. Possible plumbing leaks beneath the foundation may also contribute to differential foundation movements. We recommend that plumbing leak testing be performed to assess if leaks are occurring beneath the foundation.

- In order to help control the effects of surface water around the home, all water draining off the roof eaves should be collected in gutters and downspouts and redirected to drain to the street located along the front of the residence.

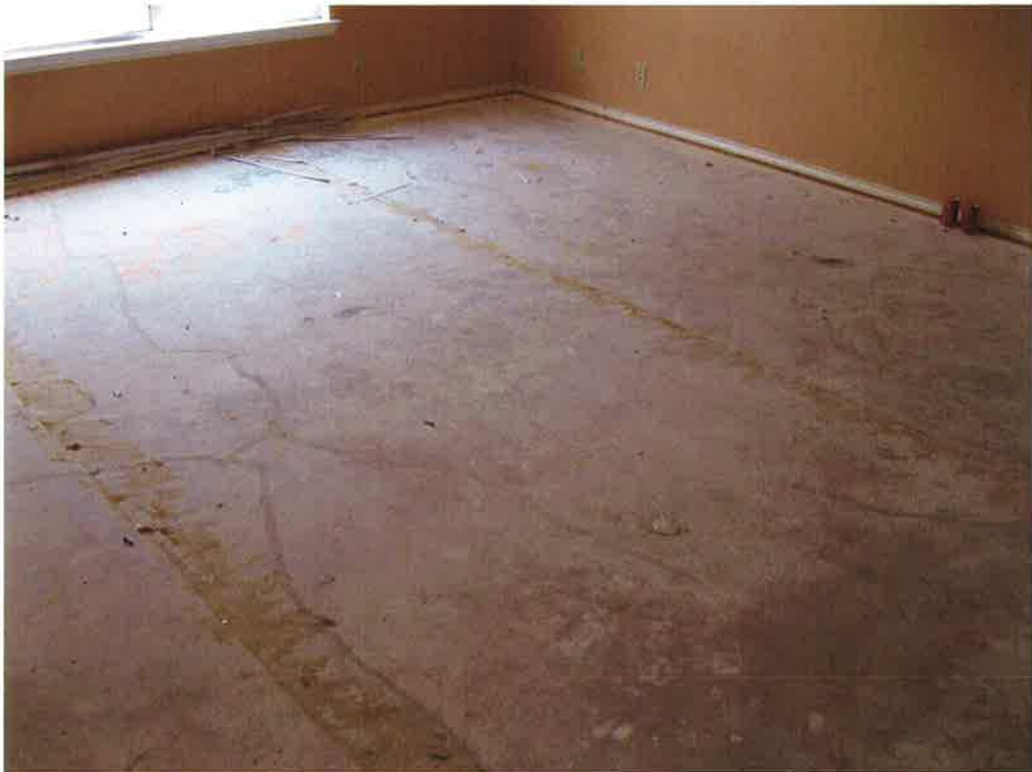
**PHOTOGRAPH 11**

- Several previously patched diagonal and transverse cracks were observed on the surface of the living room floor slab as shown on Photograph 11 in Attachment B. These cracks vary up to about 0.05-inches in width.

- The cracks in the concrete foundation are plastic shrinkage and dry shrinkage cracking and crack widths are related to soil movements supporting the foundation and will not impact good long term performance of the foundation.
- The differential elevation movements are not associated with plumbing leaks; however, this should be confirmed by performing plumbing leak testing on both domestic water supply lines and the sanitary sewer lines within and beneath the foundation.
- The foundation cracks are normal, with crack widths of less than 1/16-inch.
- The foundation and frame do not demonstrate failure cracking conditions.
- The concrete foundation does not demonstrate materials weakness or construction deficiencies.
- The concrete foundation supporting the home and the wood frame is considered structurally adequate.

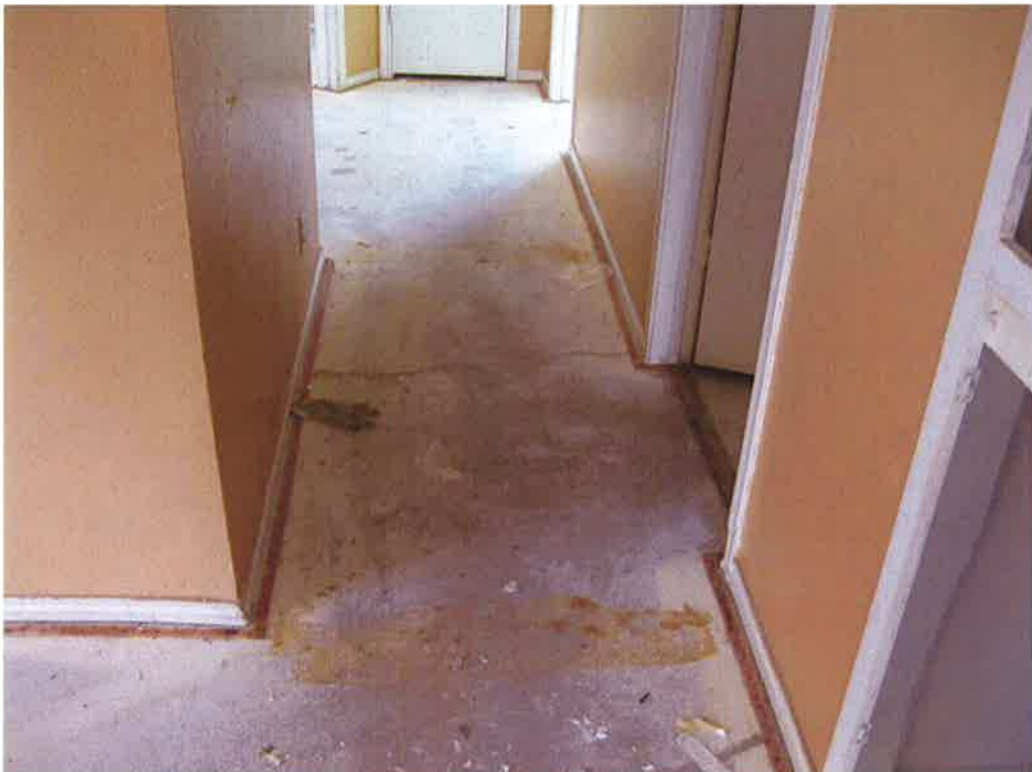
**PHOTOGRAPH 12**

- Several previously patched transverse cracks were observed on the surface of the living room floor slab as shown on Photograph 12 in Attachment B.

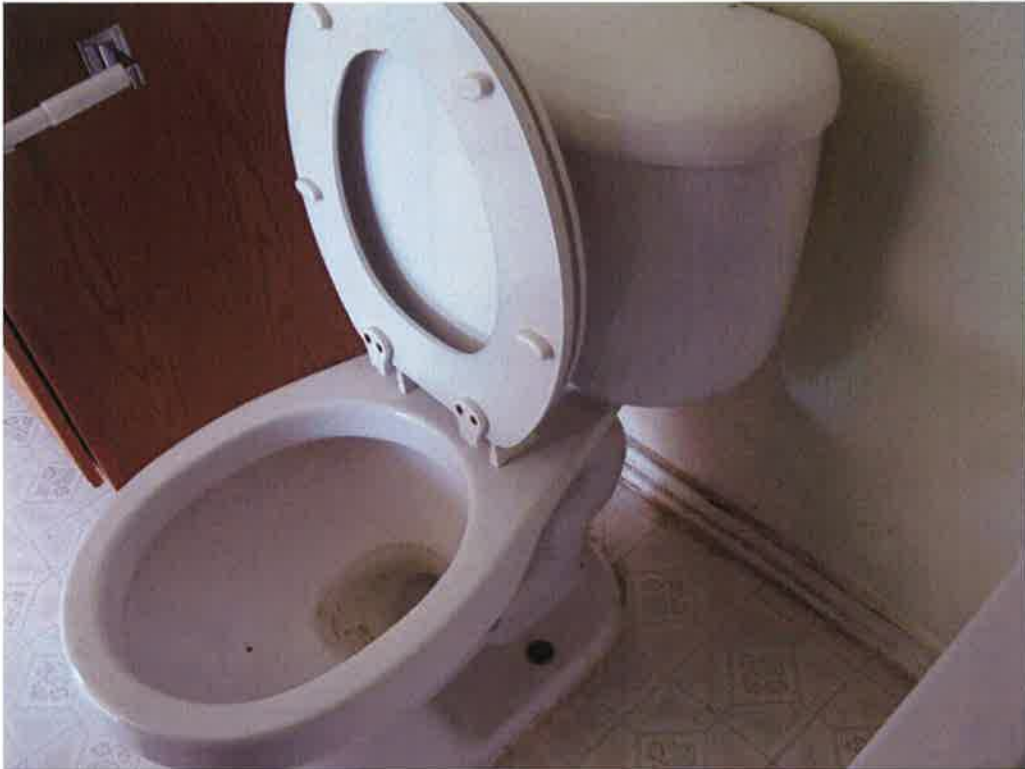
**PHOTOGRAPH 13**

- Water damage was observed along the wood molding located behind the water closet as shown on Photograph 13 in Attachment B.

- We recommend that plumbing leak testing be performed on the domestic water lines and the sanitary sewer lines within and beneath the foundation to assess if leaks are occurring beneath the floor slab.
- Irrigation should be controlled within a 10-foot zone around the perimeter of the foundation. The moisture content of the surface clay soils should be maintained at a uniform condition year round. The ground within this area should not be allowed to become dry to the point where the ground cracks and pulls away from the foundation. Water should also not be allowed to pond near the foundation.
- The soils in the yard need to be maintained adjacent to the foundation year round. This can be managed by watering along the perimeter of the foundation with soaker hoses connected to 12-foot long garden hoses that are attached to

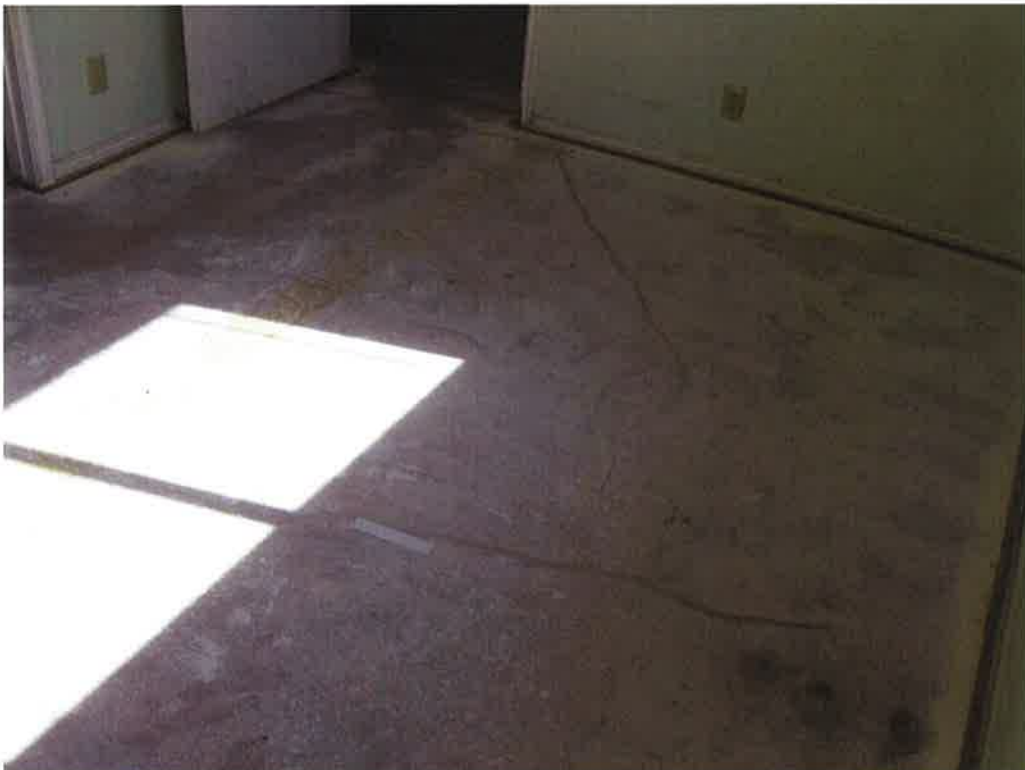
**PHOTOGRAPH 14**

- Previously patched longitudinal and transverse cracks were observed across the floor slab as shown on Photograph 14 in Attachment B. These cracks vary up to about 0.03-inches in width.

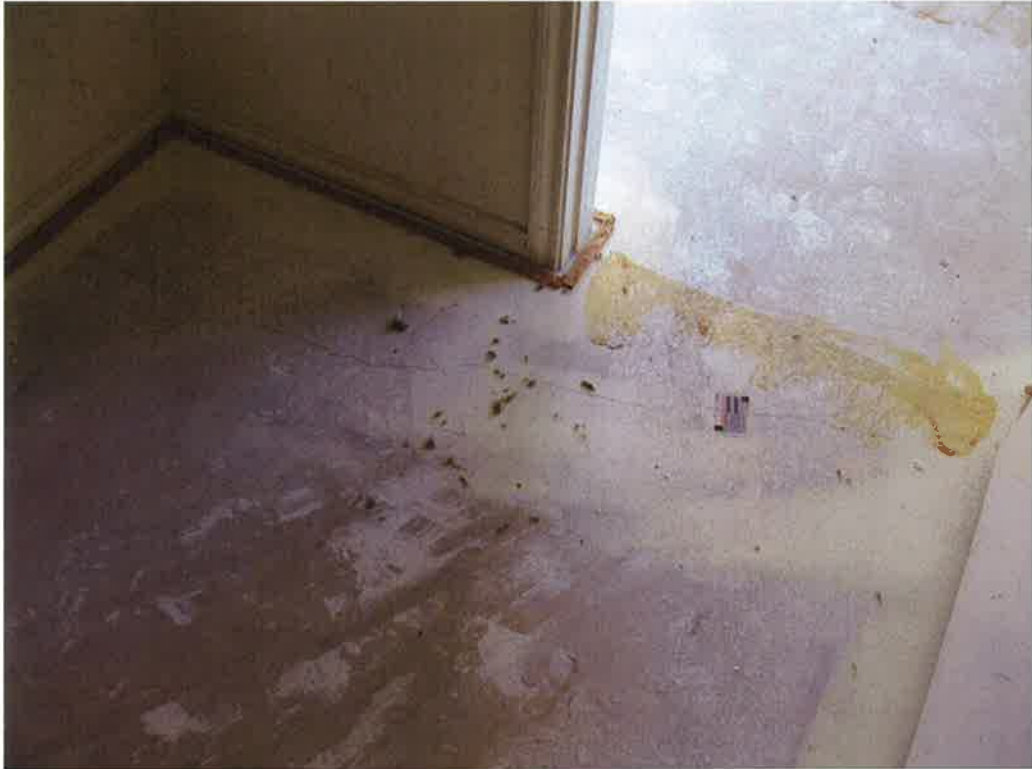
**PHOTOGRAPH 15**

- A transverse crack was observed across the closet floor slab as shown on Photograph 15 in Attachment B. This crack varies up to about 0.02-inches in width.

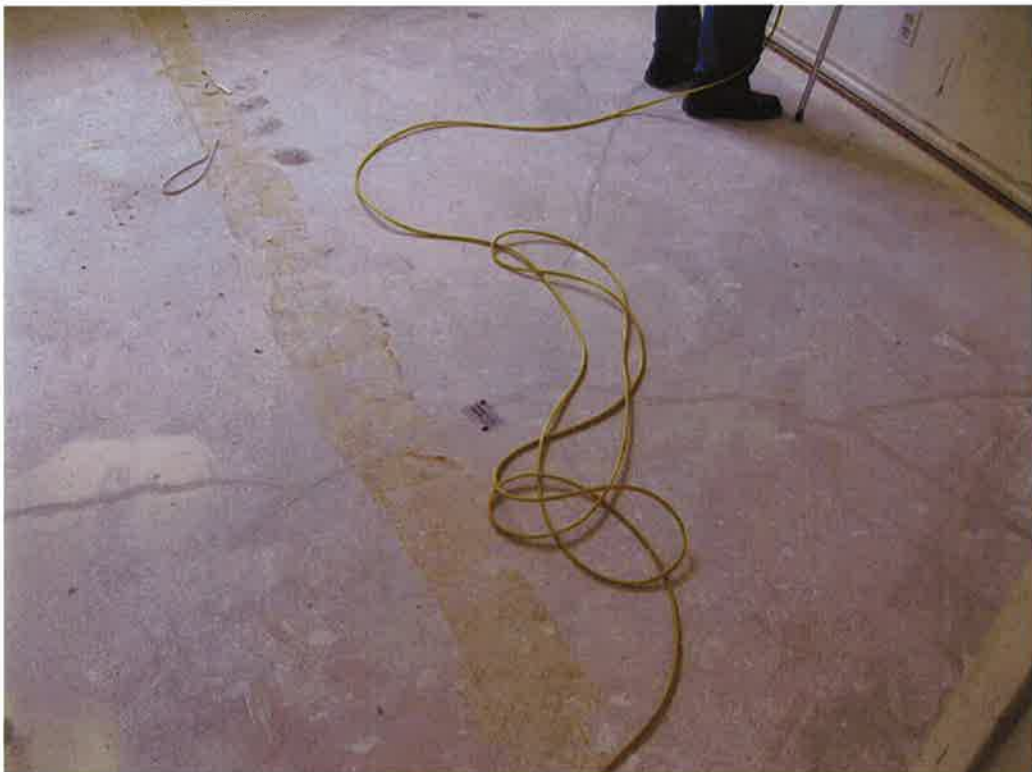
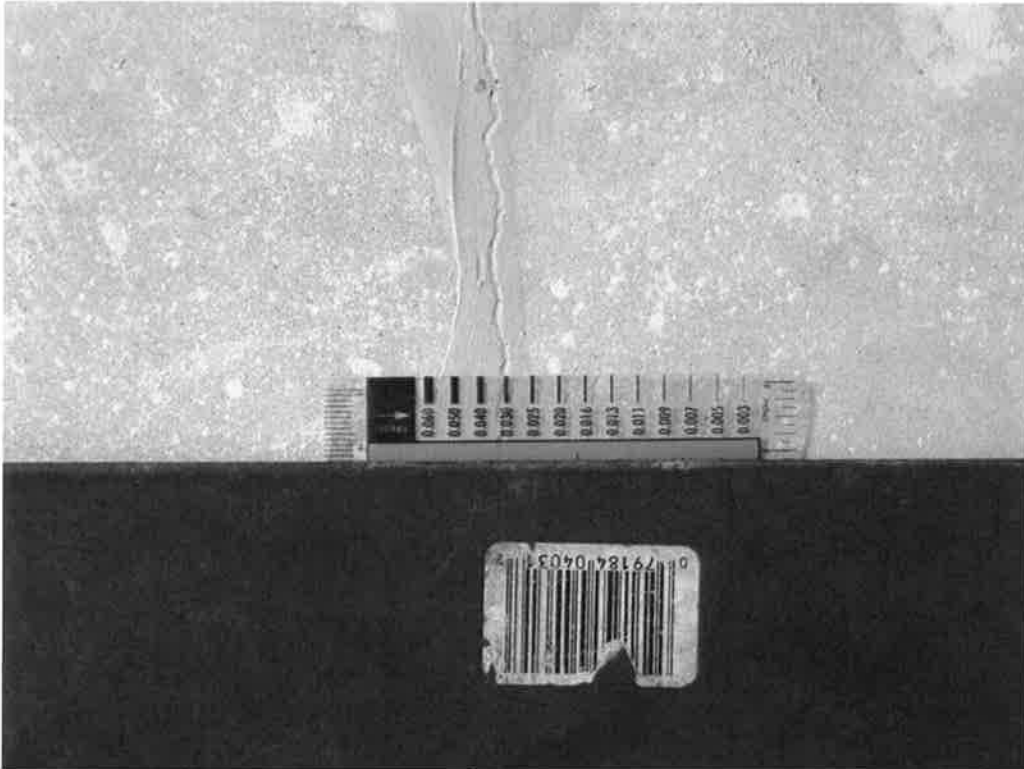
- Previously patched longitudinal and transverse cracks were observed across the floor slab as shown on Photographs 16 and 17 in Attachment B. These cracks vary up to about 0.03-inches in width.

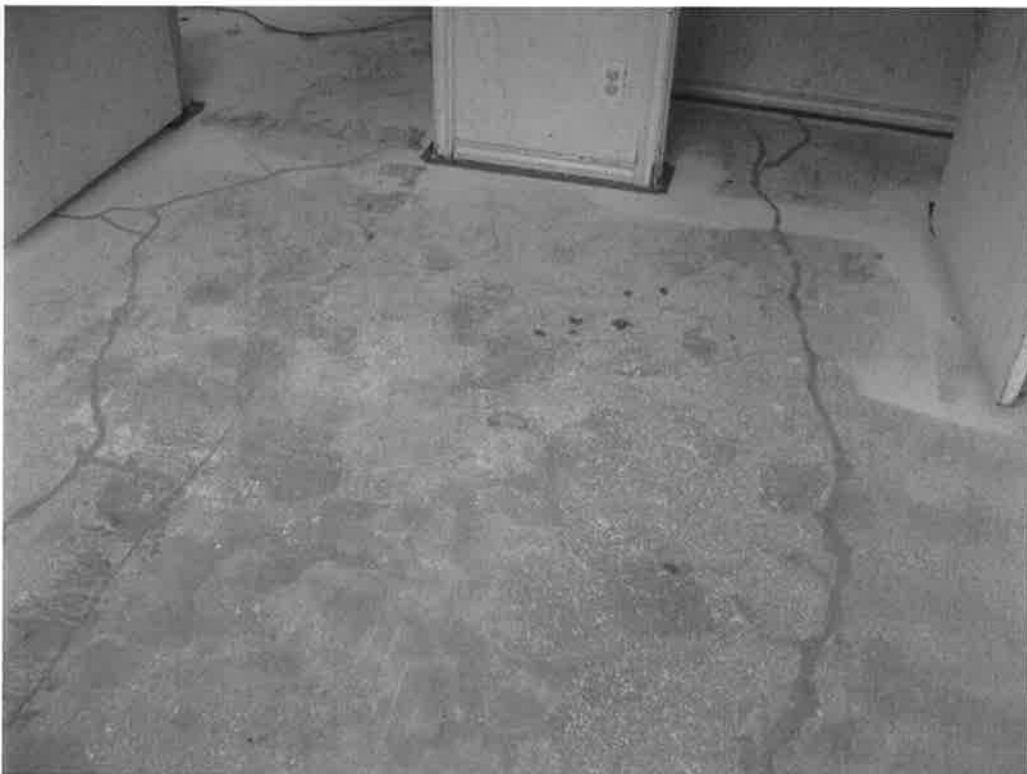
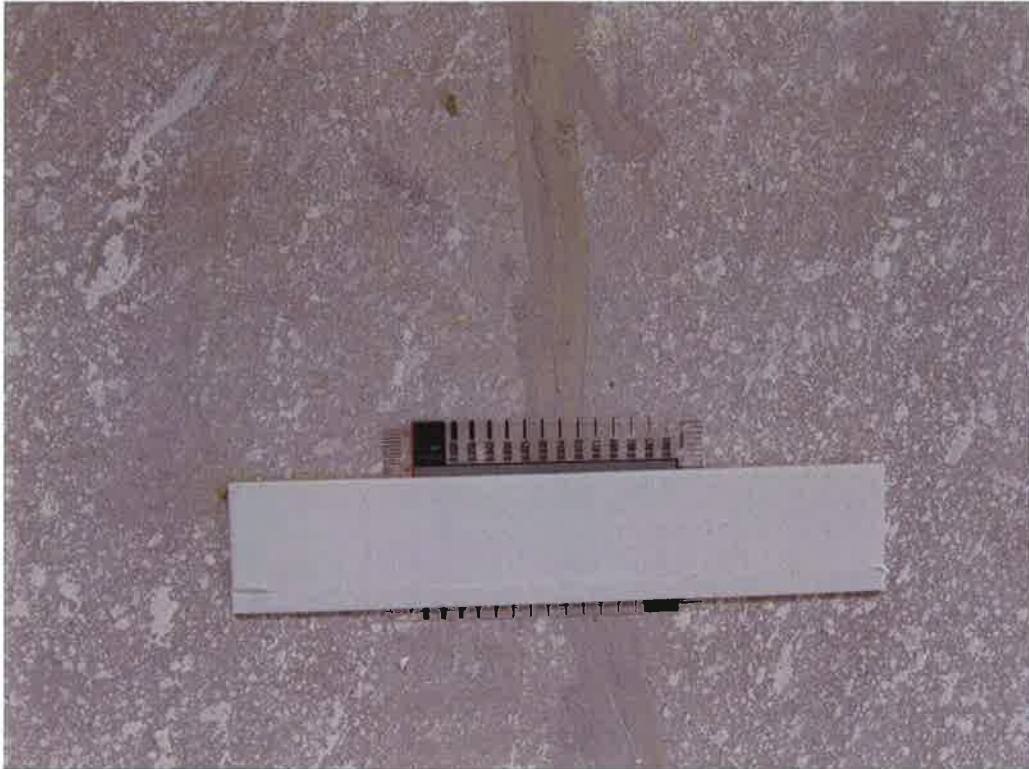
- Previously patched transverse cracks were observed across the floor slab as shown on Photographs 18 and 19 in Attachment B. These cracks vary up to about 0.016-inches in width.

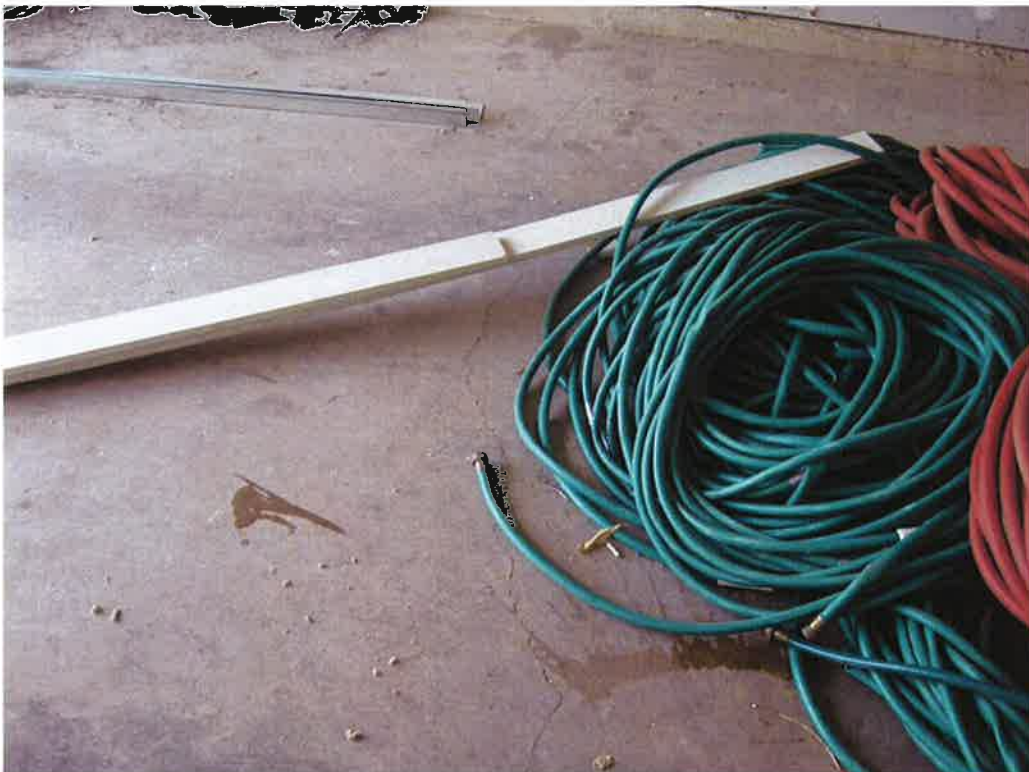
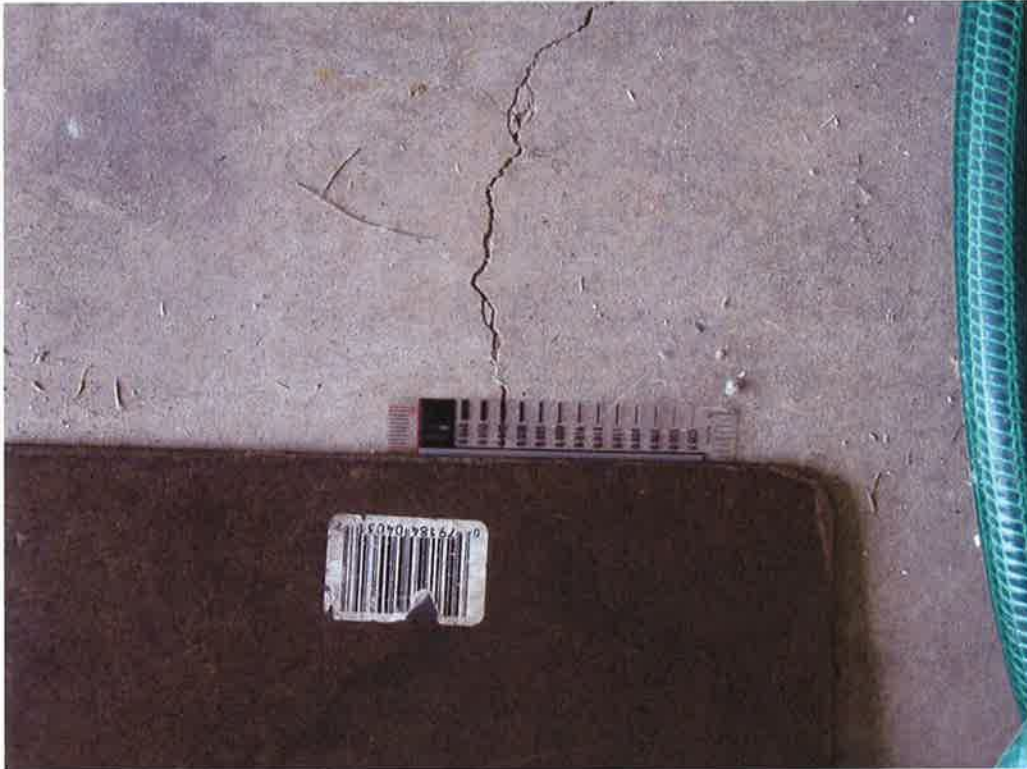
- Transverse cracks were observed across the floor slab as shown on Photographs 20 and 21 in Attachment B. These cracks vary up to about 0.040-inches in width.
