Structural Report

San Mirasol Hope IV Revitalization Program Single Family Housing Design/Build Project

San Antonio, Texas

February 2007
Project CTR001-F

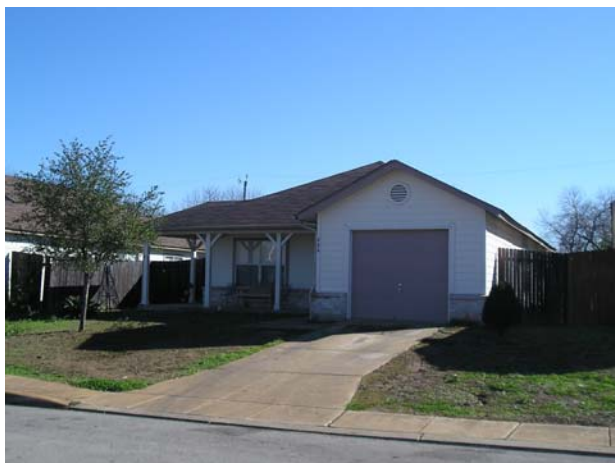
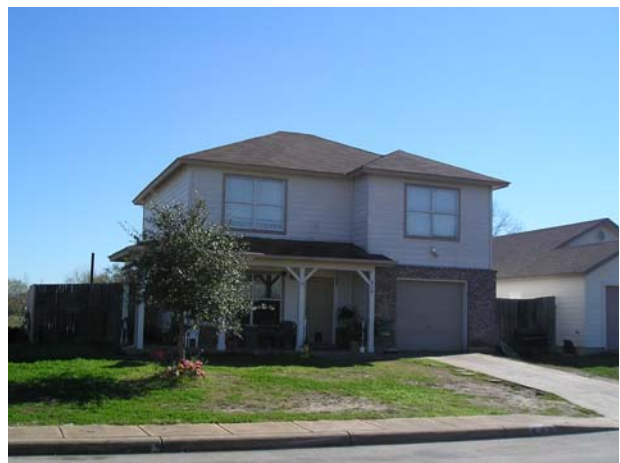
The houses were one-story or two-story, wood-framed structures and were located in a residential neighborhood (See Photographs No. 1 and No. 2). Our investigation of the houses indicated:

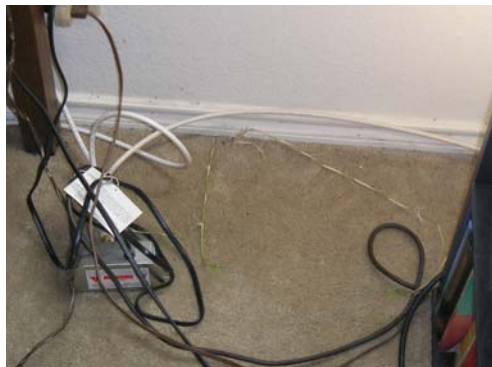
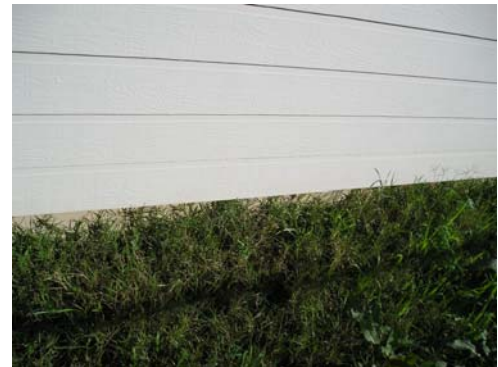
Comment: At two of the structures on Precious, it was reported that there was grass growing into the structure through the foundation. However, our observations revealed that the grass was not growing up through the foundation. The grass was found entering the structure along an exterior wall at the base of the wall (See Photographs No. 3 and No. 4). We understand that

the builder (K-B Homes) has identified this problem and determined that the grass was growing up through a gap between the siding and the foundation. We also understand that the builder is addressing this issue and has already made repairs at one of the structures.

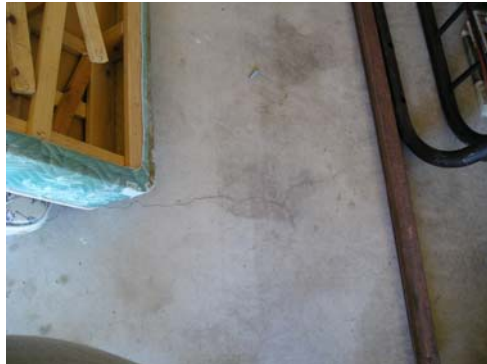
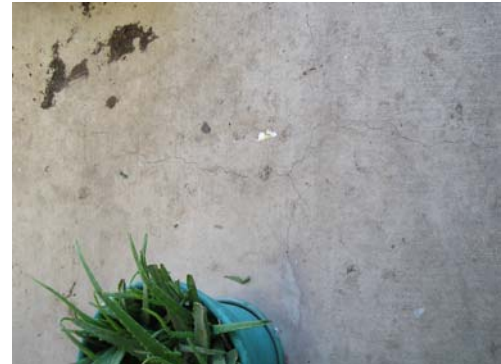
Comment: We noted cracks in the concrete slabs (See Photographs No. 5 and No. 6) at

some of the structures. These cracks were determined to be typical shrinkage cracks and were not structural cracks. Shrinkage cracks occur due to normal volumetric changes associate with the drying of the concrete. These cracks develop as the concrete cures and are random hairline cracks (less than 1/16 of an inch) that often extend to the perimeter of the slab. However, these cracks often widened due to the vehicular and pedestrian traffic, particularly in the garage areas. These cracks can also widen due to flexural movement

of the foundation due to seasonal moisture changes. Shrinkage cracks are not unusual in concrete construction and are considered cosmetic in nature.

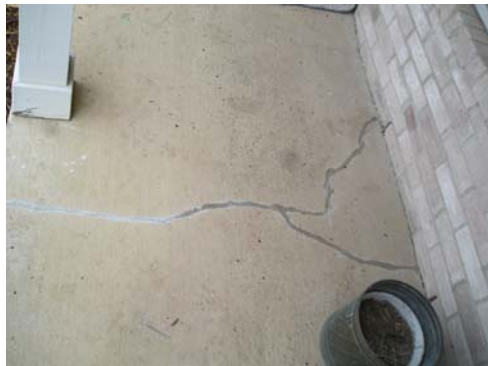
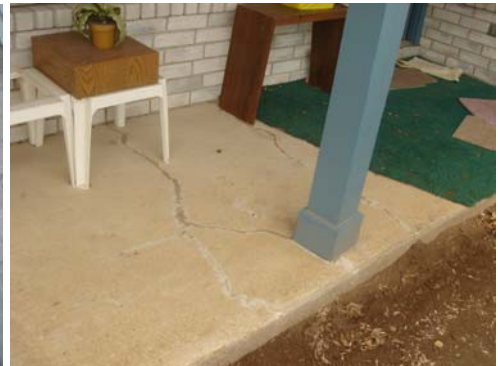
Comment: Some of the tenants reported problems with cracks in the porch that had been patched. Based on our observations, these cracks also appeared to be typical shrinkage cracks as indicted in item #2, which have been patched (See Photographs No. 7 and No. 8). It is our opinion that the quality of the workmanship used in patching these cracks has negatively magnified the appearance of the cracks. As a result, these patches are apparently being interpreted as a structural problem with the foundation. However, they are cosmetic in nature and not a structural problem.

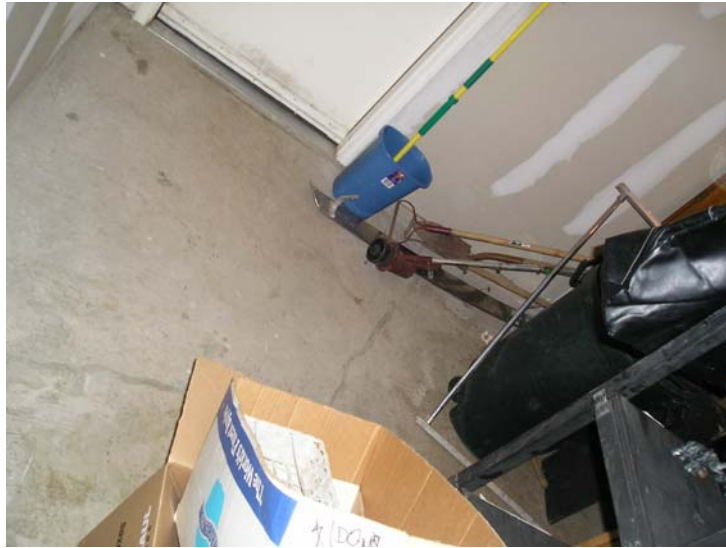
Photograph No. 9

Comment: One tenant on Precious reported excess floor slope of the foundation, which occurs at the door from the garage to the house. However, our observations

revealed that this reported floor slope was actually a handicap ramp (See Photograph No. 9). It appears that the foundation was originally constructed

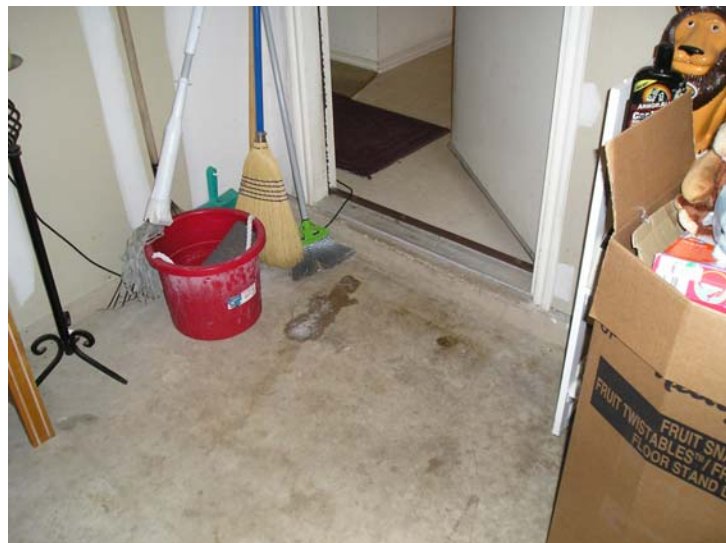
Photograph No. 10

with a “step down” between the entry and the garage (See Photograph No. 10). In this instance, a topping slab had been added to provide wheelchair access.

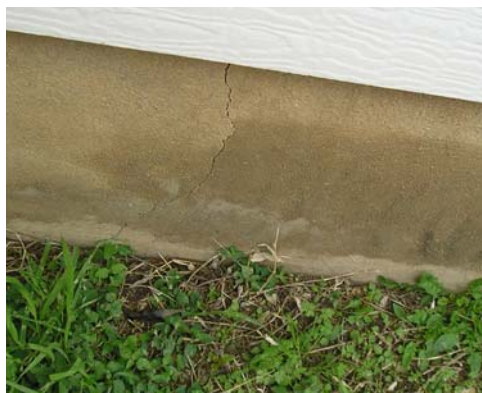
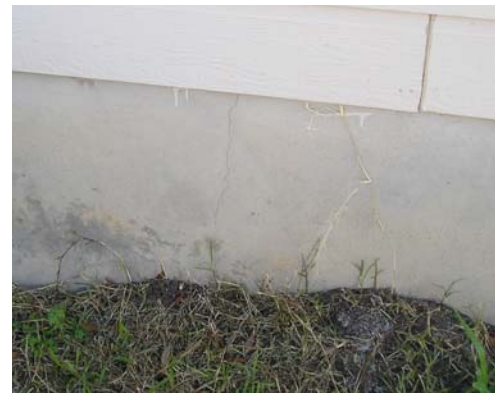
Comment: Based on our observations, the reported cracks in the side of the foundation were actually cracks in the foundation rub coat (See Photographs No. 12 and No. 13). The foundation rub coat is a thin finish coat applied to the foundation to give the foundation a uniform finish. These cracks in the rub coat are cosmetic in nature.

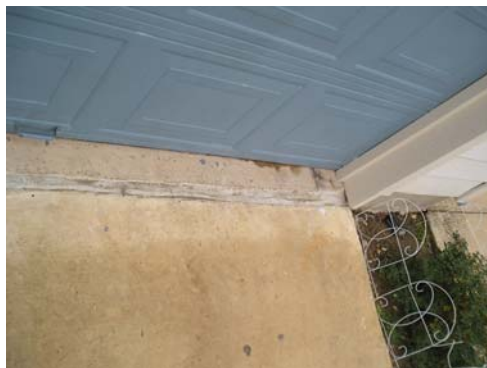
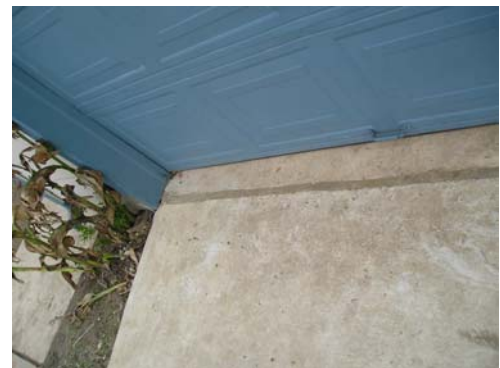
Comment: During our investigation, we noted that a sealant had been added to some of the control joints between the foundation and the adjacent flatwork (See Photographs No. 14 and 15). However, the purpose of these control joints is to

allow movement between the flatwork and the main foundation. These joints should also be maintained to prevent moisture intrusion into the underlying soils. Therefore, it is our opinion that the addition of sealant to these joints is appropriate and not an indicator of a building problem.

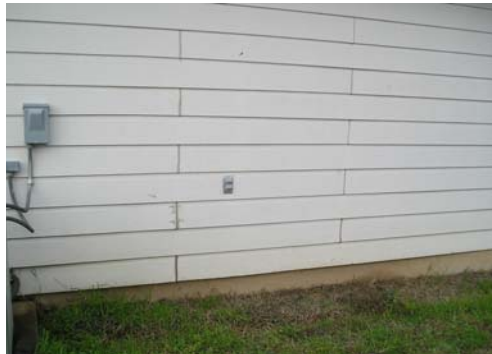
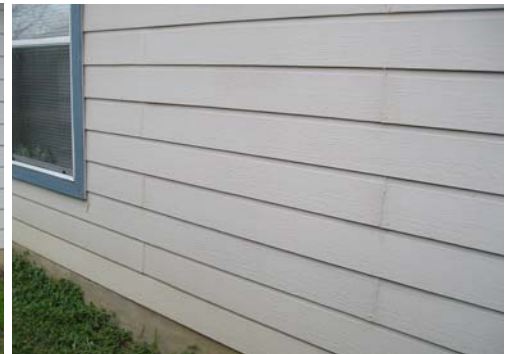
Comment: At most of the structures, we noted that a sealer had been applied to the siding joints (See Photographs No. 16 and No. 17). However, we found that the

sealant had been liberally applied and has “discolored” in most applications. Based on our observations, it is our opinion that this joint sealing was of poor workmanship and has negatively magnified the appearance of the siding. As a result, these patches are apparently being interpreted as a structural problem. However, they are cosmetic in nature and not a structural problem.

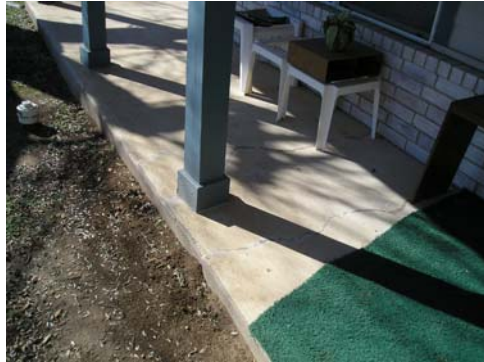
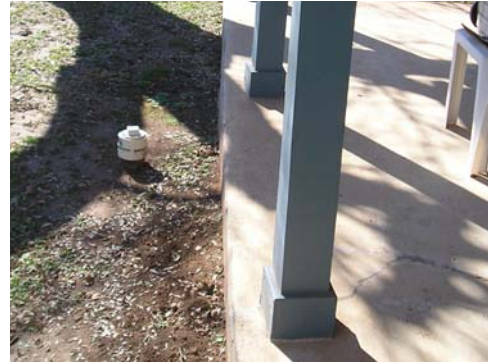
Comment: At one of the structures on Villa Grande, we noted that the porch columns appeared to be twisted (See Photographs No. 18 and No. 19). Based on our

observations, it appears that the wooden columns were “warped” at the time they were installed. Therefore, it is our opinion that this was an as-built condition and not the result of differential movement of the porch slab. This condition is cosmetic in nature.

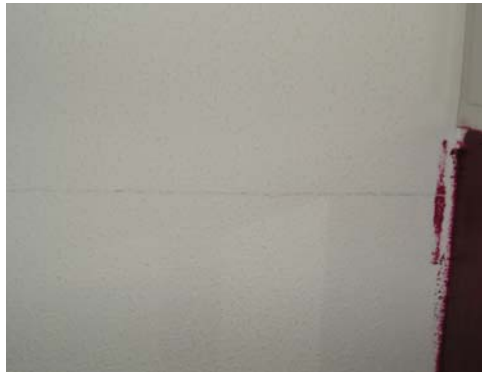
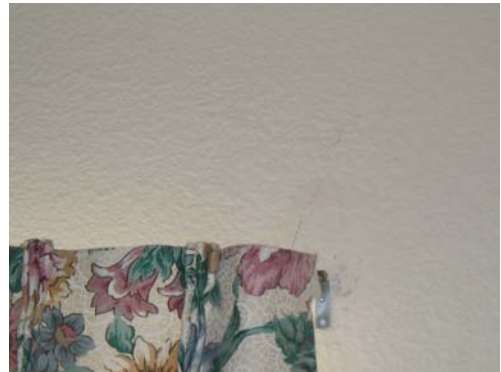
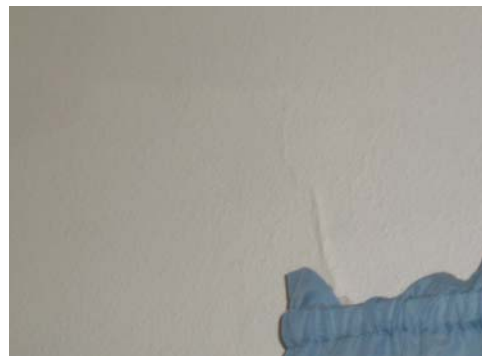
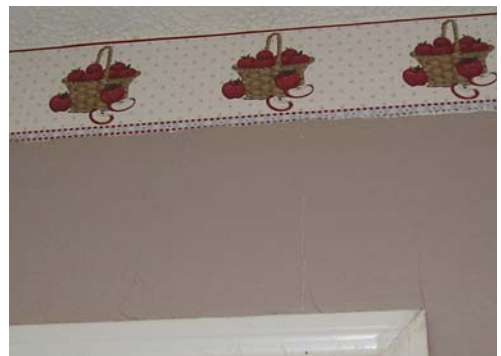
Comment: During our investigation, we noted sheetrock cracks in the interior finishes (walls, ceiling, etc.) in some of the houses (See Photographs No. 20, No. 21, No. 22, and No. 23). The majority of these cracks were very small. However,

the majority of the houses contained little or no sheetrock cracking. It is our opinion that these cracks are typical of a houses constructed in the San Antonio area, which are supported on expansive clay soils. In this instance, the geological survey indicated that the naturally existing soils at the site were highly expansive. Therefore, when moisture increases along the

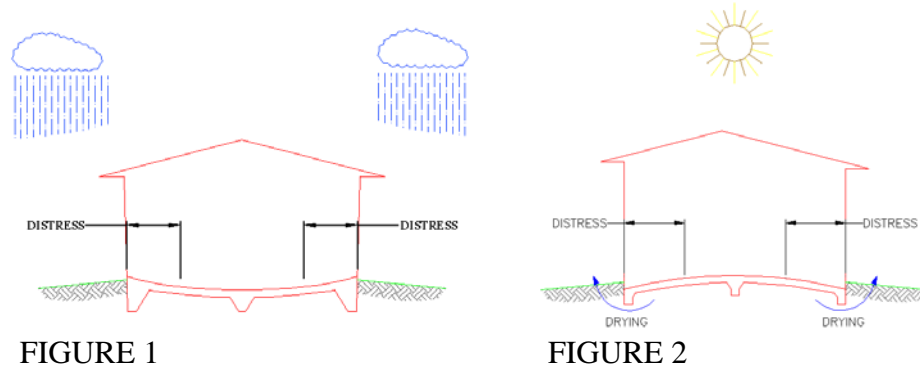
building perimeter, it can cause the underlying soils to swell and raise the perimeter (edges) of the foundation (See Figure 1). On the other hand, as the moisture contained in the soil around the foundation's perimeter decreases (dries out), the perimeter of the foundation can move in a downward direction (See Figure 2). The drying out effect can be caused by the natural

loss of moisture through evaporation, or this drying may be significantly increased by the effect of vegetation located near the foundation. These movements can cause walls and ceilings to crack, and doors to stick throughout the structure. Therefore, it is our opinion that the cracking was a result of differential foundation movement due to seasonal moisture changes.

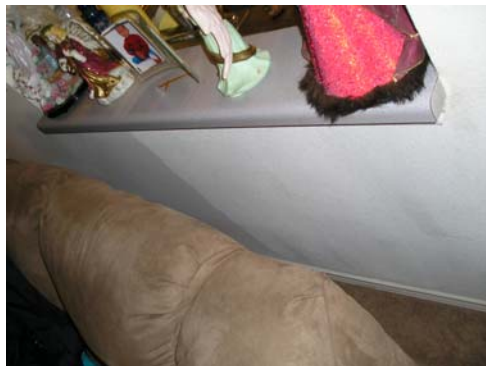
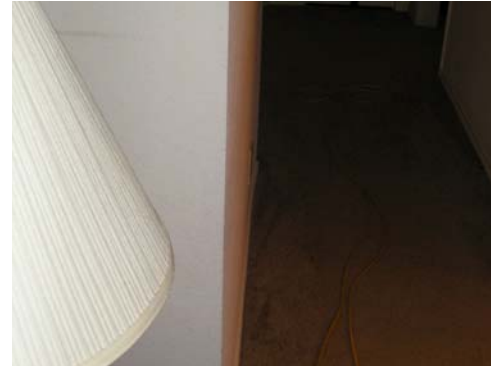
Comment: One of the tenants located on Precious reported that two of the walls of the structure were “bowed or wavy”. At this particular residence, we did note some “waviness” in the sheetrock of one of the interior walls and along the baseboard of another interior wall (See Photographs No. 24 and No. 25). Based on our observations, it appears that these are an as-built condition. They are primarily a workmanship issue (alignment) and are not due to foundation movement. It is therefore our opinion that these conditions are cosmetic in nature.

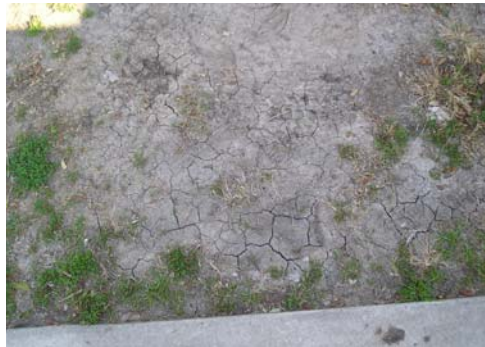
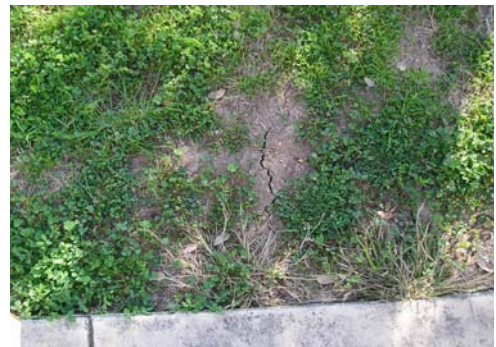
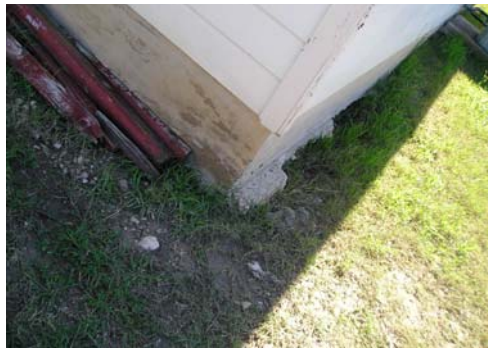
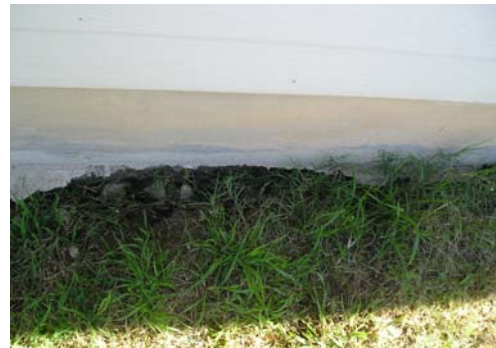
Comment: Several of the tenants reported problems with soil cracks and erosion of the soil along the foundation (See Photographs No. 26, No. 27, No. 28 and No. 29). Based on our observations, it is our opinion that landscaping along the perimeter of the structures (See Photographs No. 30 and No. 31) is not being

being maintained (watered). This condition contributes to the cracking of the soils. In addition, since there is no vegetation to hold the soils in place, they are very susceptible to erosion during heavy rains.

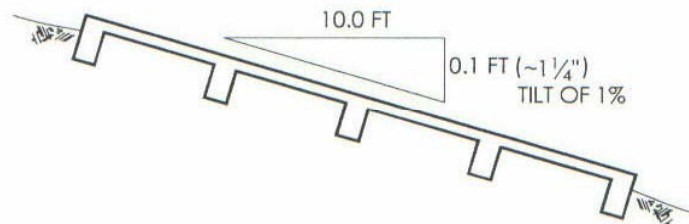
FIGURE 3 – Tilt Schematic

Comment: Although we found little to no distress to the interior and exterior finishes of the structure, our office found a noticeable floor slope in one of the two-story homes located on Precious. Based on these items, we have determined that the foundation has undergone a significant uniform tilt (See Figure 3). Foundation tilt occurs when the foundation moves uniformly as a unit. Due to the floor slope, we would recommend that this condition be brought to the builders attention for the purpose of addressing the need for remedial foundation repair.
