INDOOR ENVIRONMENTAL QUALITY EVALUATION

**MARTINEZ RESIDENCE
452 PRECIOUS, VILLAS AT FORTUNA
SAN ANTONIO, TEXAS**

Project No. 7A-020
May 17, 2007

**Re: Indoor Environmental Quality Evaluation
Martinez Residence, 452 Precious, San Antonio, Texas**

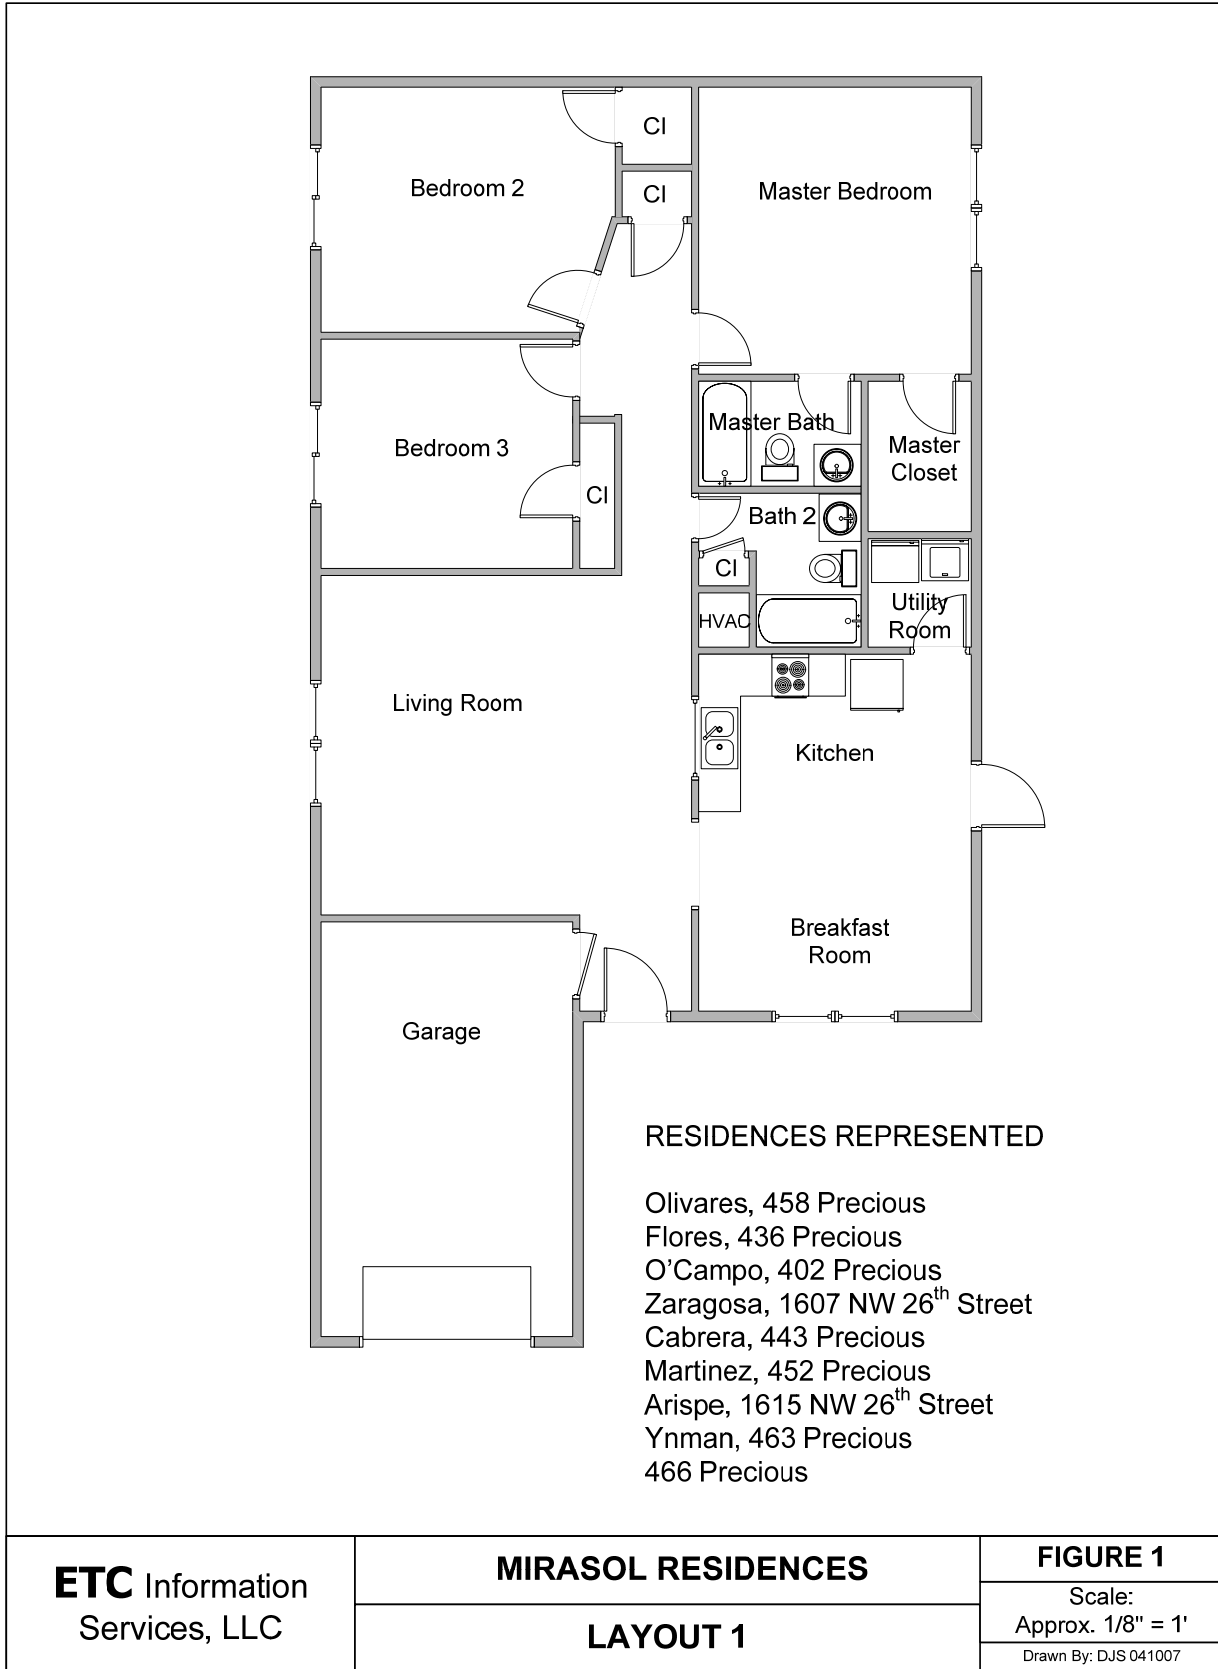
The subject residence is approximately seven years old and is a single-family dwelling located in west San Antonio, between West Commerce and Culebra Road, near St. Mary's University. It appears to have a reinforced concrete foundation, Hardiplank® siding external wall finish, conventional wood framing, and a complex hip and gable roof with composition shingles. It is a one-story structure with three bedrooms, two bathrooms, Kitchen, Breakfast Room, Living Room, Utility Room, and an attached one-car Garage. The layout of the subject residence is shown schematically in Figure 1.
