Aladdin Environmental LLC

April 9, 2008

Re: 470 Precious, San Antonio, TX

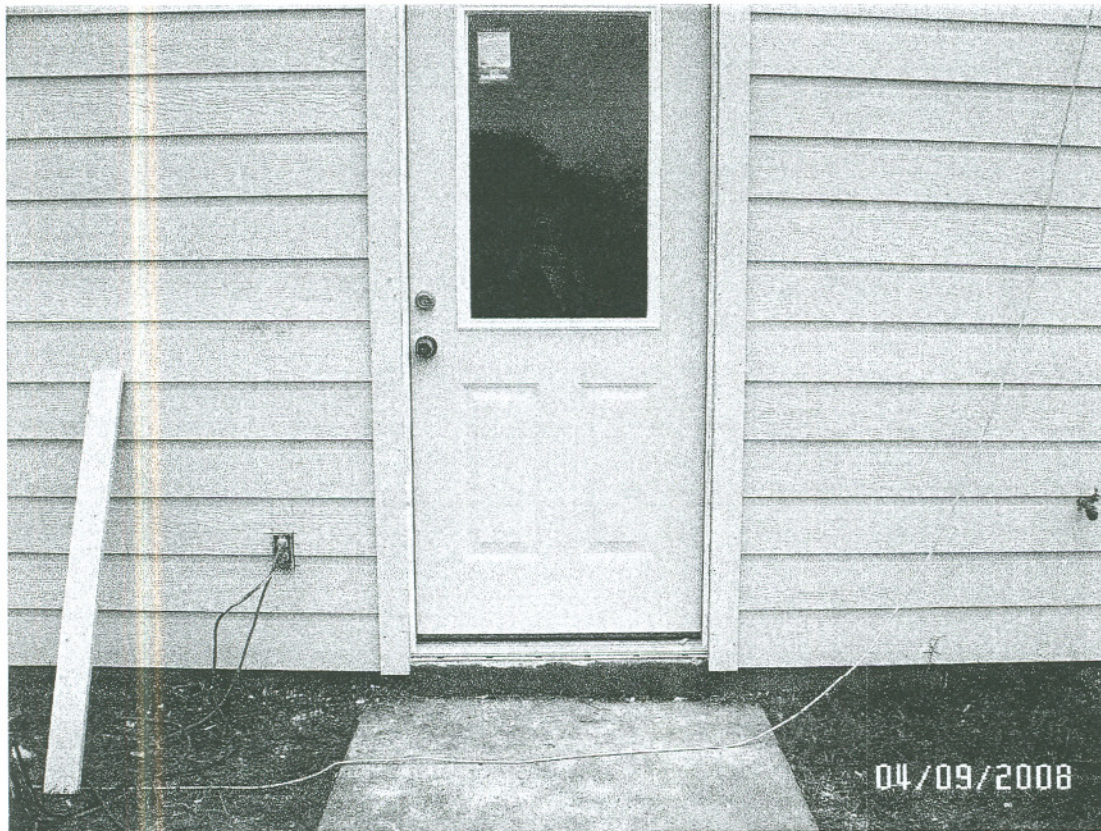
New back door, frame & siding

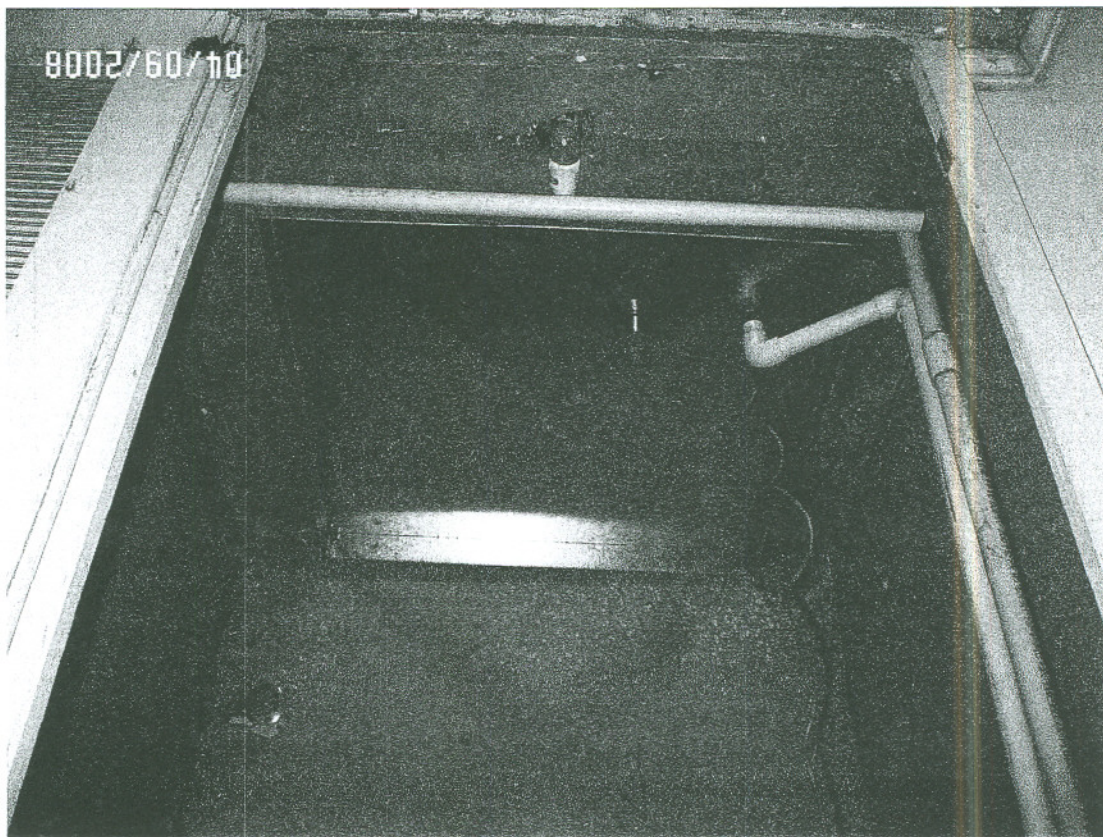
New overflow pan

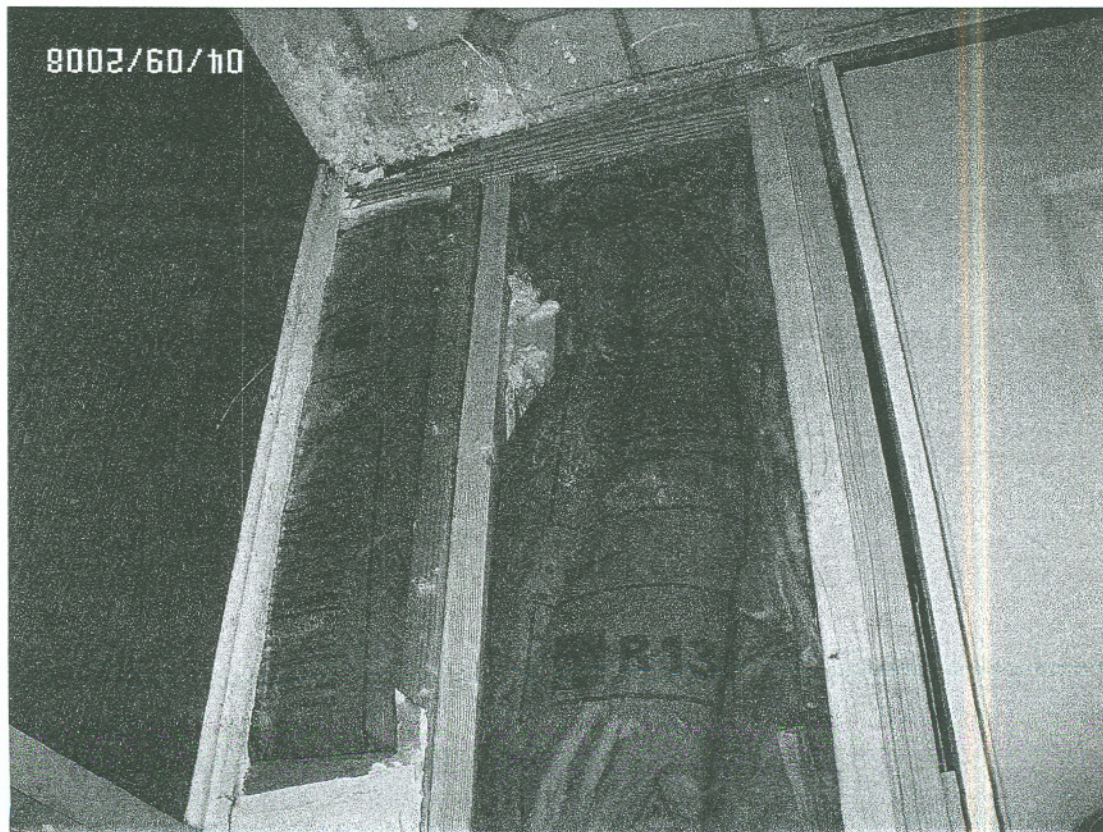
New frame, insulation, studs & baseplate
