Aladdin Environmental LLC

April 7, 2008

Re: 470 Precious, San Antonio, TX

General Recommendations and/or Observations

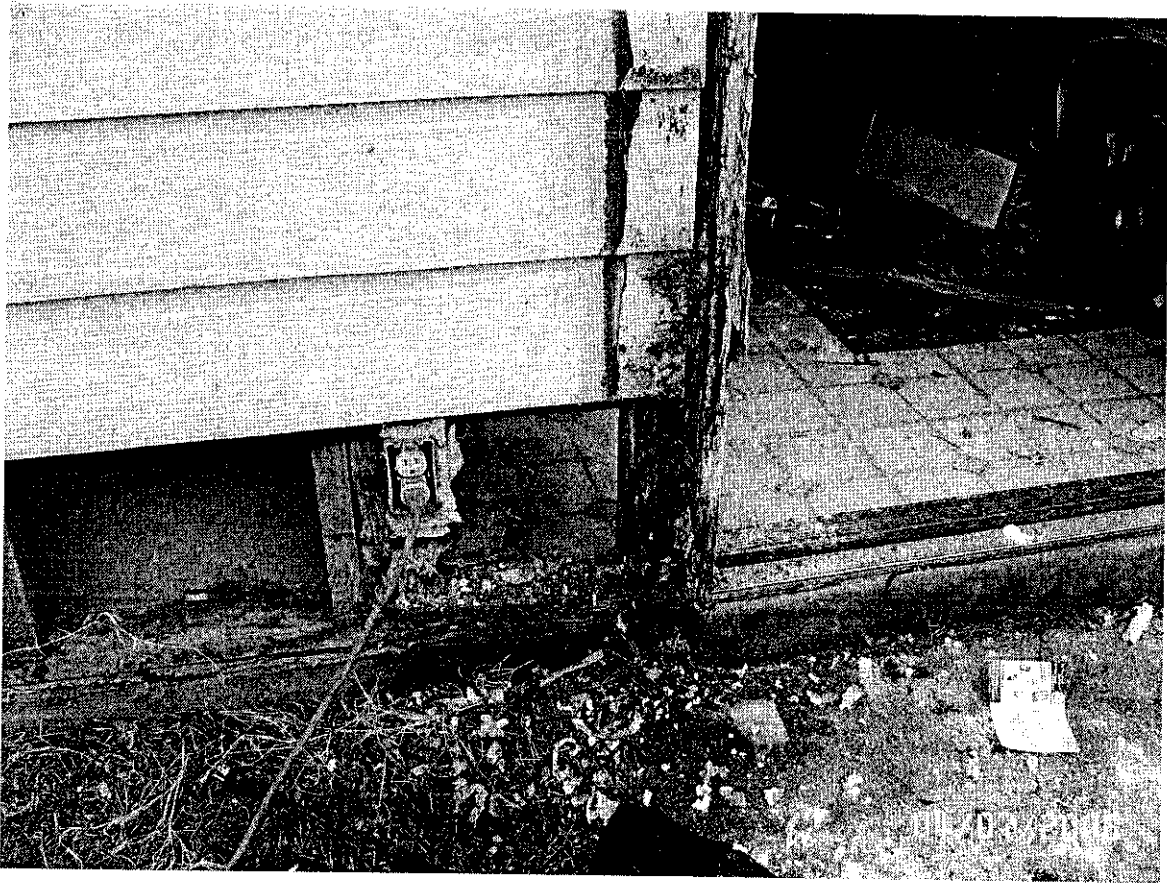
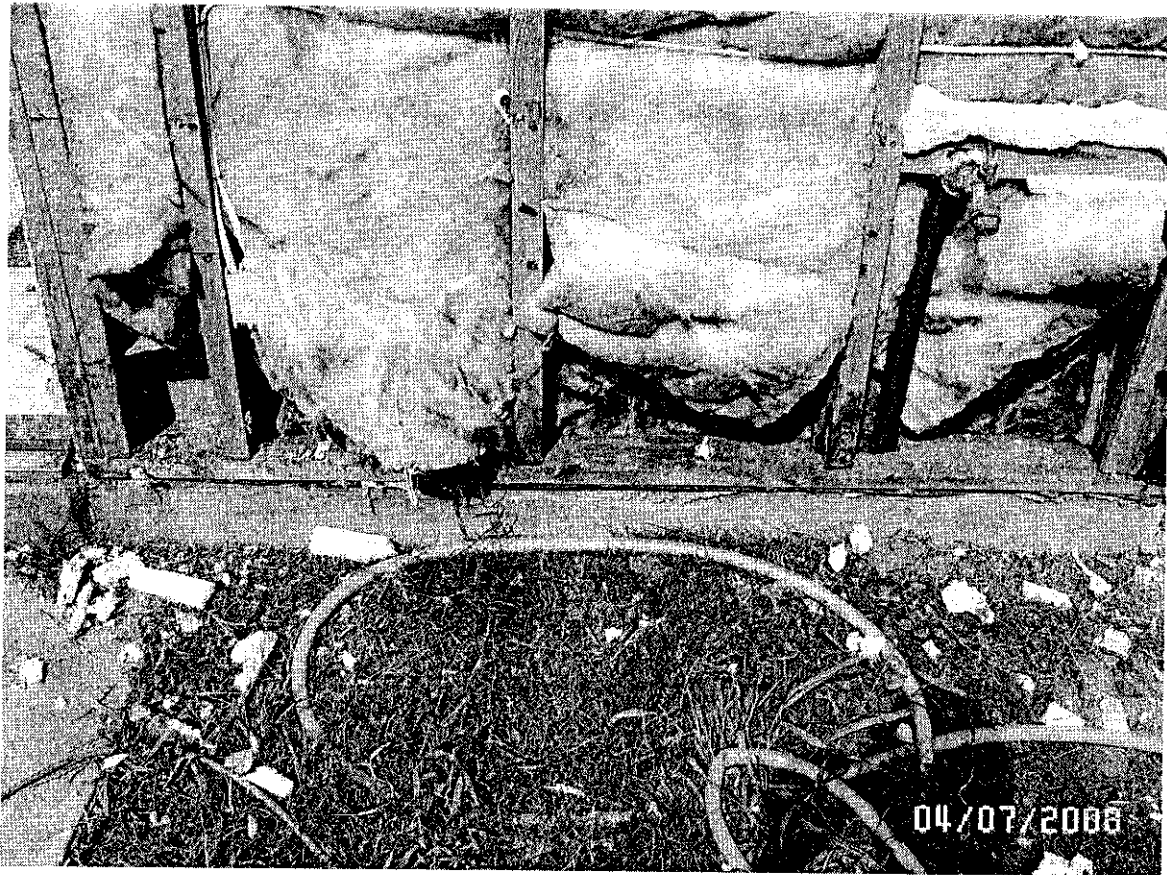
- The back door showed signs of water damage, wood rot and possible microbial growth. The apparent cause of this moisture was from the A/C overflow drain located directly above this area.

Back Door

- Recommend the entire door and frame be replaced.
 - Recommend the sheetrock approximately 18" around the perimeter of the door and approximately 2' high between the door and the corner of the house be removed and replaced.

- Recommend the damaged wood framing be removed and replaced. This would include studs on both sides of the door frame, the baseplate on both sides of the door and the lower portion of 2 studs between the door and the corner.

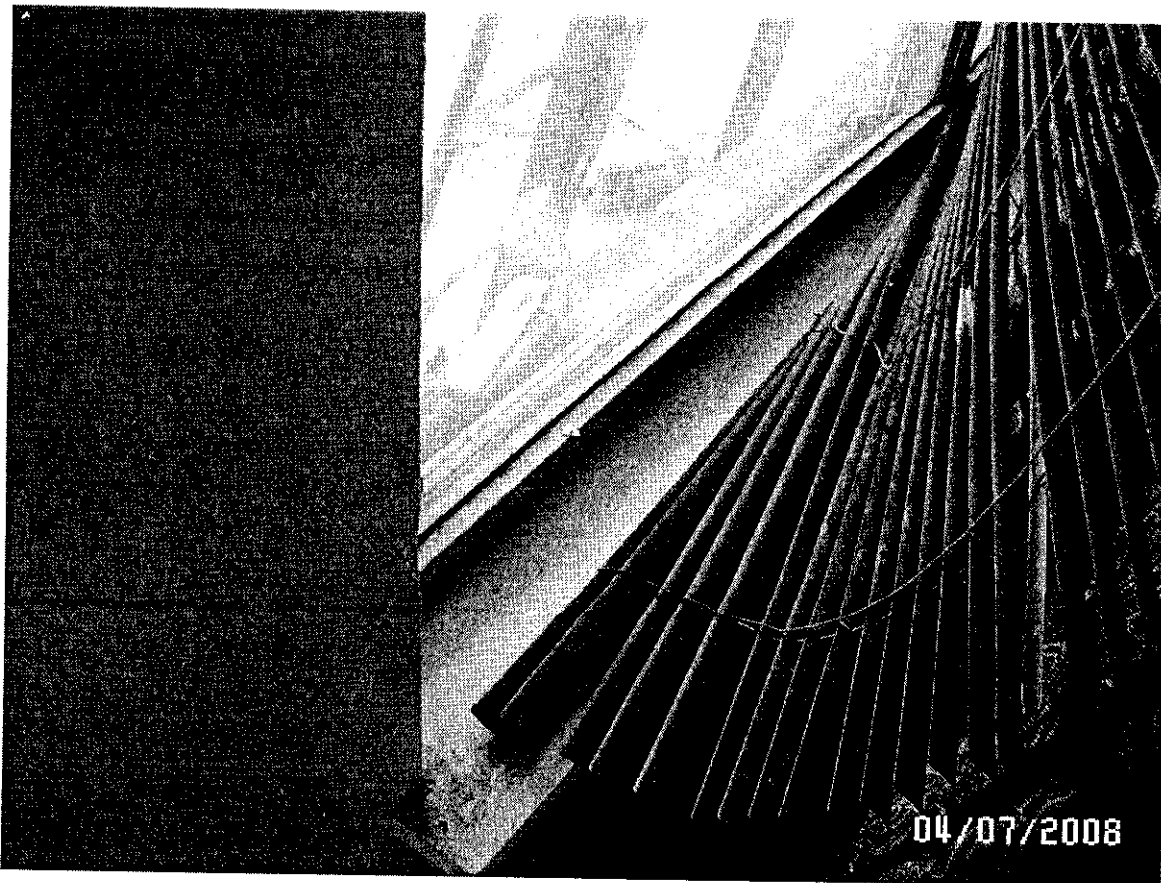
- Recommend items such as paint or any hazardous material be stored properly.
- Windows – Flashing around the exterior of the windows was in the process of being replaced. The windows throughout showed signs of debris buildup.

Living Room window

- Recommend the window and sill be cleaned and sanitized.
 - Recommend the window be maintained to prevent moisture and debris buildup.
- Upstairs – The carpet was in visibly poor condition and had a strong urine odor. In some areas patches of carpet were missing from what appeared to be pet damage.

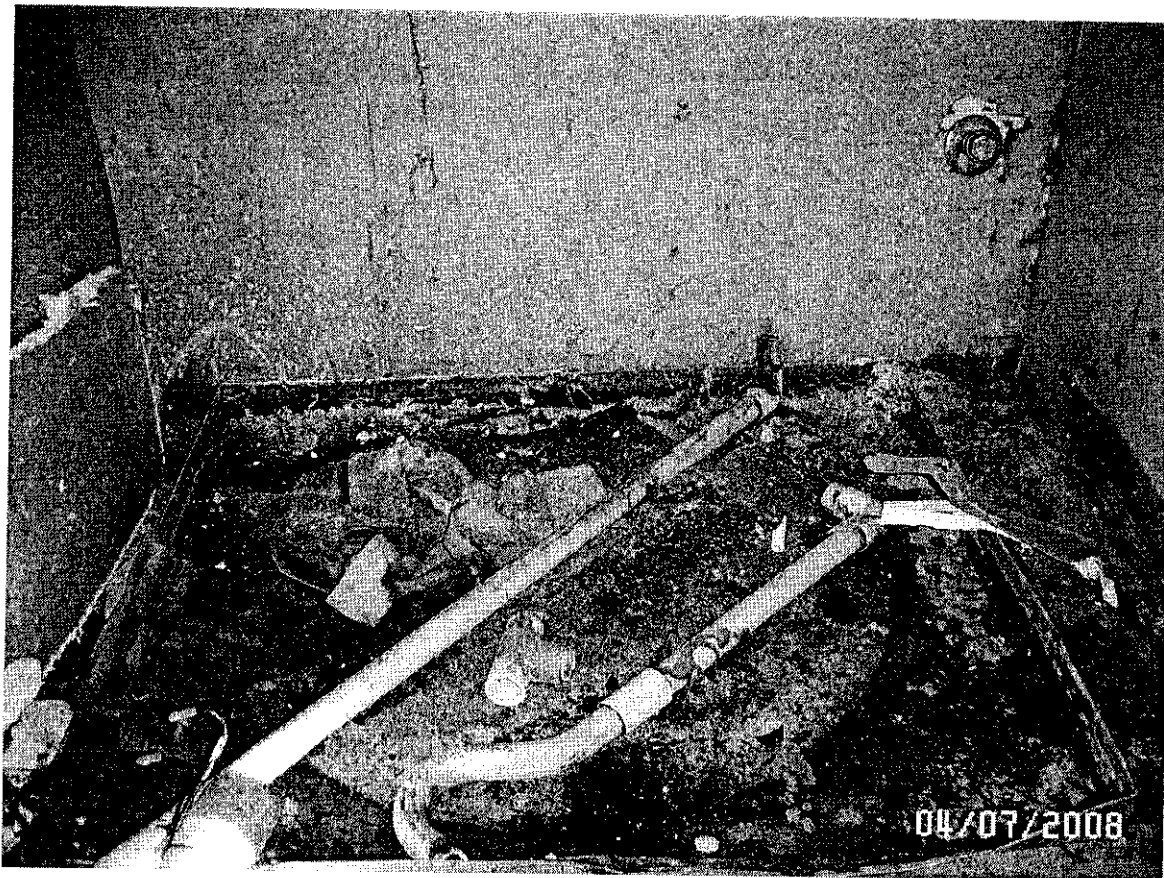
- The HVAC system and ductwork was in the process of being replaced.
- The water heater was in the process of being relocated. The overflow pan in this area (also used for the A/C system) showed signs of considerable water damage.

A/C overflow pan

- Recommend the overflow pan be removed & replaced.
 - Recommend the wood subfloor be cleaned, sanded and sanitized.
- Kitchen – The base shelf below the sink stored numerous household products including paint.

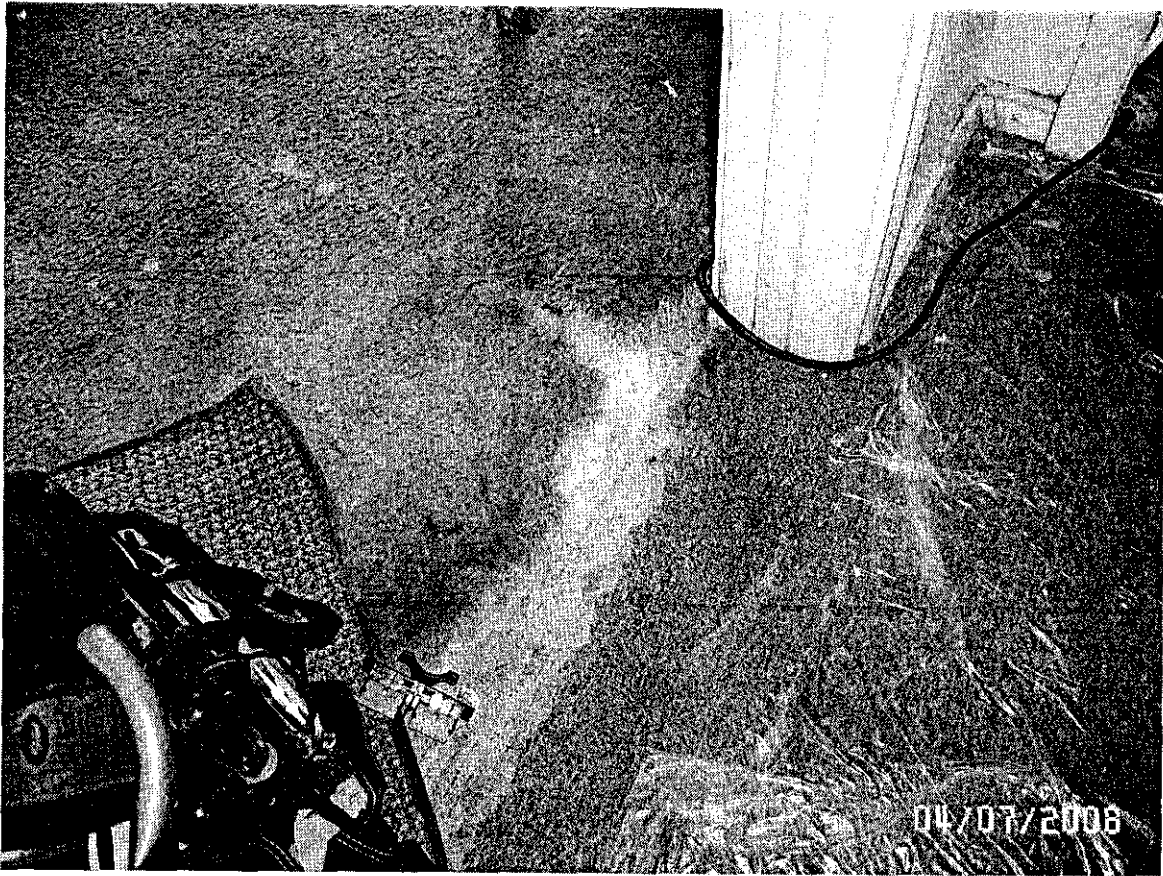
Upstairs carpet

- Recommend the carpet be maintained properly to prevent an adverse reaction to the quality of the indoor air.
- Bathrooms – Moisture readings in both upstairs bathrooms were normal. Both vanities had considerable household contents as well as debris.

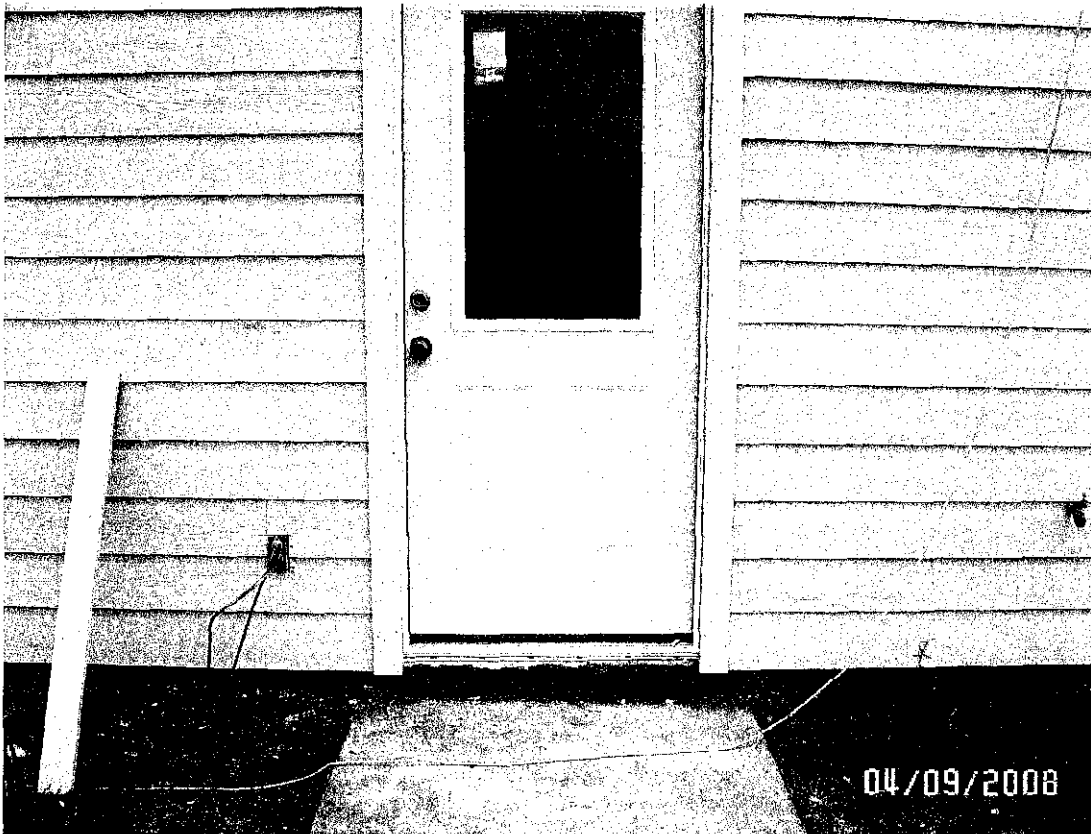
New back door, frame & siding

- This scope of work included the Back Door area and the A/C return (previous water heater closet).
 - The back door, door frame, recommended wood framing, insulation & exterior siding were removed and replaced. The recommended sheetrock was removed (to be replaced following inspection of wall cavity). There were no remaining signs of water damage or microbial growth. The entire area tested dry with a moisture meter.
 - The HVAC ductwork and unit had been replaced.
 - The previous overflow pan had been replaced. The wood subfloor in this area had no signs of elevated moisture or microbial growth.
 - The carpet in this area had been removed.
- Recommend the A/C unit, return and condensate drain be maintained properly to prevent a reoccurrence of this problem.
