Aladdin Environmental LLC

Re: 470 Precious, San Antonio, TX

Aladdin Environmental is pleased to submit this environmental evaluation on the above residence located at 470 Precious, San Antonio, TX. This limited evaluation was performed on August 22nd, 2008. We have observed the standard of care generally exercised by the profession under similar circumstances and conditions to complete this report.

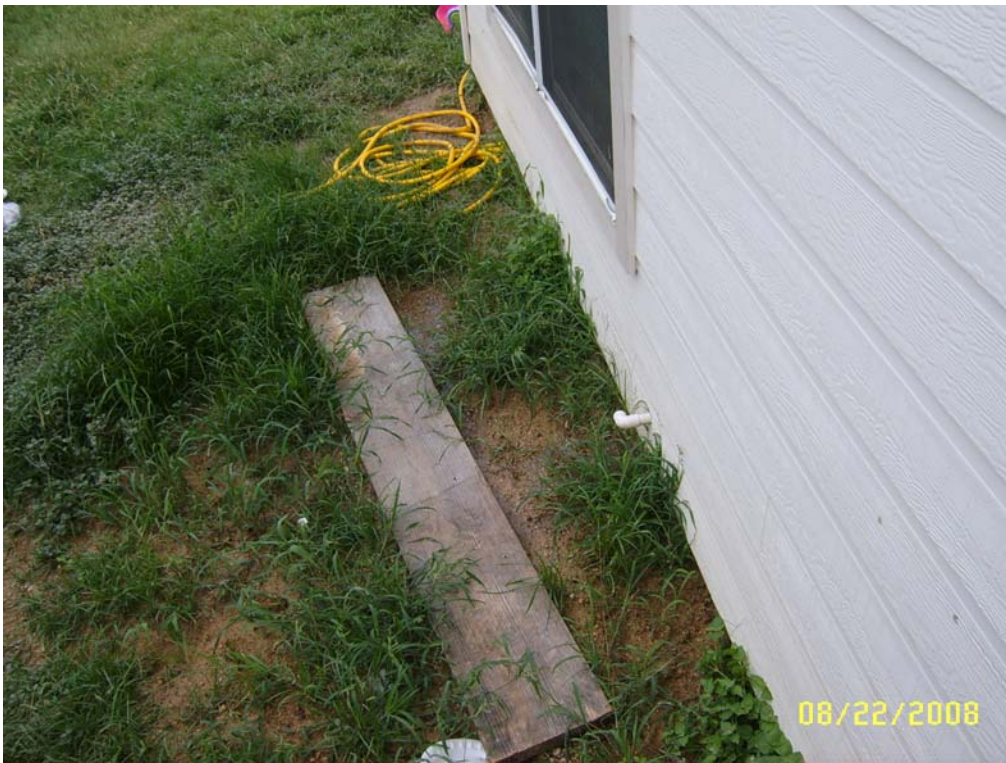
- Homeowner expressed concerns with the A/C condensate line dripping on the exterior of the house. It does appear this should be addressed to prevent the pooling water that was taking place next to the foundation. This inspection did not cover foundation issues or areas outside the living space.

A/C condensate line - water pooling

- Recommend correcting the A/C condensate line from dripping next to the foundation.
 - Recommend the base on the living room side be replaced. During replacement, if further damage is found, sheetrock may need to be removed.

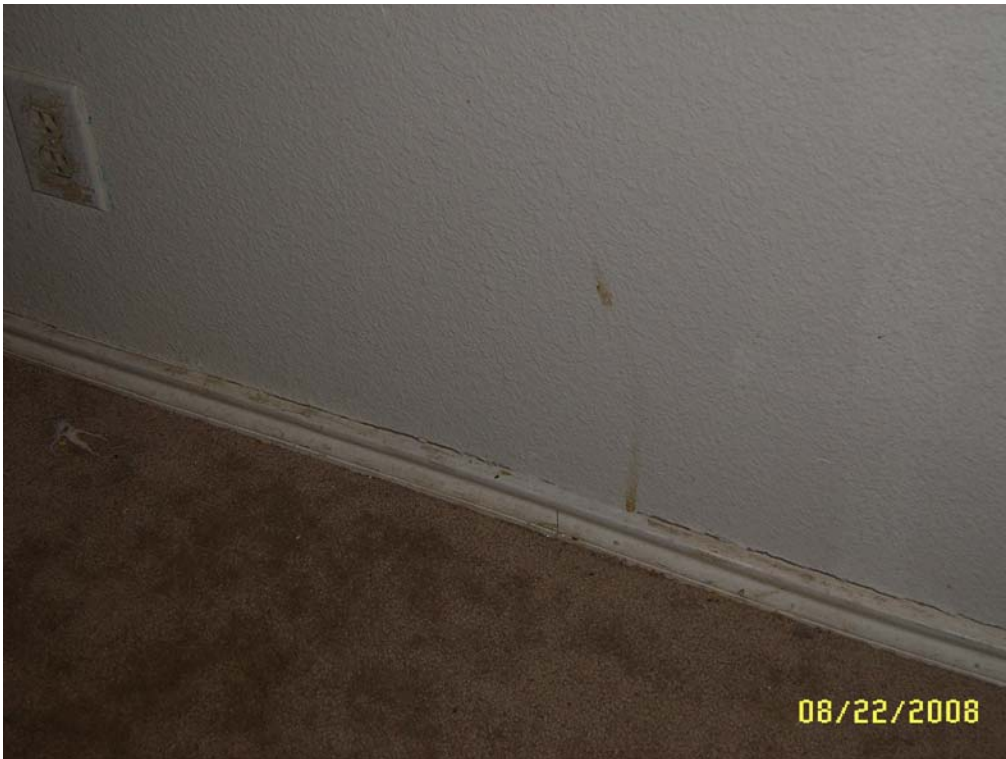
Living Room wall backing condensate line

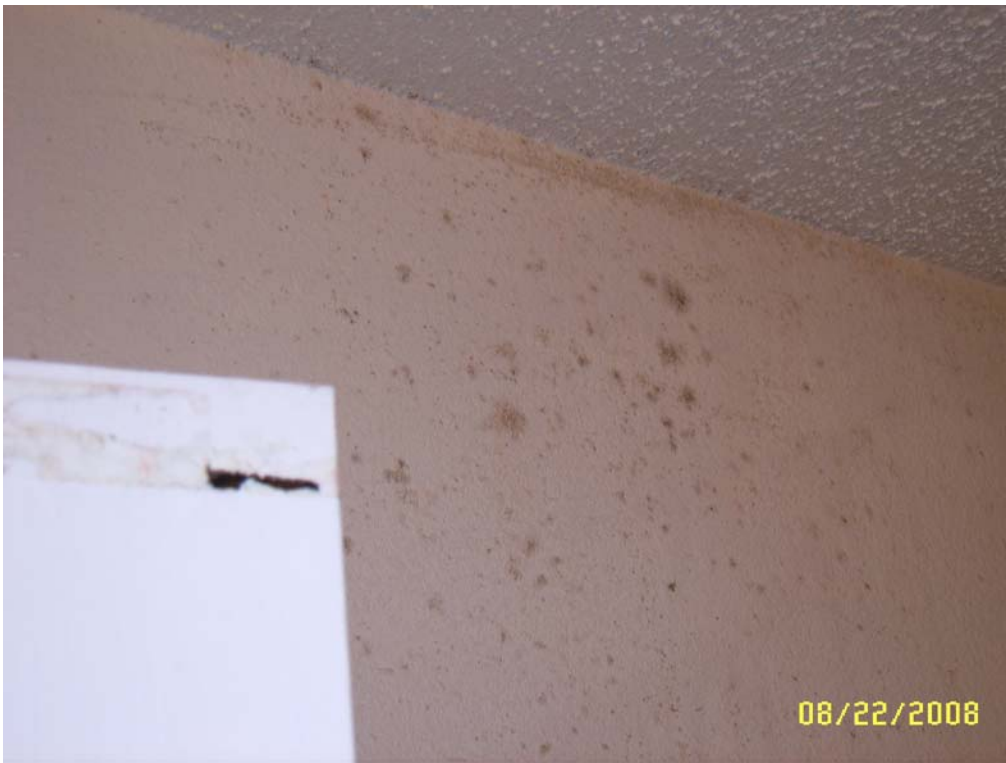
- A swab (surface) sample was taken on the wall in the upstairs Hall Bathroom. There was what appeared to be surface microbial growth on the wall. Lab results indicate a “Rare” level of *Alternaria* type spores. “Rare” amount is within generally accepted guidelines. There was also a “High” level of *Yeast*. There was no *Alternaria* or *Yeast* found in the two air samples taken upstairs.

- Upstairs Hall Bath - There is a growth that is described in the swab sample above on the walls of the Hall Bath. This appears to be a result of high humidity during showering. The moisture level in the walls was normal during this inspection.

Hall Bath - growth on wall

- Recommend the walls be cleaned and sanitized.
 - Recommend the exhaust vent be used during and after showers to remove moisture from the air.
- Master Bath – Homeowner states leaks are present around the toilet. This was not observed during this inspection, however there was minor water damage to the side of the vanity and the base behind the toilet appeared to have heavy dirt/debris on it.

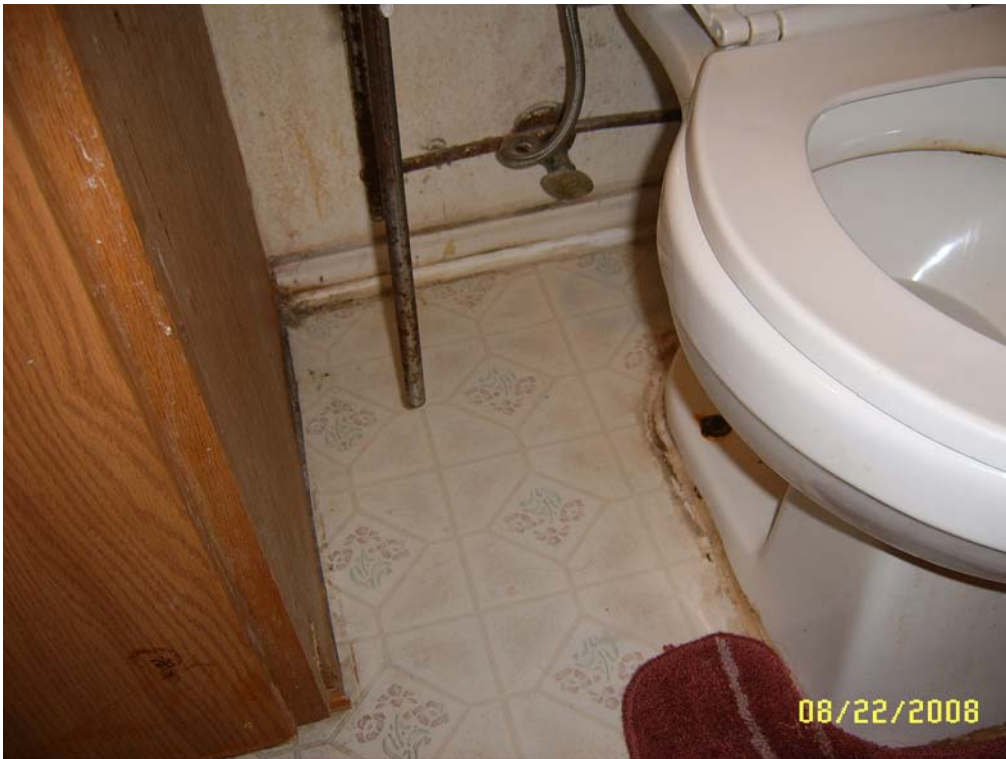
Master Bath – toilet area

- Recommend locating and correcting leak. Possibly from wax ring on toilet.
