GJM CONSULTING, INC.

FIELD REPORT 0806 - 07

JUNE 11, 2008

PROJECT Testing of windows and structural wall area at the perimeter of the window unit for verification of resistance to water penetration. Exterior wall material had been removed and new flashing material installed between the window frame and structural wall material. Some of the existing sliding window units had been removed and new units installed. Exterior finish wall materials reinstalled, sealed and repainted.

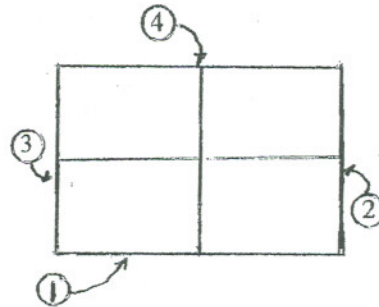
WINDOW NUMBER 1

No water penetration to the interior
Between window frame and wall
observed

2 3' 0" x 5' 0" SINGLE HUNG UNITS

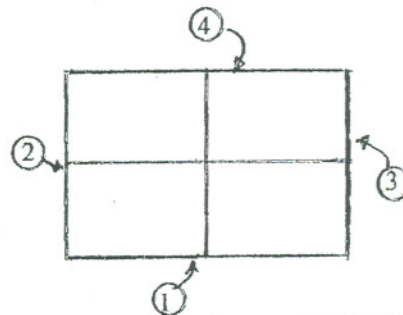
WINDOW NUMBER 4

No water penetration to the interior
between window frame and wall observed

TWO 3'-0" x 5'-0" SINGLE HUNG UNITS
