INDOOR ENVIRONMENTAL QUALITY EVALUATION

**SMITH RESIDENCE
514 PRECIOUS, VILLAS AT FORTUNA
SAN ANTONIO, TEXAS**

**SAN ANTONIO HOUSING AUTHORITY
SAN ANTONIO, TEXAS**

Project No. 7A-020
May 16, 2007

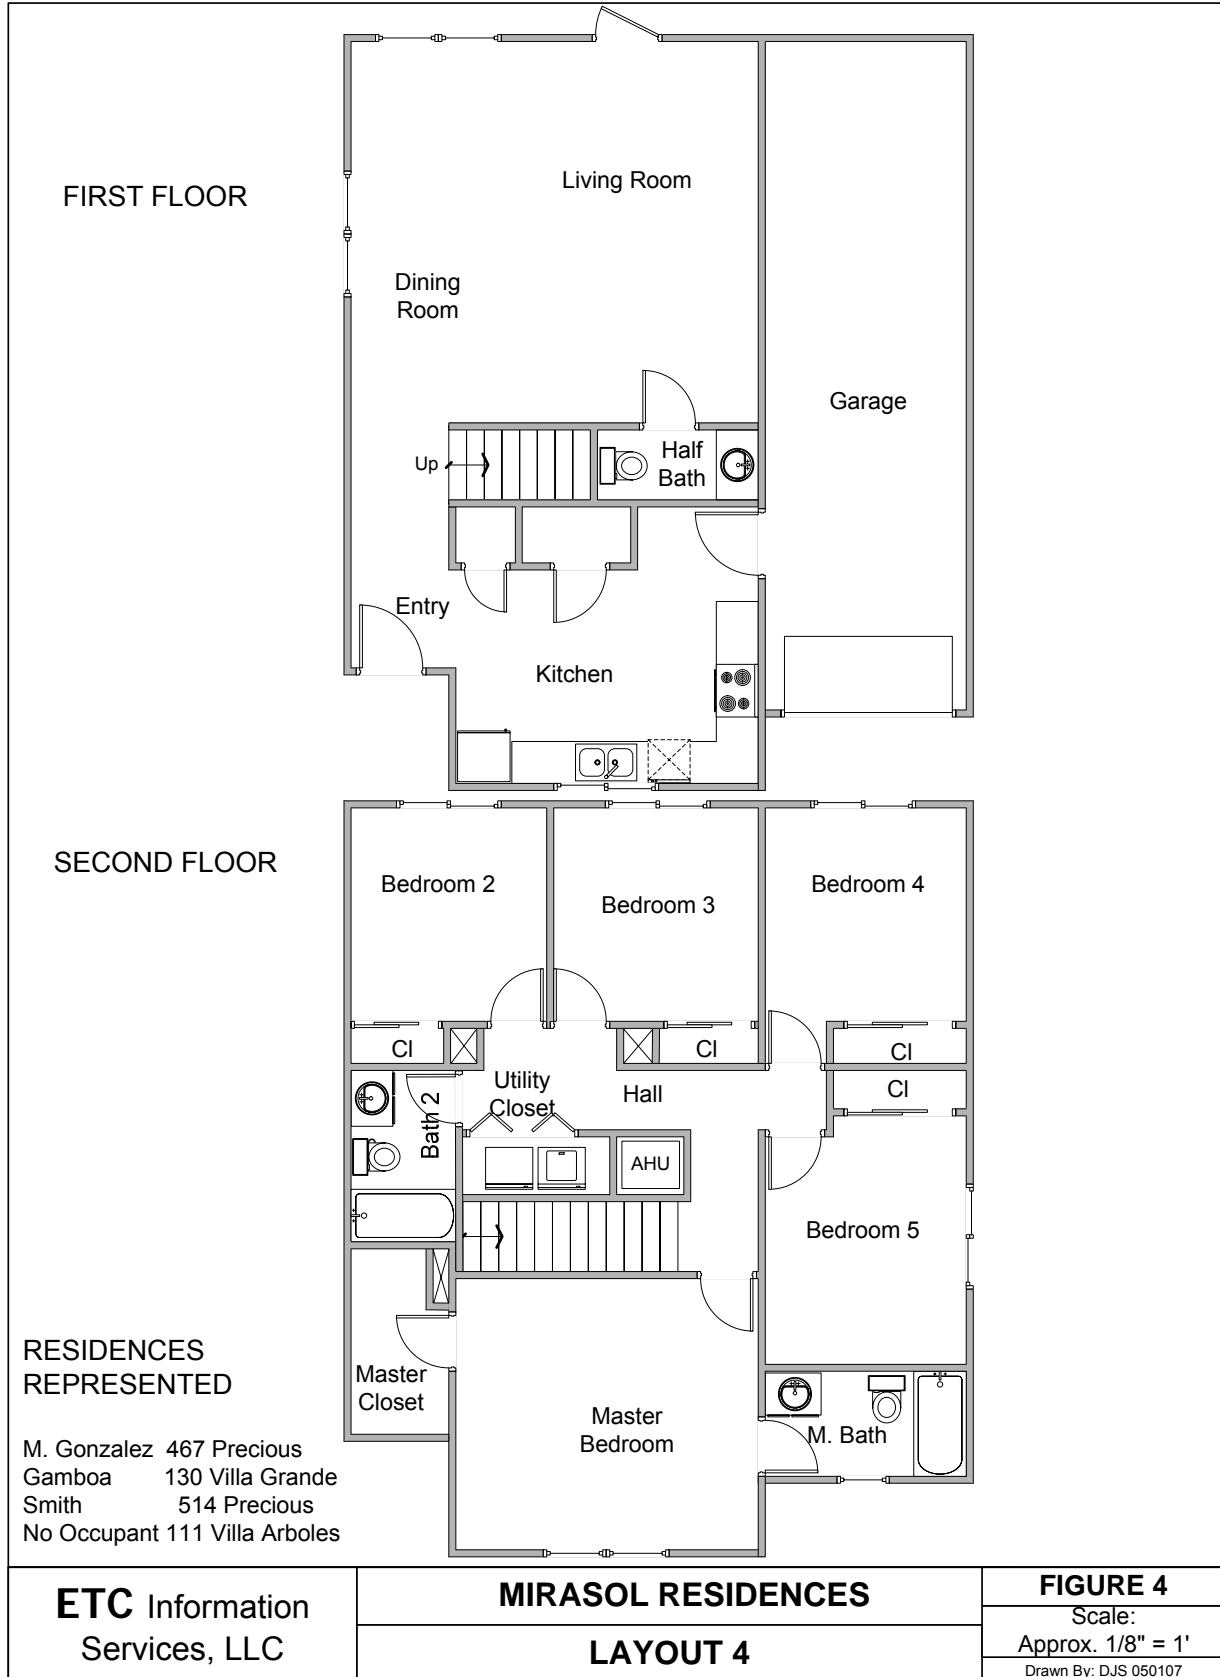
The subject residence is approximately seven years old and is a single-family dwelling located in west San Antonio, between West Commerce and Culebra Road, near St. Mary's University. It appears to have a reinforced concrete foundation, Hardiplank® siding external wall finish, conventional wood framing, and a complex hip and gable roof with composition shingles. It is a two-story structure with five bedrooms, two bathrooms, one half-bath, Kitchen, Dining Room, Living Room, Utility Closet, and an attached one-car Garage. The layout of the subject residence is shown schematically in Figure 4.
