FIELD REPORT 0806 - 02

JUNE 4, 2008

PROJECT Testing of windows and structural wall area at the perimeter of the window unit for verification of resistance to water penetration. Exterior wall material had been removed and new flashing material installed between the window frame and structural wall material. Some of the existing sliding window units had been removed and new units installed. Exterior finish wall materials reinstalled, sealed and repainted.

TEST LOCATION No. 2.
638 Mathews

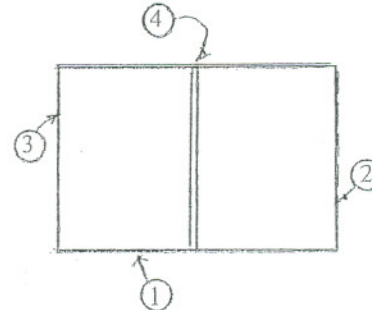
WINDOW NUMBER 1

No water penetration to the interior observed .

TWO 3'-0" x 5'-0" SINGLE HUNG UNITS

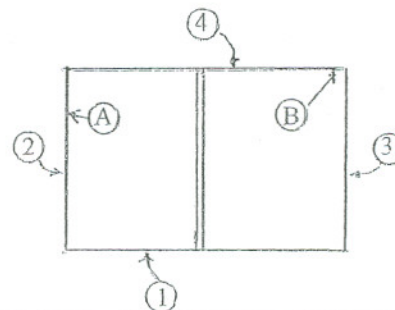
WINDOW NUMBER 4

No water penetration to the interior observed .

TWO 3'-0" x 5'-0" SINGLE HUNG UNITS

(A) 3 minutes into test water application No. 2. water observed between glass and seal six inches below top of glass panel. This water may enter the glass pocket at the top corner joint.

(B) 2 minutes into test water application No. 3. water observed on the glass surface below the seal 2 inches from the jamb. This water may enter at the corner joint. During test water application No. 4 at the top of the window unit, the water volume on the interior of the glass did not increase.
