# GJM CONSULTING, INC.

FIELD REPORT 0806 - 02

JUNE 4, 2008

**PROJECT** Testing of windows and structural wall area at the perimeter of the window unit for verification of resistance to water penetration. Exterior wall material had been removed and new flashing material installed between the window frame and structural wall material. Some of the existing sliding window units had been removed and new units installed. Exterior finish wall materials reinstalled, sealed and repainted.

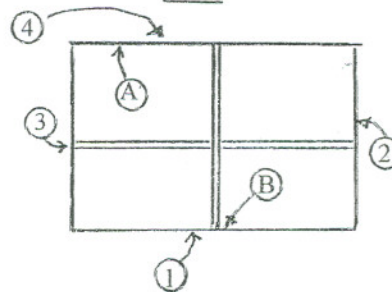
WINDOW NUMBER 1

No water penetration to the interior between window frame and wall observed.

- (A) Water entered between glass and seal at top of glass flowed down interior surface of glass.
- (B) Water on wood sill. Appeared to have penetrated corner joint of window frame.

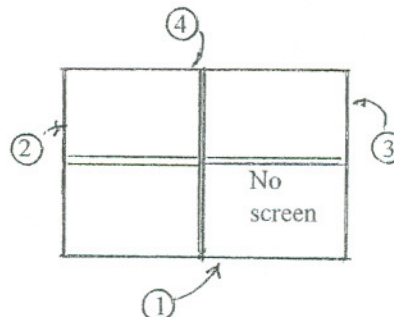
WINDOW NUMBER 5

No water penetration to the interior observed.

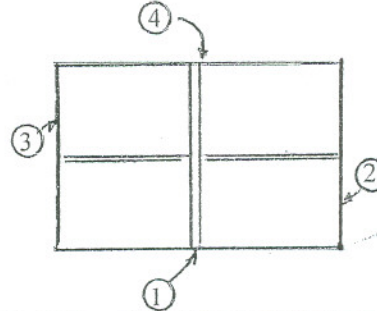
WINDOW NUMBER 1

No water penetration to the interior observed .

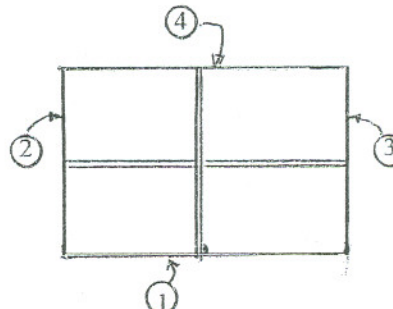
WINDOW NUMBER 5

No water penetration to the interior observed .

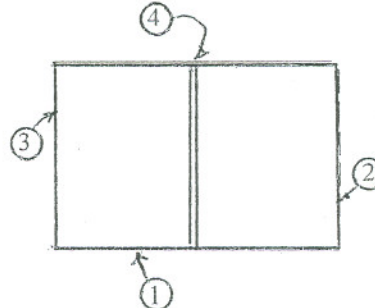
#### WINDOW NUMBER 1

No water penetration to the interior observed .

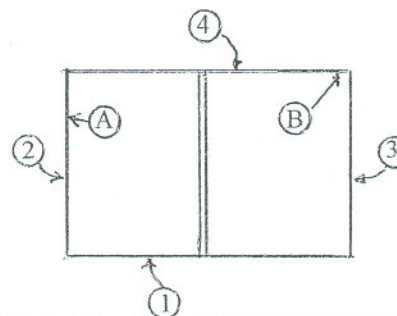
#### WINDOW NUMBER 4

No water penetration to the interior observed .

(A) 3 minutes into test water application No. 2. water observed between glass and seal six inches below top of glass panel. This water may enter the glass pocket at the top corner joint.

(B) 2 minutes into test water application No. 3. water observed on the glass surface below the seal 2 inches from the jamb. This water may enter at the corner joint. During test water application No. 4 at the top of the window unit, the water volume on the interior of the glass did not increase.

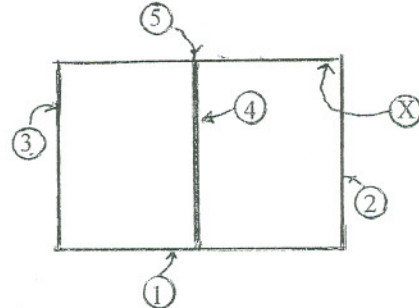
WINDOW NUMBER 1

No water penetration to the interior  
between window frame and wall observed.

(X) Two minutes into test water application No. 2  
water observed between glass and seal at the top  
of the fixed glass panel 3" from jamb. The water  
flowed down the glass to the top of the vent panel.

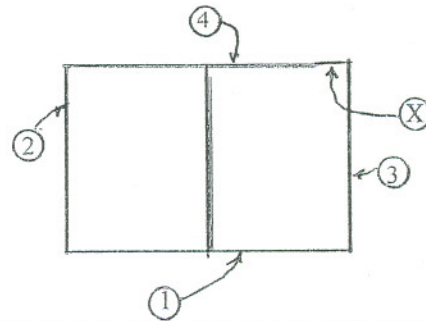
WINDOW NUMBER 4

No water penetration to the interior  
between window frame and wall observed

(X) One minute into test water application No. 3  
water observed between glass and seal at the top  
of the fixed glass panel 3" from jamb. The water  
flowed down the interior surface of the glass.

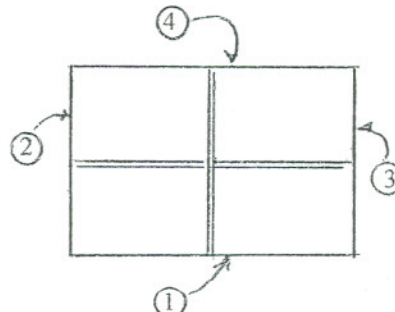
WINDOW NUMBER 1

No water penetration to the interior observed .

Water on floor 8 inches from bottom of wall  
Not from test procedure

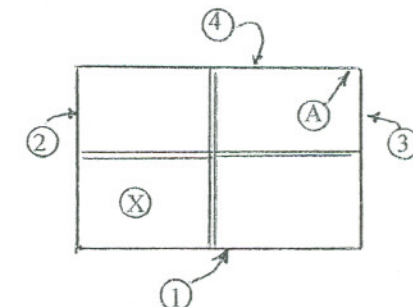
WINDOW NUMBER 4

No water penetration to the interior  
between window frame and wall observed.

(X) Interior lite of glass panel broken

(A) During test application (3) water observed on interior of glass between glass and seal. Volume of water on interior increased during test application No. (4).

At conclusion of test, water observed on floor at the bottom of the wall 8 inches from the left jamb of the window . Interior wall surface at the window jamb and sill felt dry. During an inspection of the exterior of the window and wall, a joint in the siding appeared to be open. This joint is in line with the area where water was observed on the interior floor.
