**AccuTech
Consultants, LLC**

Structural Report

**San Antonio Housing Authority
Single Family Housing Design/Build Project
San Antonio, Texas**

June 2007
Project CTR001-F

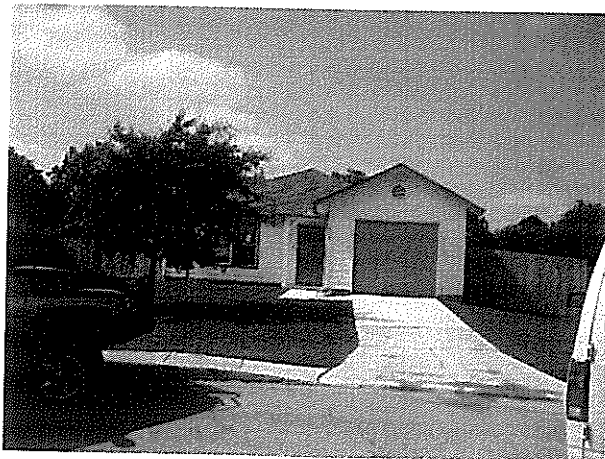
Photograph No. 1

These houses were one-story or two-story, wood-framed structures and were located in residential neighborhoods (See Photographs No. 1 and No. 2). Each of these homes was constructed

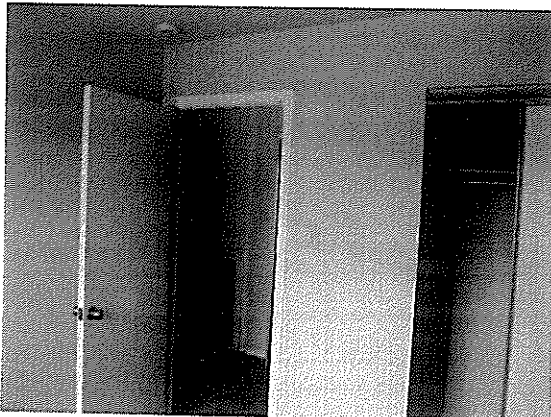
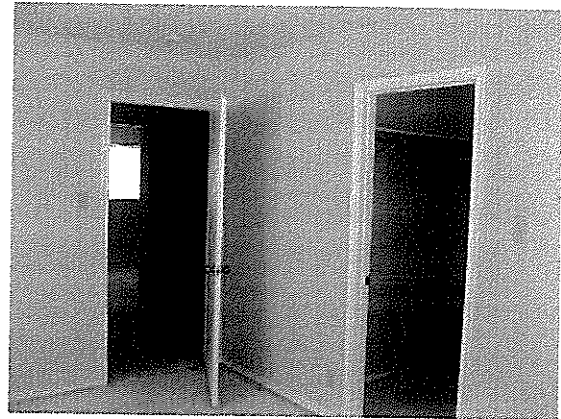
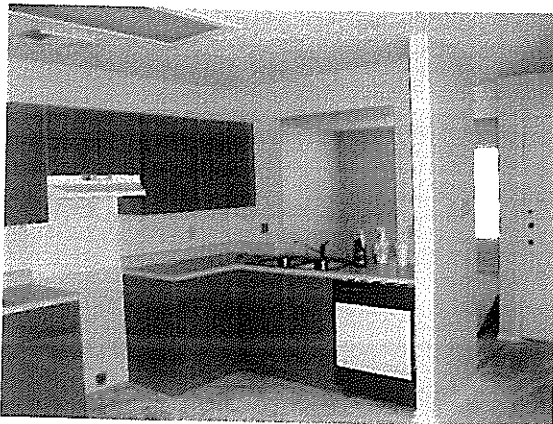
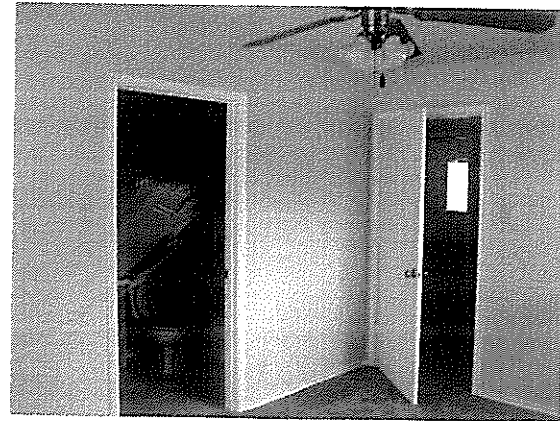
- The interior of most of the homes had been recently patched and painted. Therefore, little to no distress was found in the interior finishes of most of the homes (See Photographs No. 1 through No. 4).

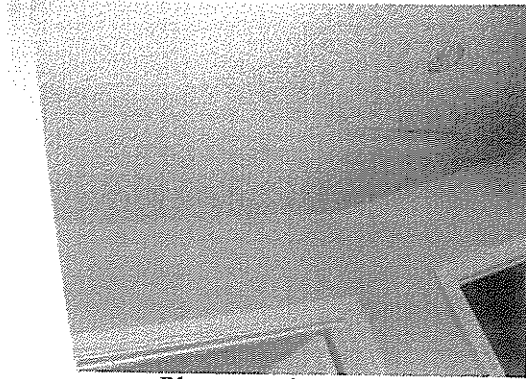
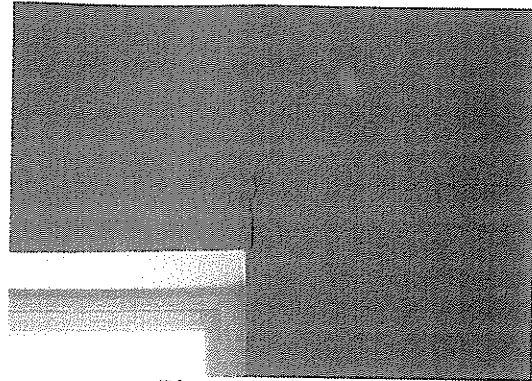
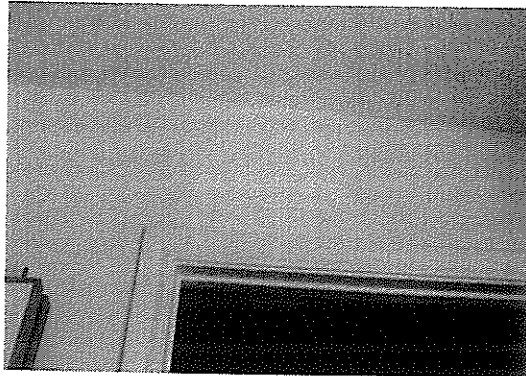
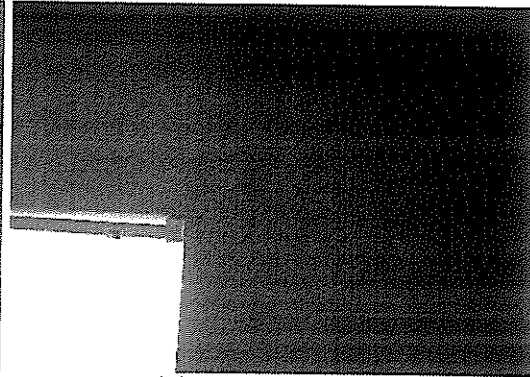
- There were some houses (houses #2, #6, #11, #13, #16, #19, #20, #24, and #26) where some minor cosmetic distress and/or patching was noted (Reference Photographs No. 5 through No. 8).

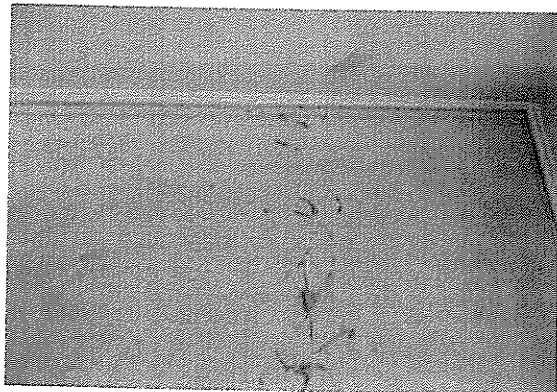
Photograph No. 9

- Cracking of the floor slabs was noted in a few of the houses (houses #2, #10, #12, #13, #15, #16, #20, #24, and #26) (See Photographs No. 9 and No. 10). Some of these

10. Our observations revealed that some of the homes (houses #2, #3, #7, #9, #10, #12, #13, #15, #16, #20, #24, #25, and #26) had cracks and/or patched cracks in the slabs (in both the interior floors and exterior porches). Our observations also revealed that these cracks

were typical shrinkage cracks and were not structural cracks. Shrinkage cracks occur due to normal volumetric changes associated with the drying of the concrete. These cracks develop as the concrete cures and are random hairline cracks (typically less than 1/16 of an inch) that often extend to the perimeter of the slab. However, these cracks often widen due to the vehicular and pedestrian traffic, particularly in the garage areas. These cracks can also widen due to flexural movement of the foundation due to seasonal moisture changes. Shrinkage cracks are not unusual in concrete construction and are considered cosmetic in nature.

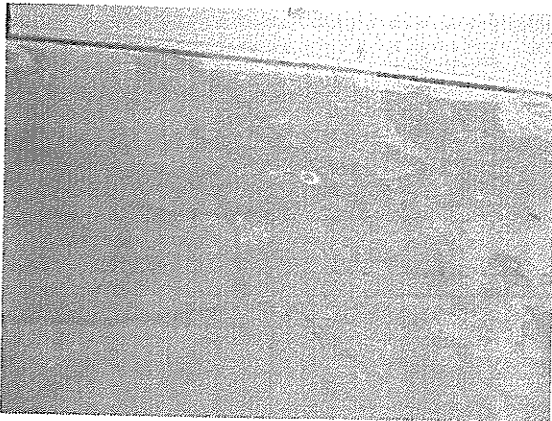
Photograph No. 11

cracks had been patched (houses #15, #16, #20, and #24) (See Photographs No. 11 and No. 12). An unusually large amount of patched slab cracks were noted in house #24 (See Photograph No. 12).

11. We noted that the some of the shrinkage cracks were patched. In some cases, the patching that was conducted appears to have negatively magnified the appearance of the cracks. It is our opinion that this condition was the result of the quality of workmanship used in the repair of these cracks.

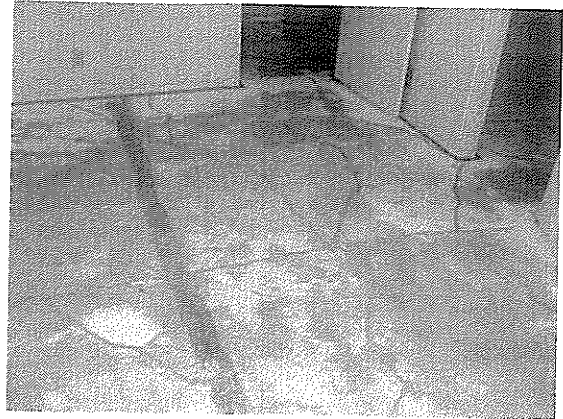
Photograph No. 12

However, the structure located at 431 Precious (house #24) had an unusually large amount of patched shrinkage cracks. This condition indicates that there may have been a large amount of water used in the concrete mix. Although these cracks have been patched, we have no background information related to these repairs. Therefore, we recommend that the contractor and/or designer be contacted to confirm that these cracks are cosmetic in nature.

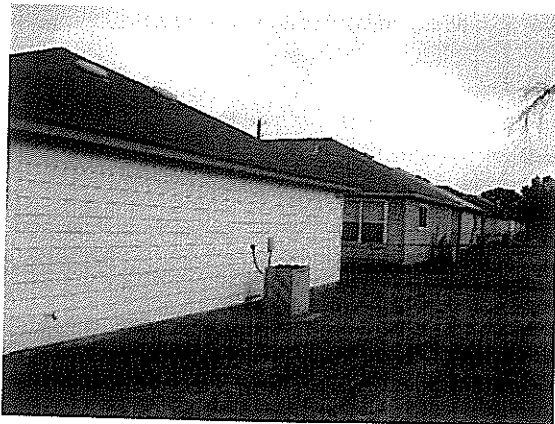
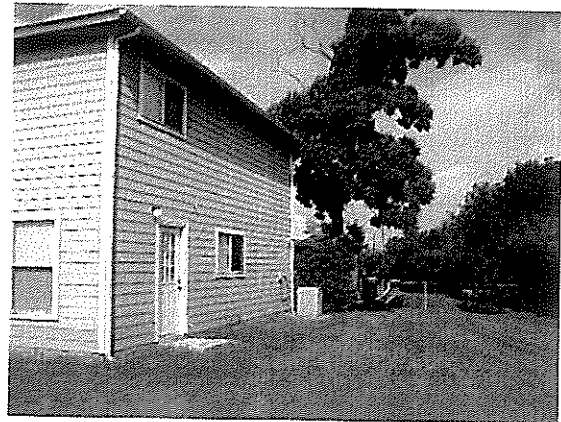
- There was generally little to no distress to the exterior veneer at most of the houses (See Photographs No. 13 and No. 14).

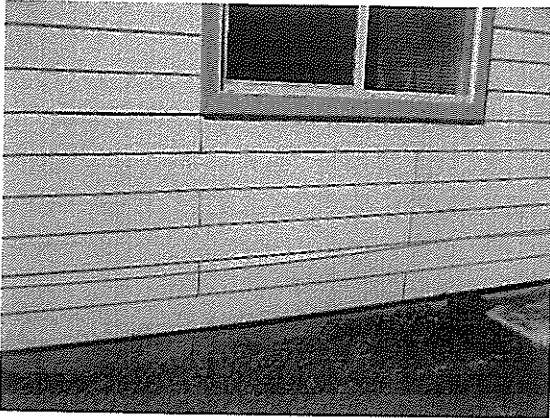
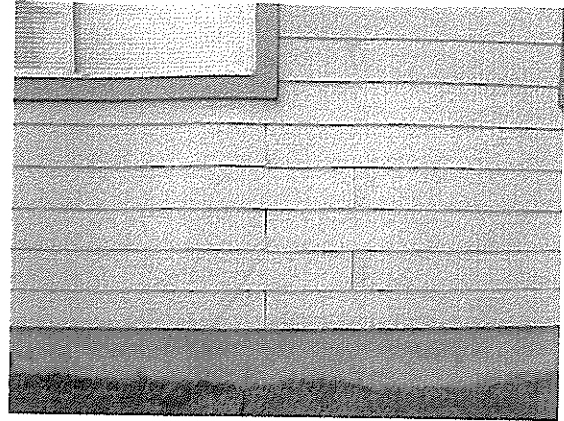
- There were separations of the siding joints at some of the houses (houses #3, #5, #8, #9, #10, #11, #14, #26, #27, and #28) (See Photographs No. 15 and No. 16). Some of these separations had been sealed.

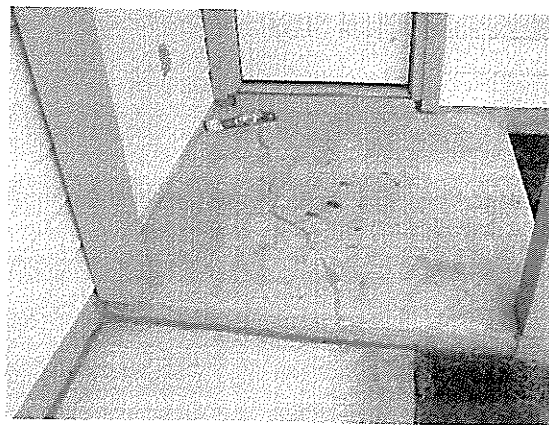
Photograph No. 17

- At one of the houses (house #16), the wall base plate extended out past the edge of the foundation.
- There was a crack in the brick veneer at one of the houses (house #16).
- Cracks or patched cracks were noted in the porch slabs of some of the homes (house #3, #7, #9, #16, and #25) (See Photograph No. 17).

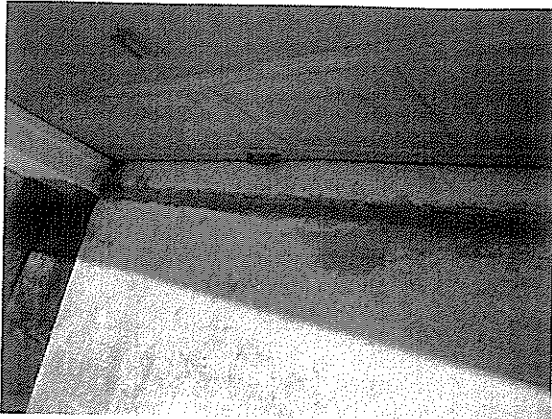
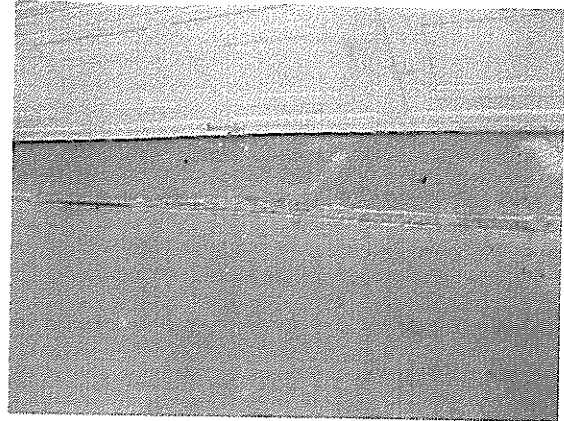
- Sealant had been added to the control joints between the foundation and the adjacent flatwork at some of the structures (houses #6, #14, #18, and #26) (See Photographs No. 18 and No. 19).

13. Sealing of the siding joints was noted at several of the houses (houses #6, #14, #18, and #26). It was also noted that the sealant had been liberally applied and has “discolored” in most applications. Based on our observations, it is our opinion that this joint sealing was of poor workmanship and has negatively magnified the appearance of the siding. This condition is cosmetic in nature.

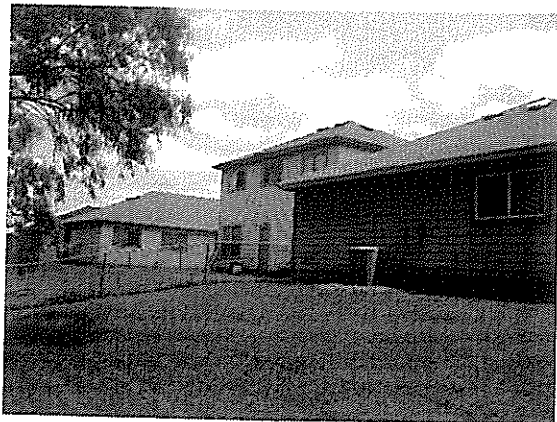
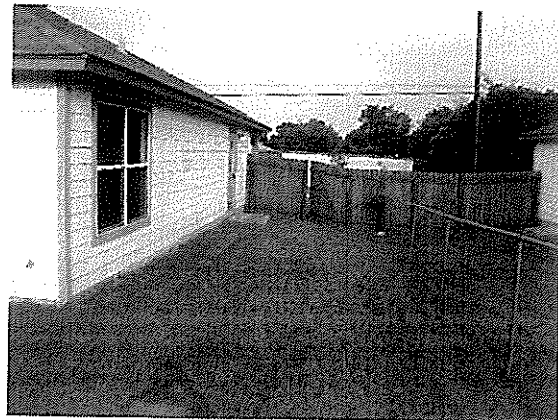
- Some of the structures may have been constructed on fill sites (houses #2, #3, #8, #9, #10, #11, #14, #15, #16, #19, #20, #23, #24, #25, #26, #27, and #28) (See Photographs No. 20 and No. 21).

- The site grading at several of the homes (houses #2, #3, #8, #9, #10, #11, #14, #15, #16, #19, #20, #23, #24, #25, #26, #27, and #28) appeared to provide inadequate drainage.
- The landscaping at the houses consisted of grass and other various types of vegetation (weeds).

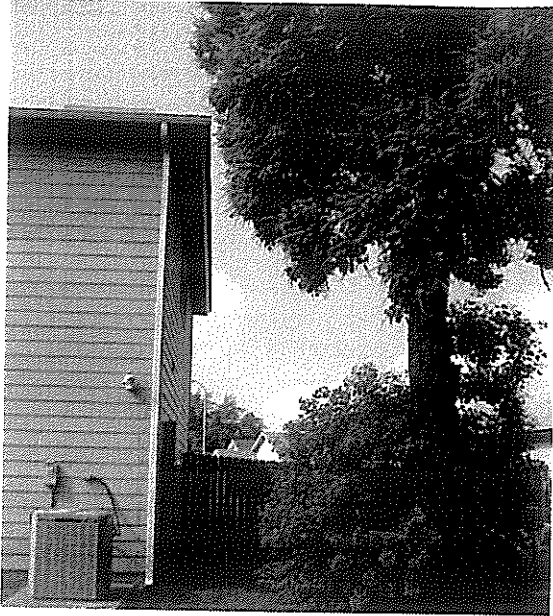
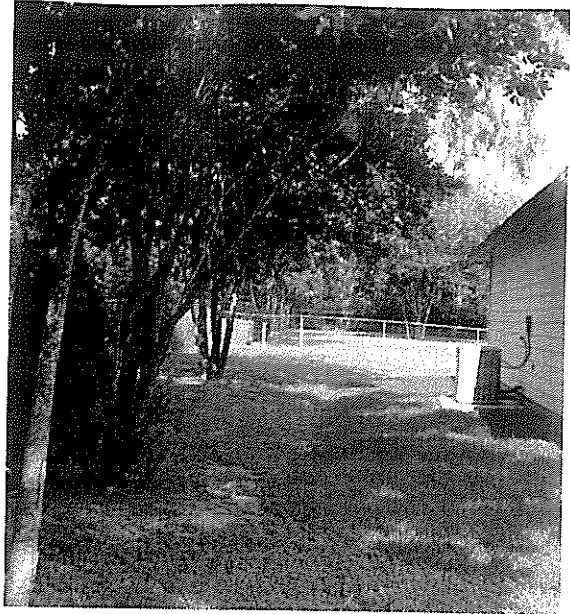
- There were large trees in close proximity to some of the houses (house #10, #12, #15, #17, #19, #20, #21, and #25) (See Photographs No. 22 and No. 23).

- Some of the foundations (houses #12, #17, #21, #25) were found to have relatively lower foundation elevations in the vicinity of a large tree or trees.
