## ADDENDUM # 2

**RFP for: Pecan Hill Tree Removal and Sanitary Sewer Retrofit**

**RE: Foundation Movement Study  
Pecan Hill Apartments  
1600 West Lawndale  
San Antonio, Texas**

**FOUNDATION MOVEMENT STUDY**

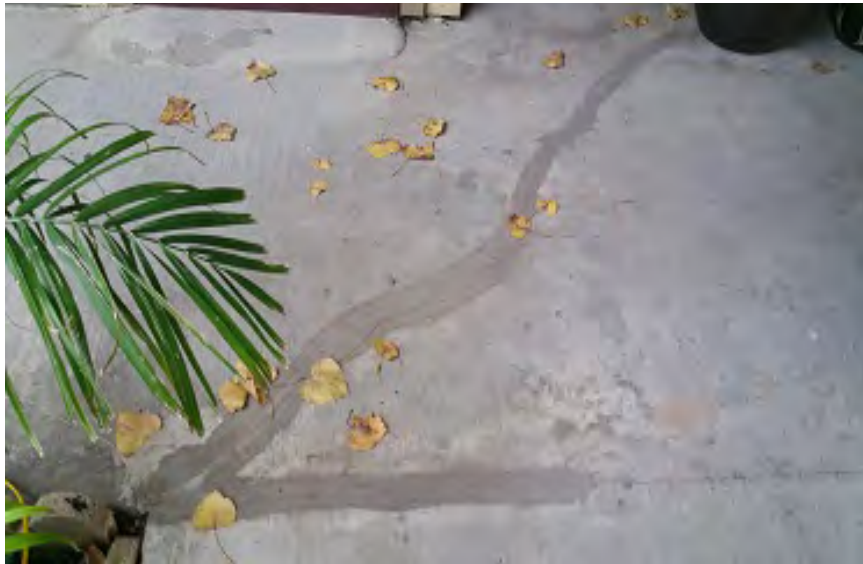
*Photo 1 – Walkway Cracks near Unit 113*

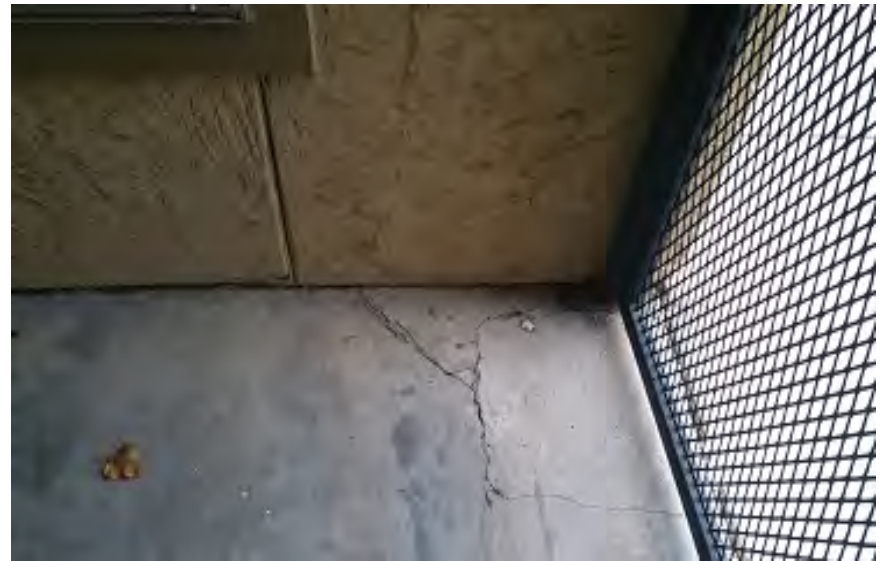
*Photo 2 – Walkway Cracks near SE Community Exit*

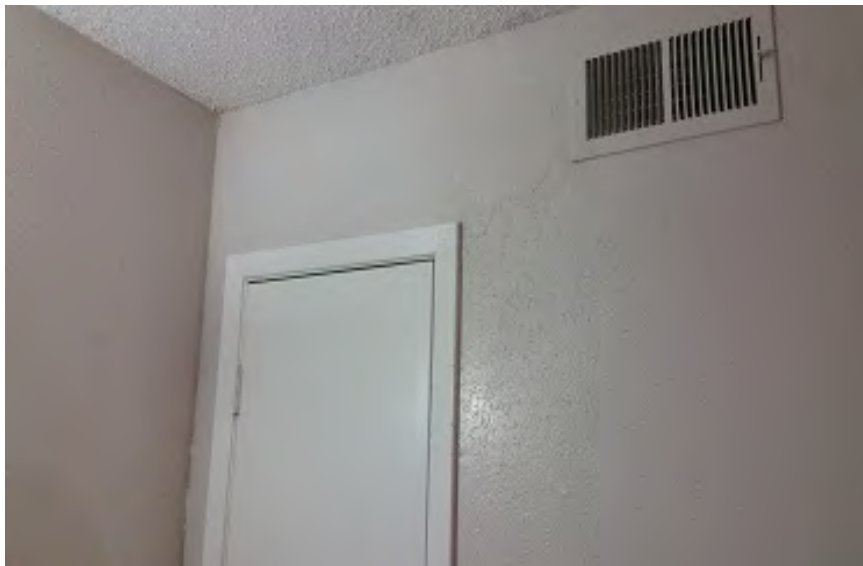
*Photo 3 – Unit 114: Wall Cracks near Closet*

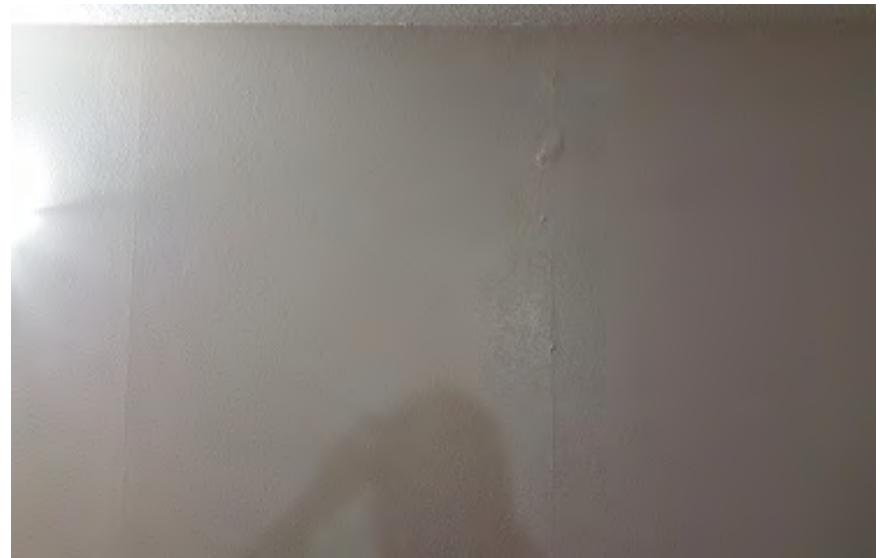
*Photo 4 – Unit 113: South Wall Crack in Living Room*

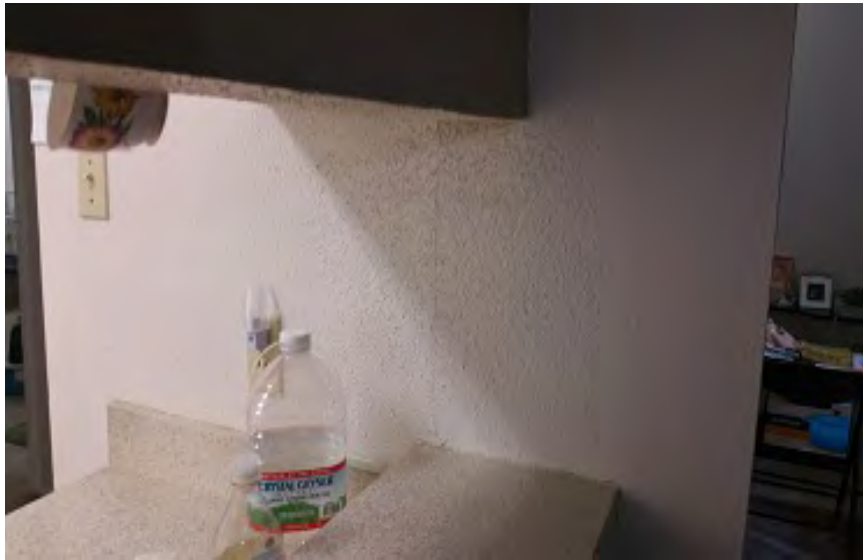
*Photo 5 – Unit 113: Cracks at Kitchen Counter*

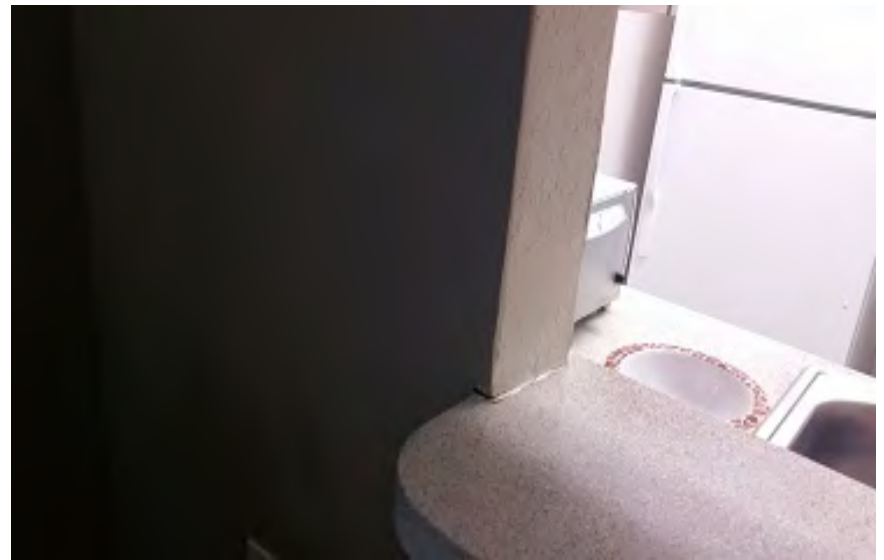
*Photo 6 – Unit 113: Cracks at Kitchen Counter*

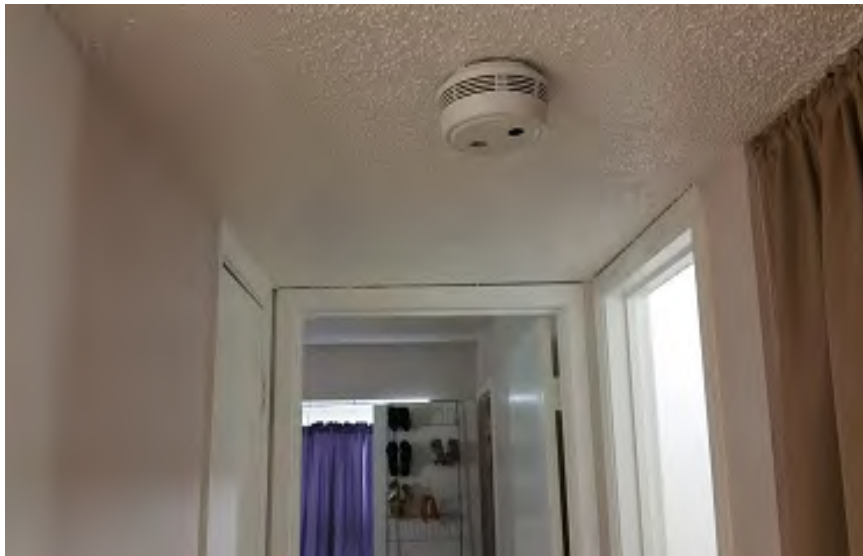
*Photo 7 – Unit 113: Cracks above doors in Hallway*

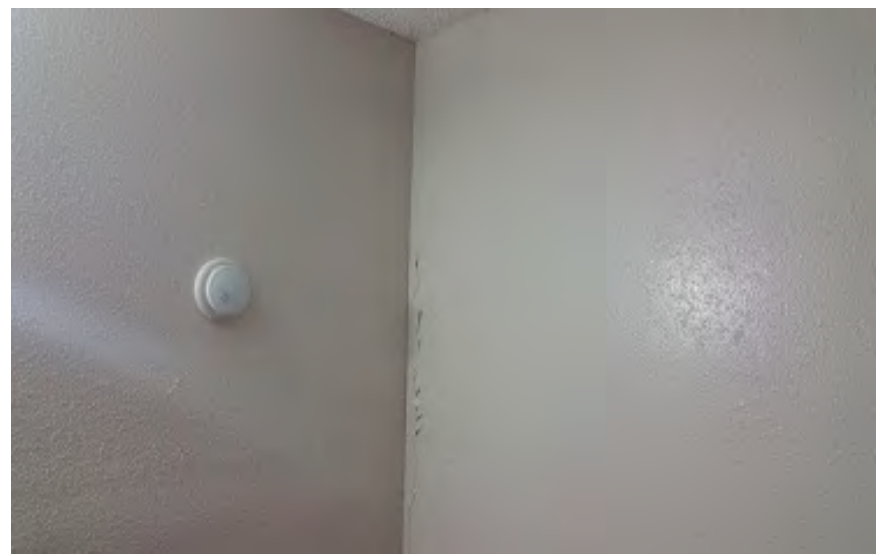
*Photo 8 – Unit 113: Crack in NE corner of Bedroom*

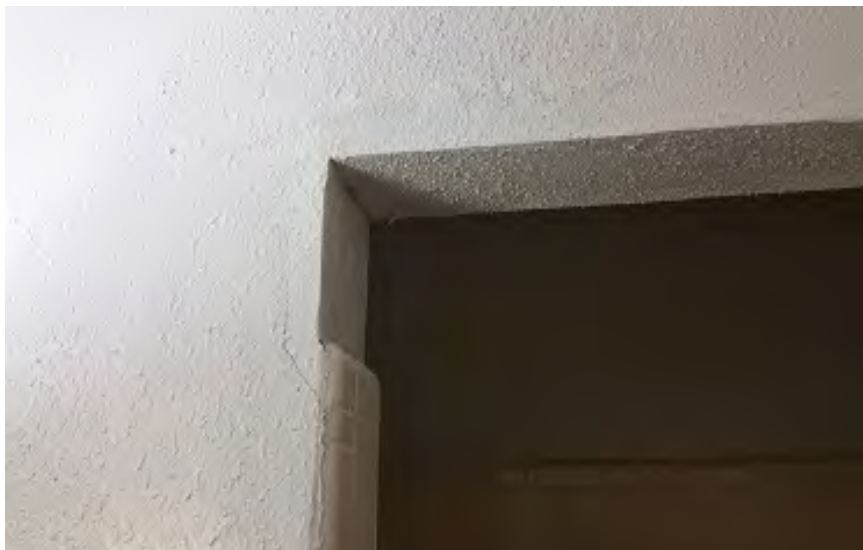
*Photo 9 – Unit 113: Cracks Shower Corner*

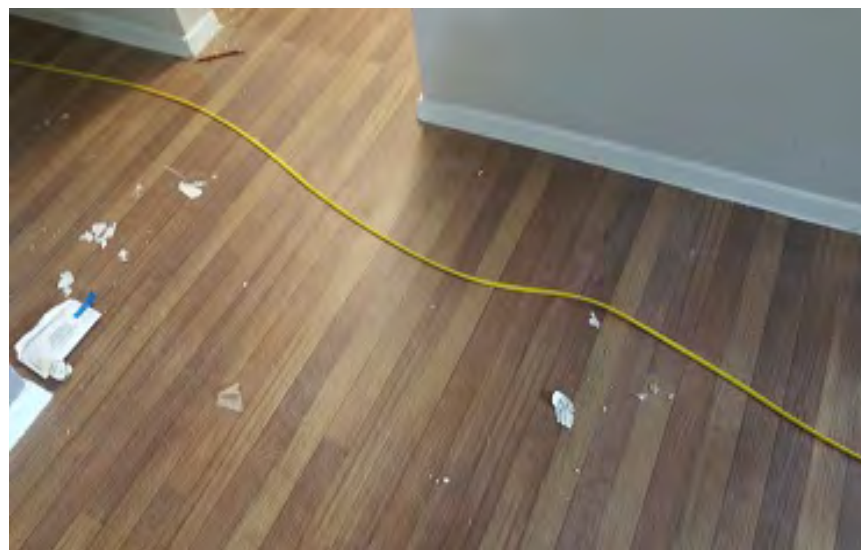
*Photo 10 – Unit 112: Heaving of Floor near Kitchen*

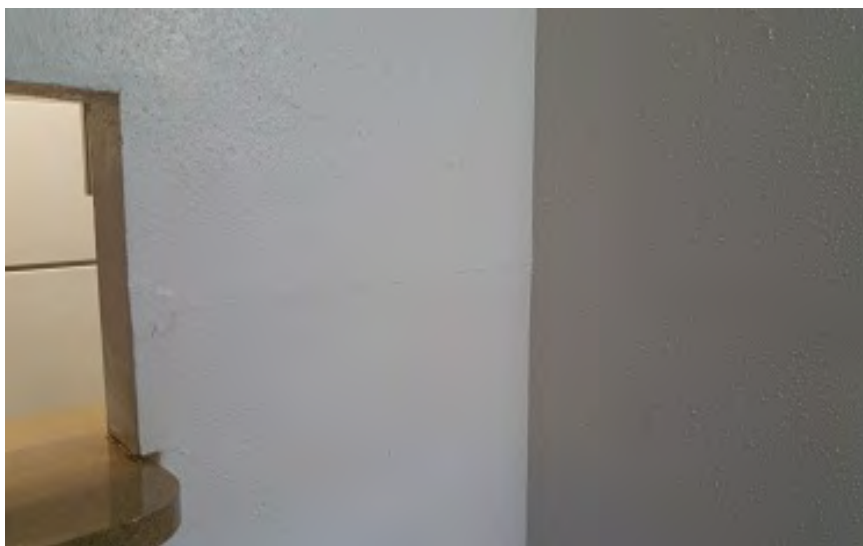
*Photo 11 – Unit 112: Crack in SE Corner of Living Room*

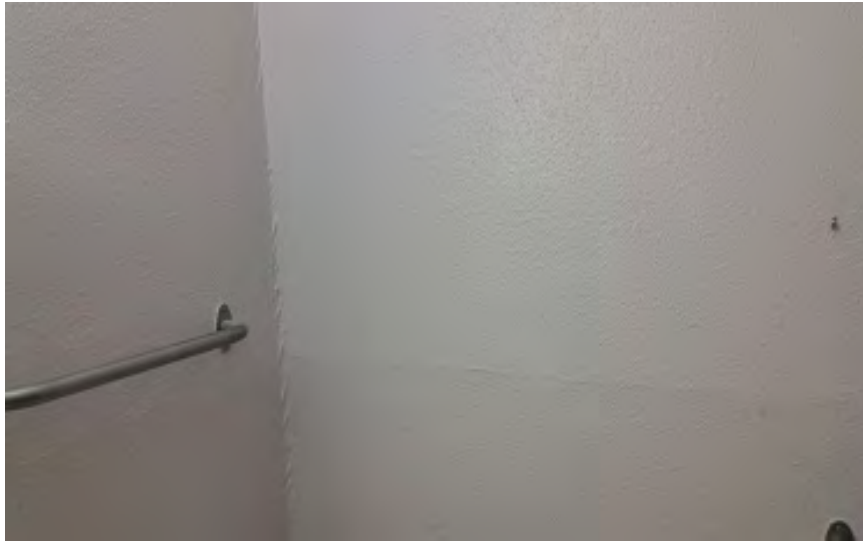
*Photo 13 – Unit 112: Cracks in Bathroom*

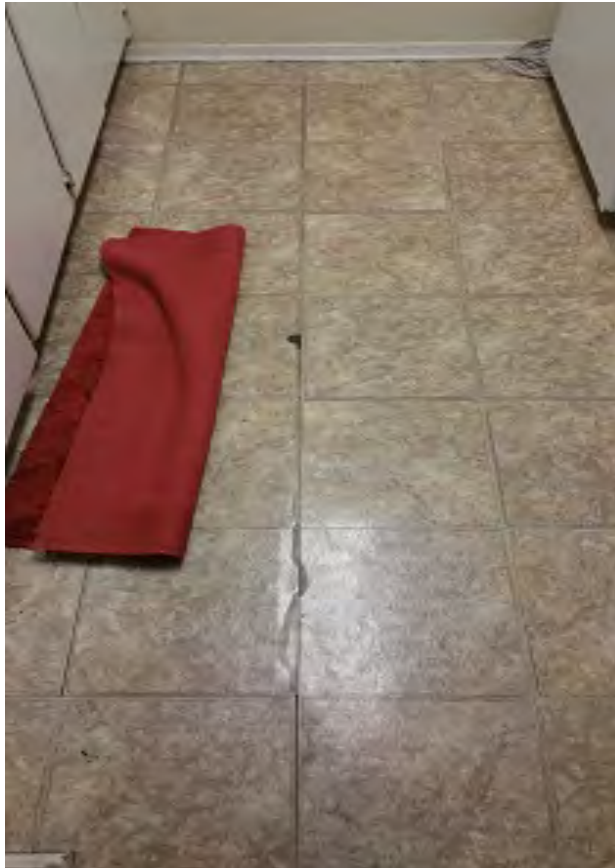
*Photo 16 – Unit 111: Heaving and Crack in Kitchen Floor*

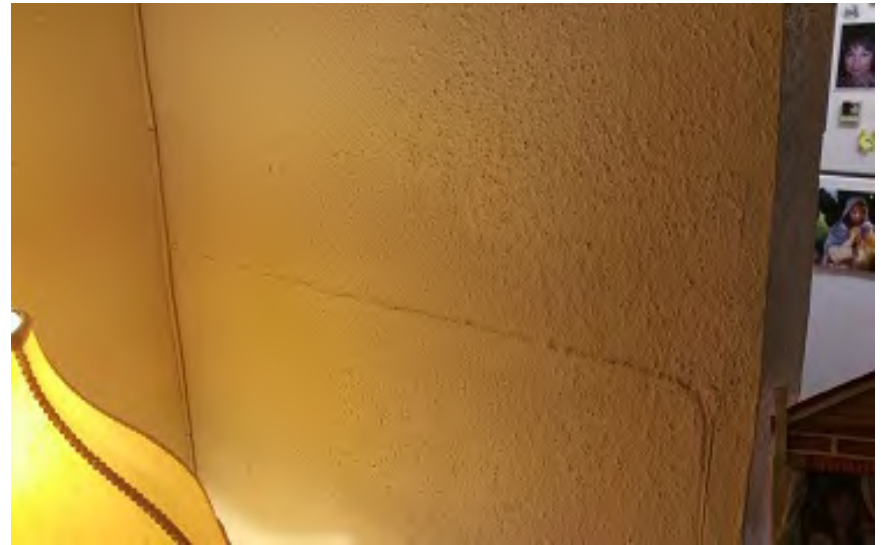
*Photo 17 – Unit 108: Wall Crack in Living Room*

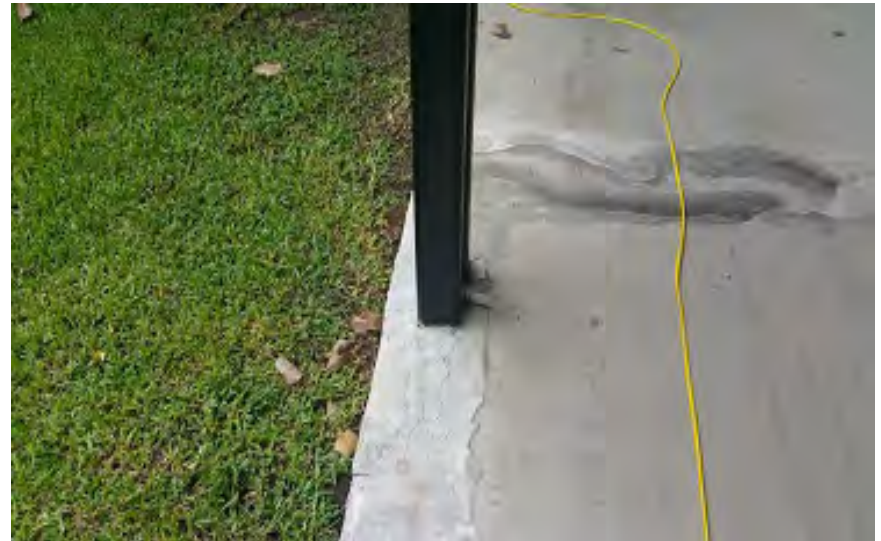
*Photo 18 –Walkway Crack near Unit 107*

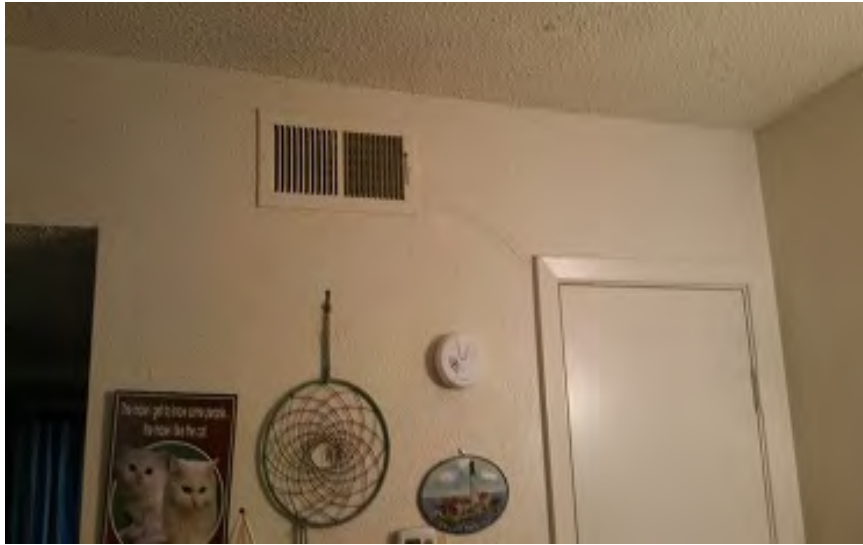
*Photo 19 – Unit 105: Crack in Living Room near Closet*

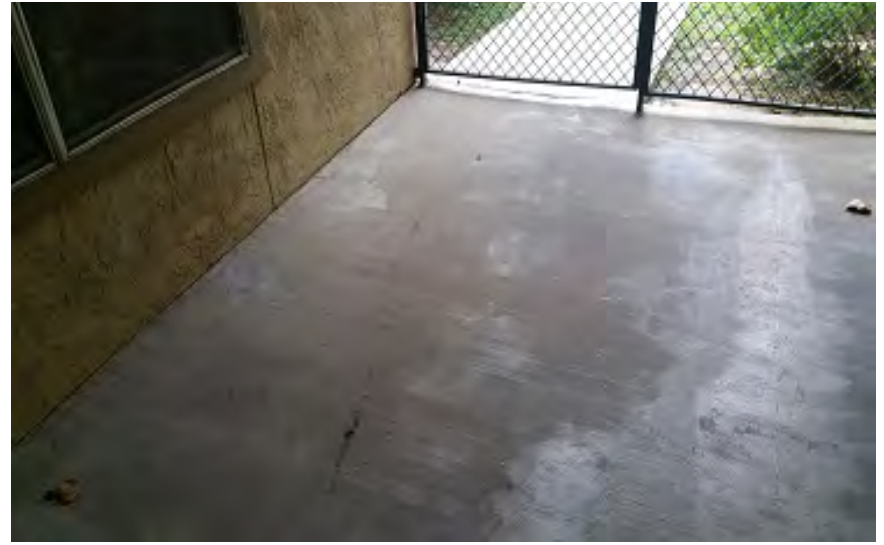
*Photo 20 – Walkway Crack near NE Community Exit*

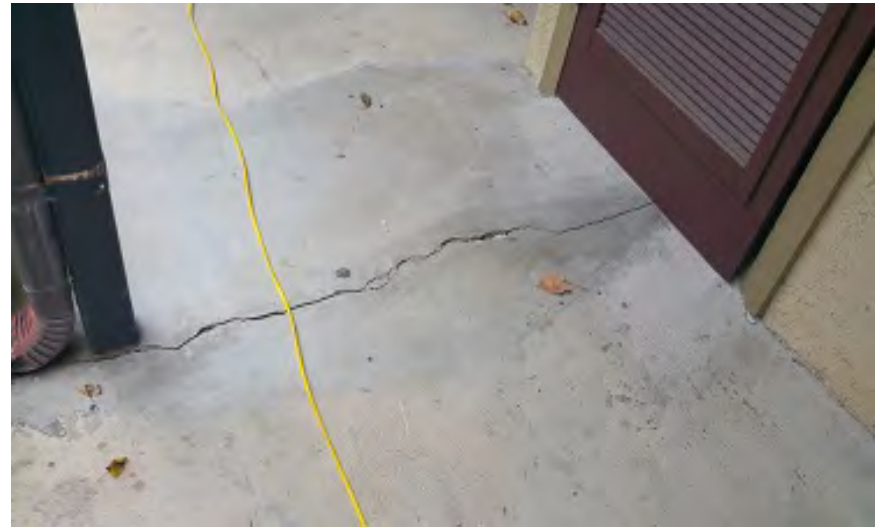
*Photo 22 – Walkway Crack near Unit 102*

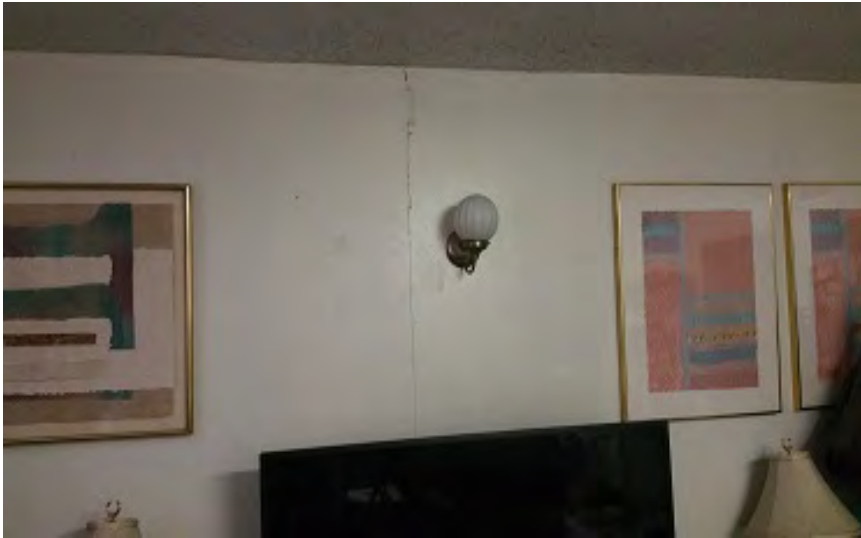
*Photo 23 – Unit 134: Crack in Living Room*

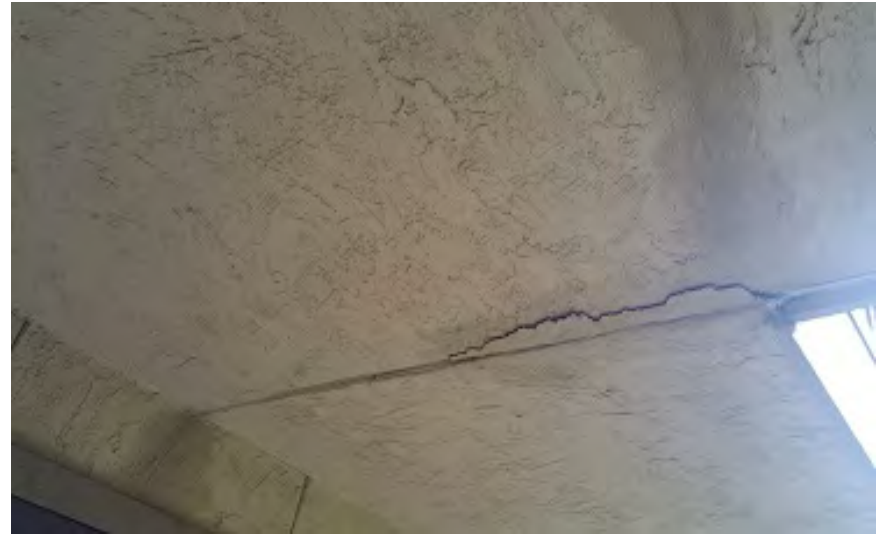
*Photo 24 – Walkway Ceiling Crack near Unit 132*

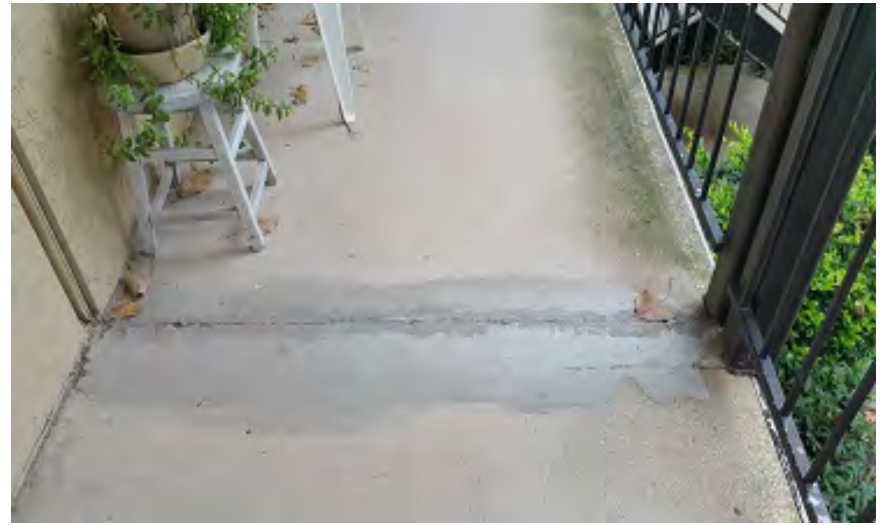
*Photo 31 – 2<sup>nd</sup> Floor: Walkway Crack*

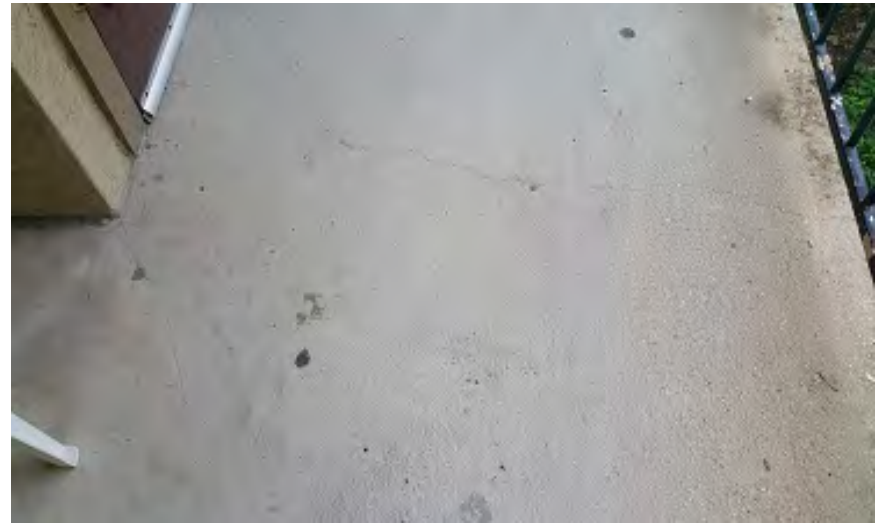
*Photo 33 – 2<sup>nd</sup> Floor: Walkway Crack*

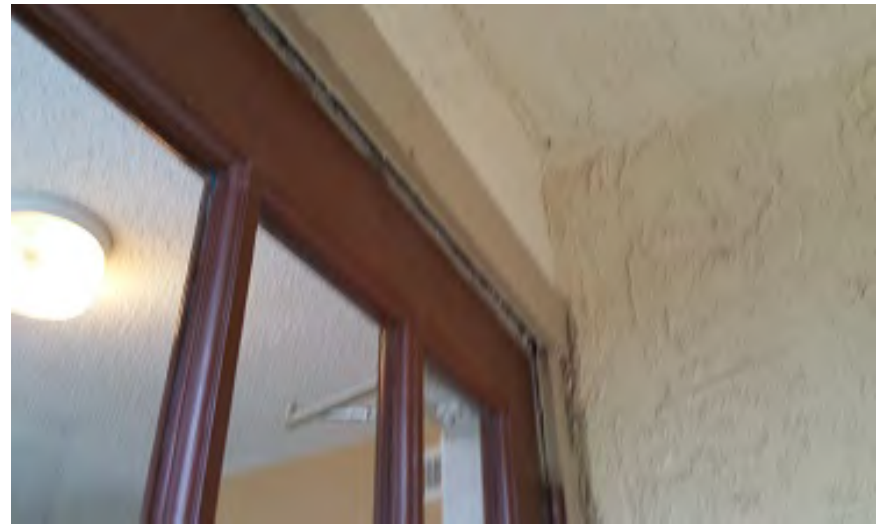
*Photo 35 – 2<sup>nd</sup> Floor: Cracking at Door Frame near Elevator Lobby*

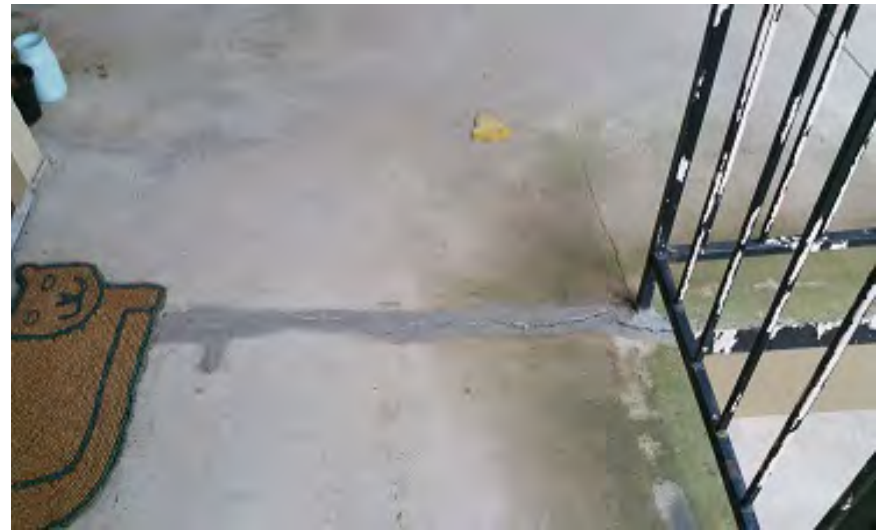
*Photo 39 – 3<sup>rd</sup> Floor: Walkway Crack*

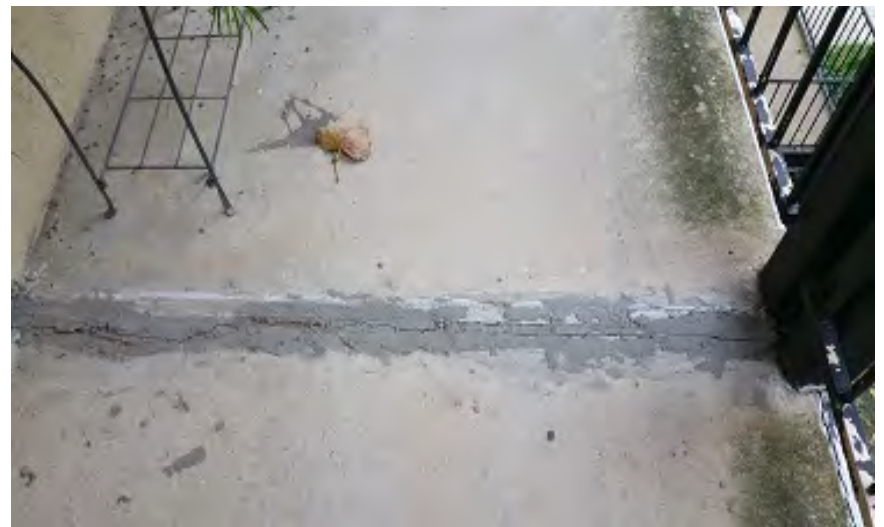
*Photo 41 – 3<sup>rd</sup> Floor: Walkway Crack*

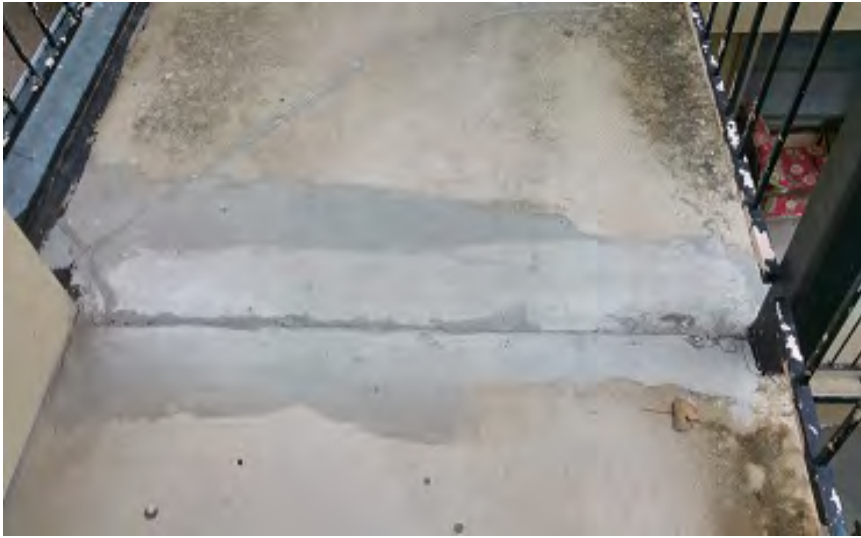
*Photo 42 – 3<sup>rd</sup> Floor: Walkway Crack*

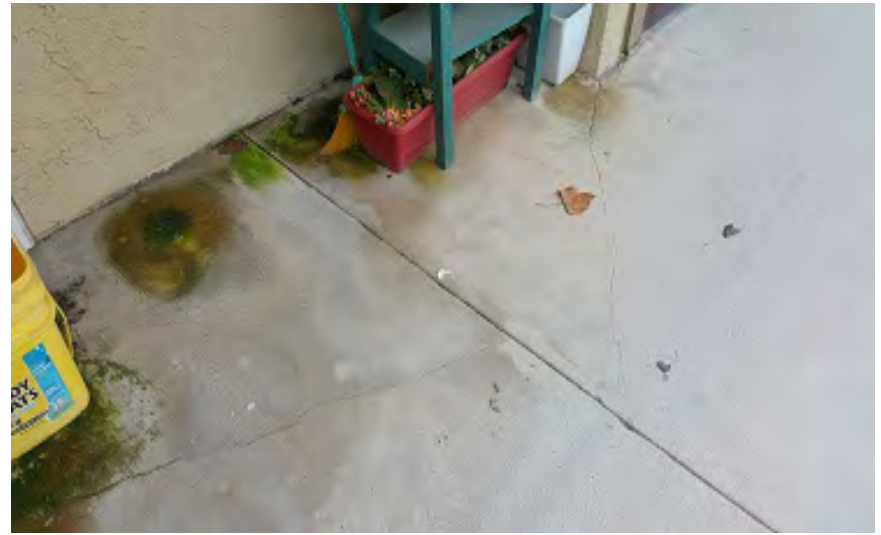
*Photo 43 – 3<sup>rd</sup> Floor: Walkway Crack*

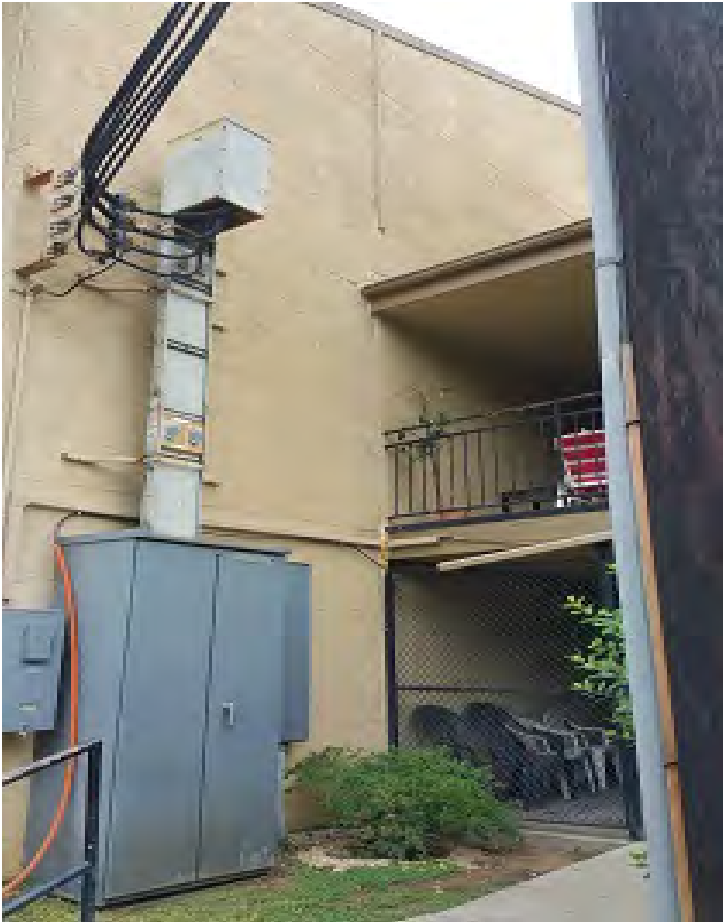
*Photo 60 – East Building: North Facade*

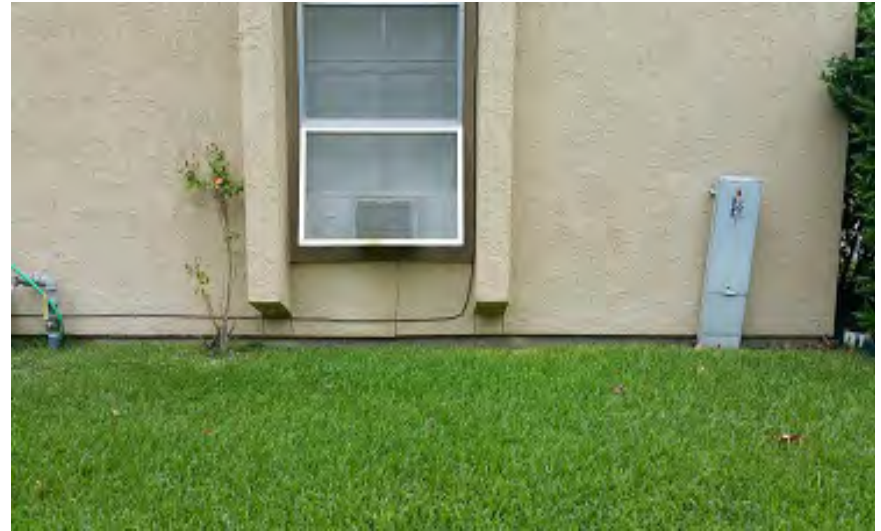
*Photo 61 – North Building: East Façade with Crack below Window*

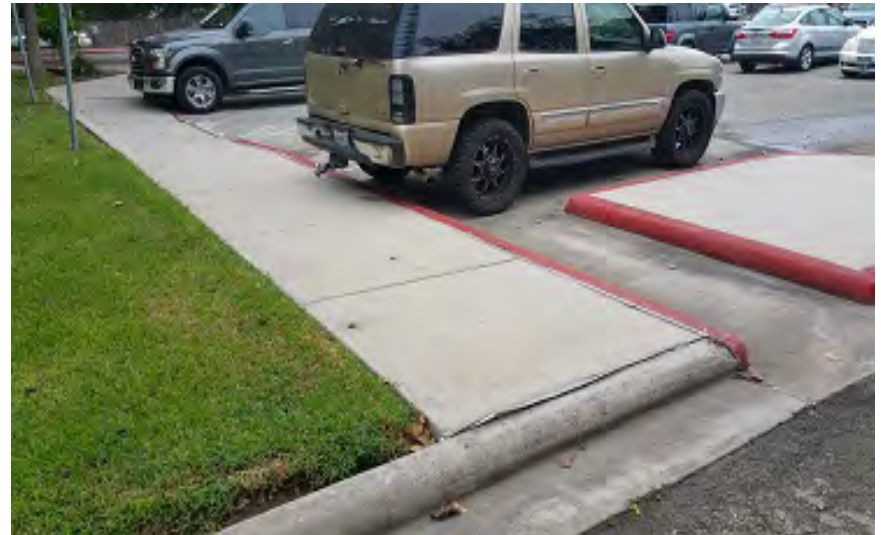
*Photo 62 –North Parking Lot: Deteriorated Concrete Joints*

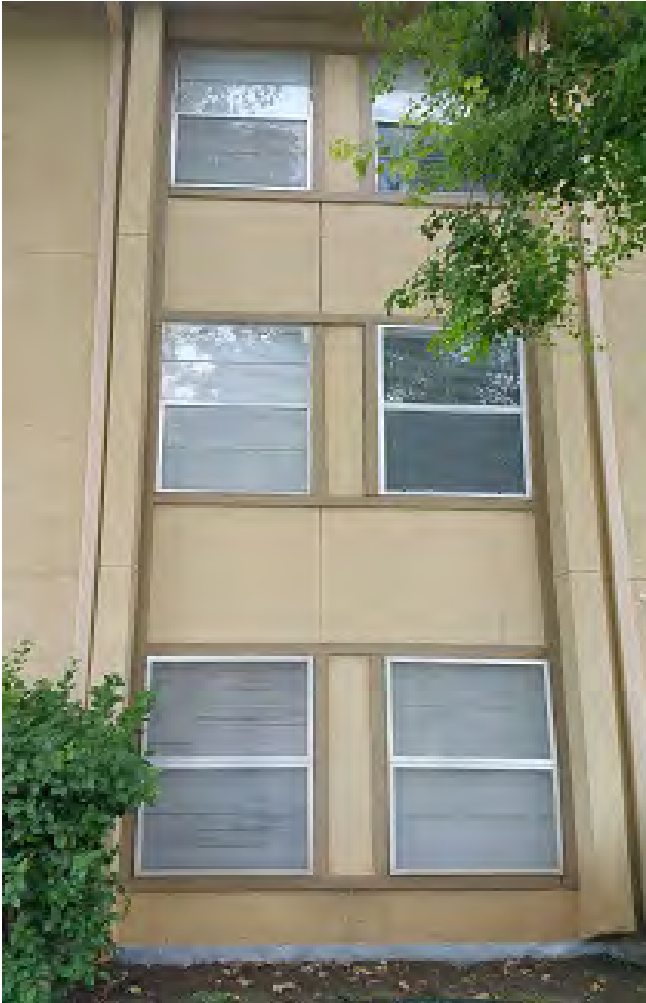
*Photo 65 – North Building: North Façade Window Area with Vertical Crack and Sheetmetal Dam at Base*

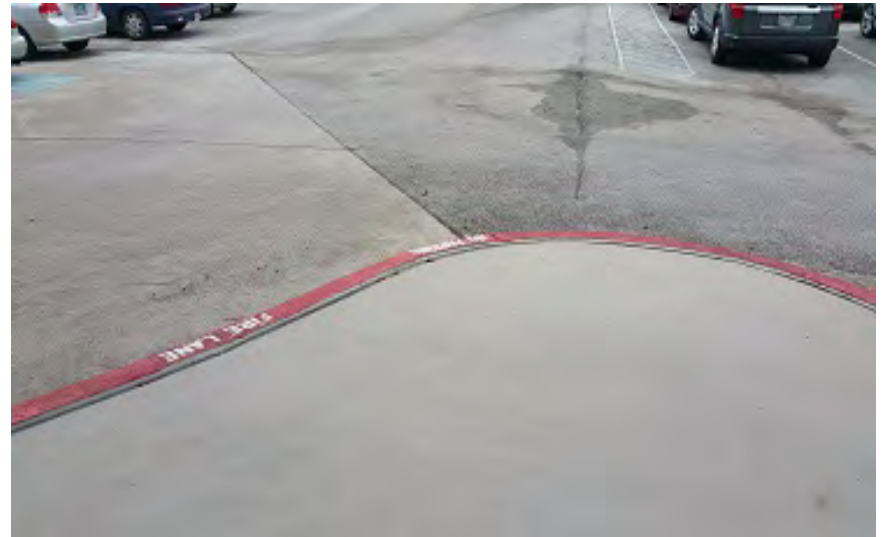
*Photo 63 – North Parking Lot: Deteriorated Concrete Joints*

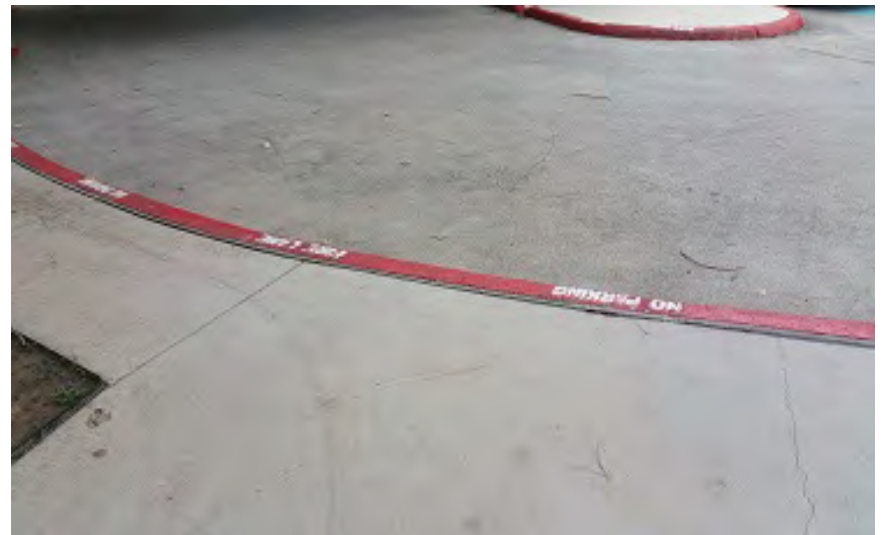
*Photo 64 –North Parking Lot: Deteriorated Concrete Joints*

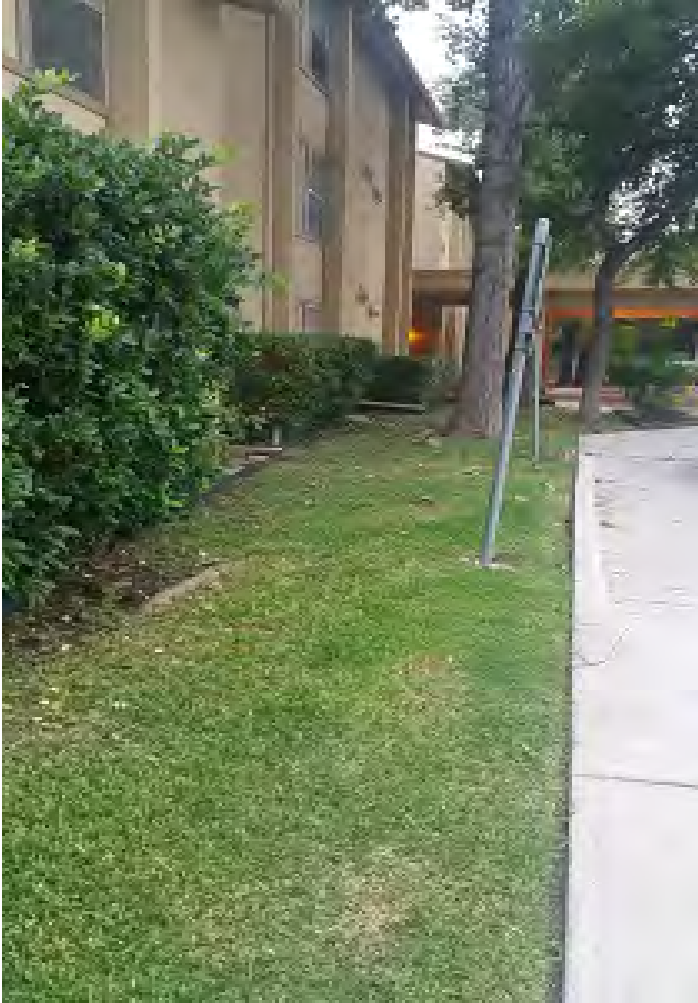
- Improper drainage along the north and west buildings.
- Downspouts empty into the planter beds or in close proximity to the building foundations.
- Downspouts serving the West Building roof slope upwards instead of a positive downward slope.
- Large trees in close proximity to the building foundations especially in the courtyard areas around the Community Building and on the North side of the North Building. In some cases, root systems are visibly protruding and appear to extend under the buildings.

*Photo 66 – North Building: Improper Drainage back towards Building (Looking West)*

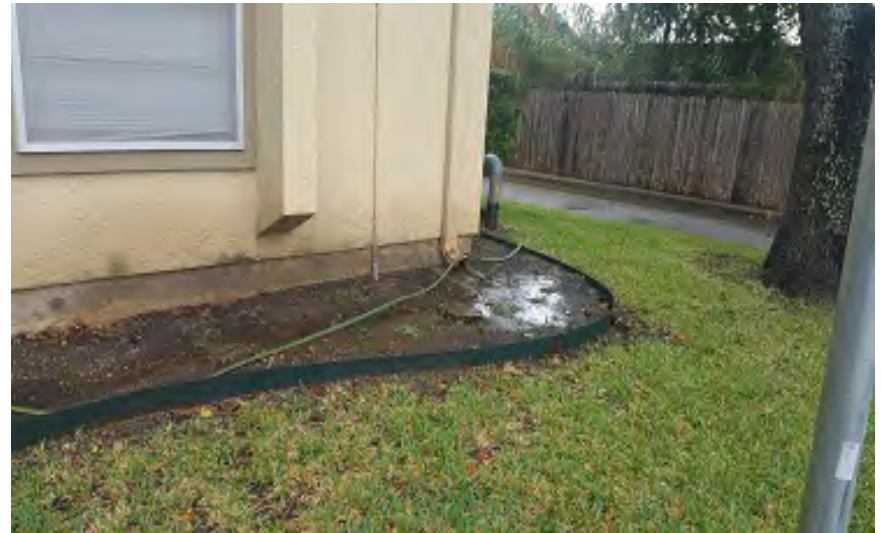
*Photo 67 – North Building: Improper Drainage at NW Corner*

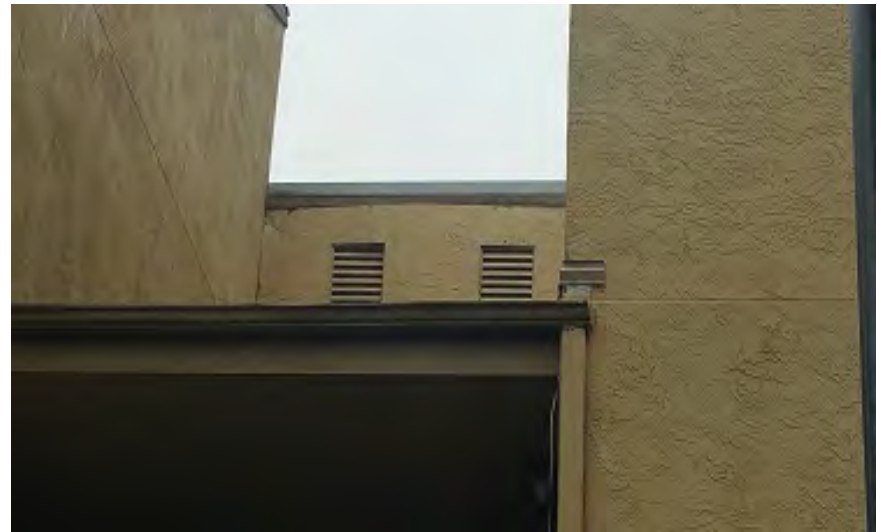
*Photo 70 – 3<sup>rd</sup> Floor Deteriorated Walkway Canopy Façade between North and East Buildings*

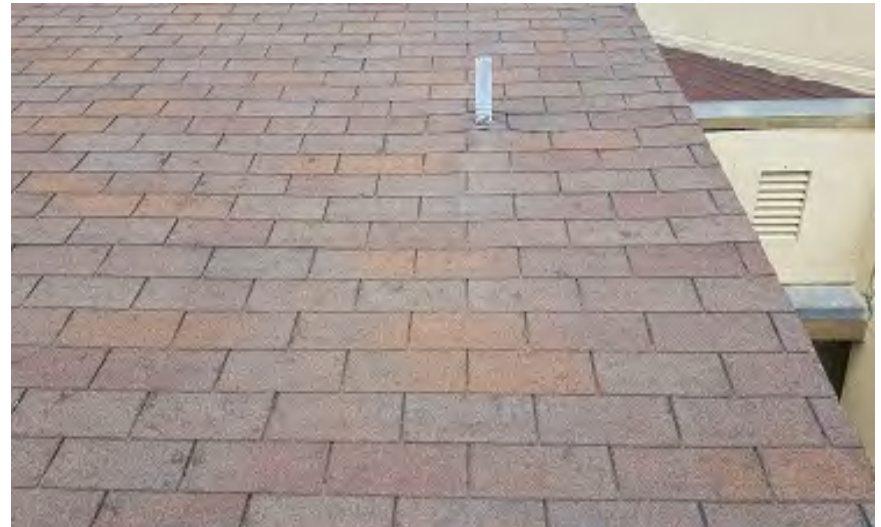
*Photo 72 – West Building Roof showing Hail Damage (Looking West)*

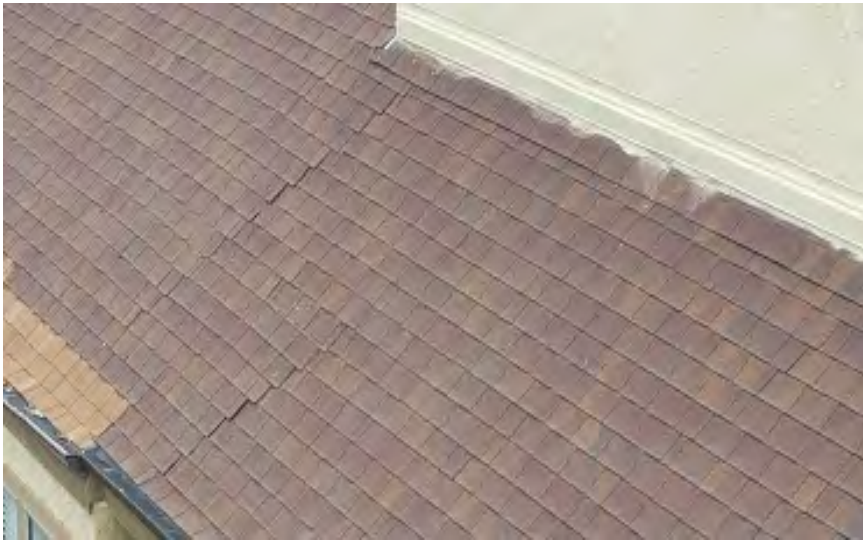
*Photo 73 – North Building: Walkway Canopy Roof showing Improper Patching (Looking West)*

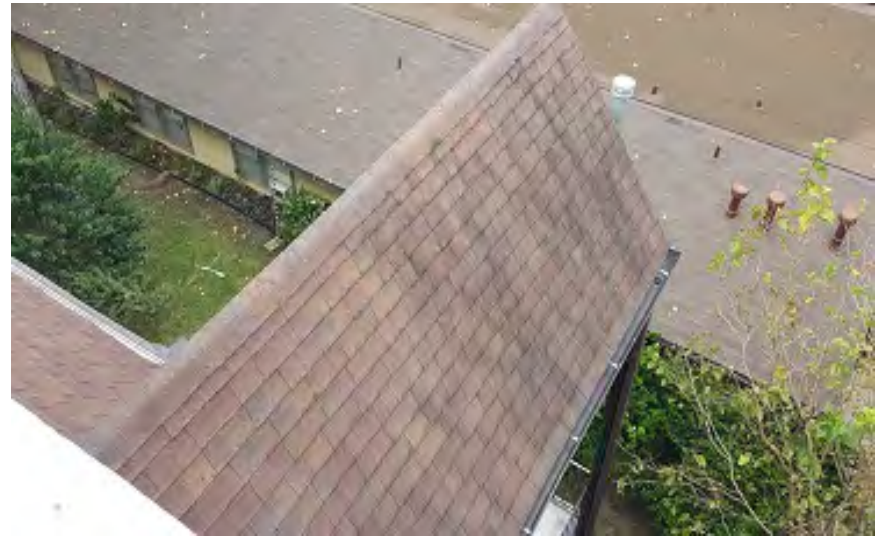
*Photo 74 – East Building: North Stairway Roof showing Hail Damage*

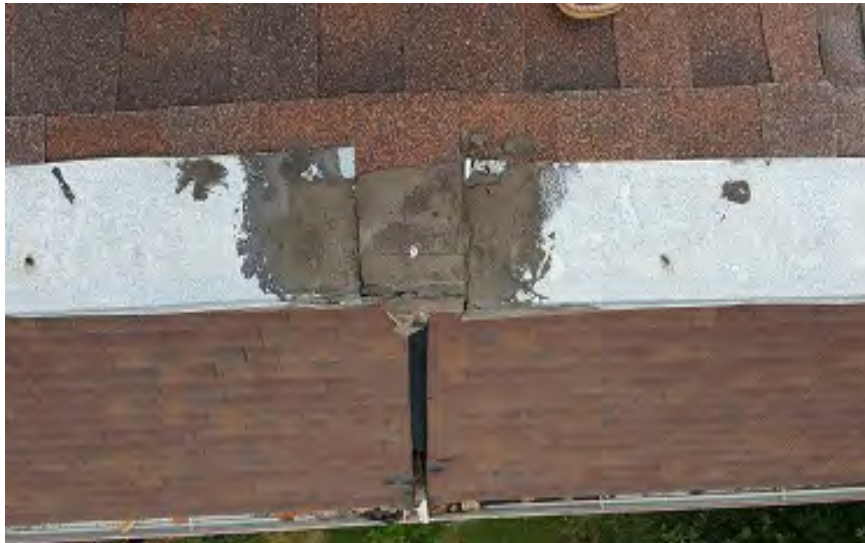
*Photo 77 – East Building: Northern Deteriorated Expansion Joint at Walkway Canopy Roof*

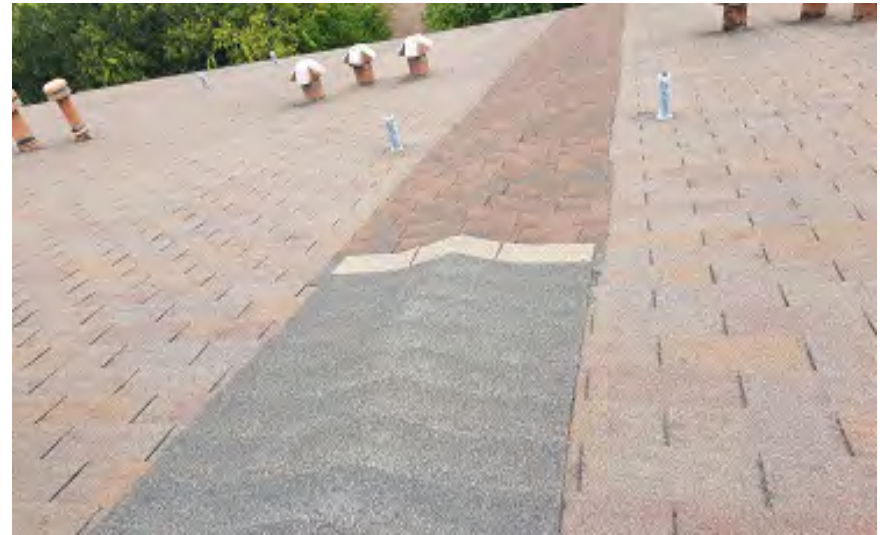
*Photo 78 – East Building Southern Roof Expansion Joint Improperly Covered with a Shingle Patch*

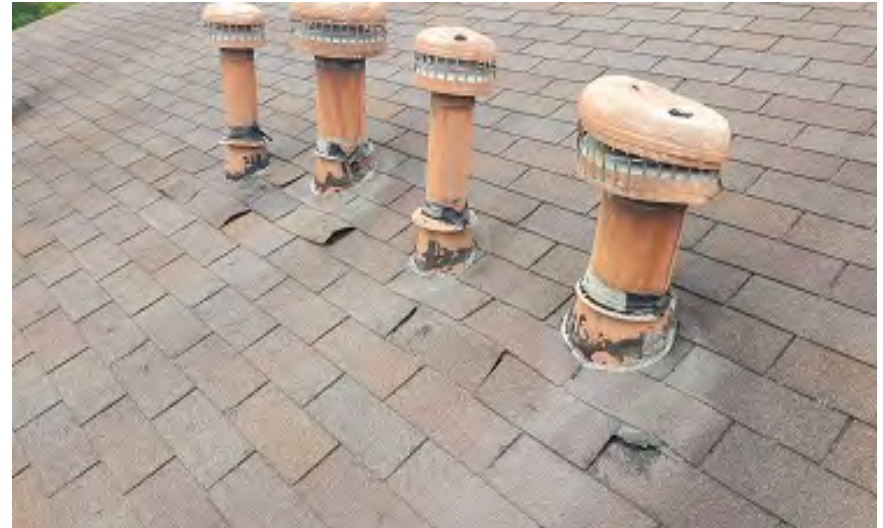
*Photo 80 – East Building: Deteriorated Flashing and Roofing at Vent Penetrations*

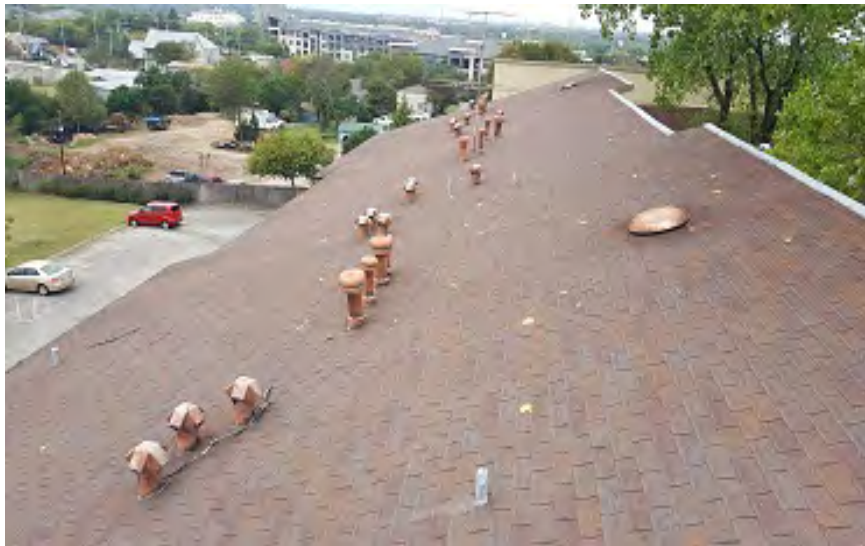
*Photo 81 – South Building Roof showing Deteriorated Vents, Penetrations, and Flashings (Looking West)*

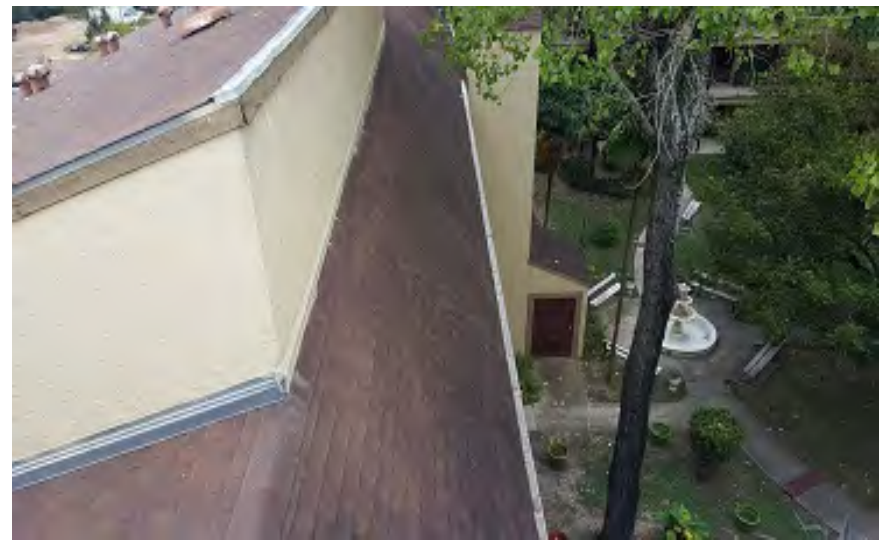
*Photo 82 – South Building Walkway Canopy Roof showing Hail Damage and deteriorated Ridge Construction (Looking West)*

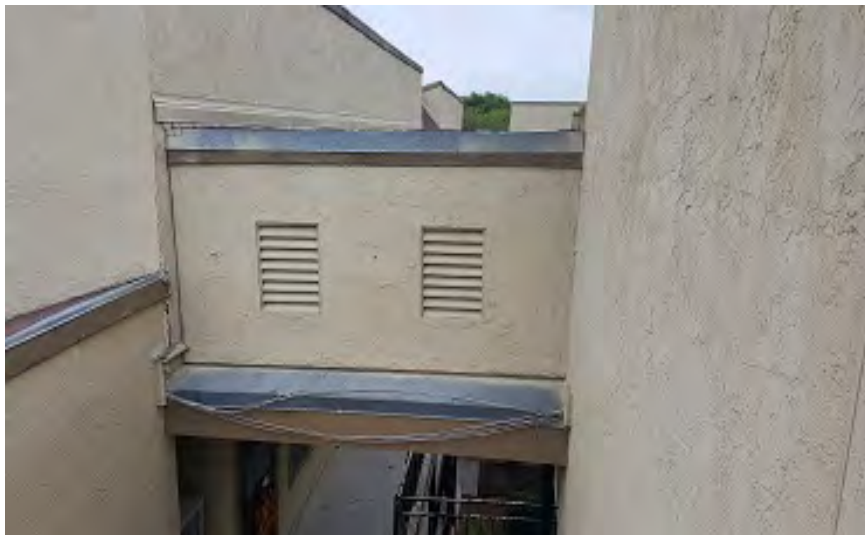
*Photo 83 – Walkway Canopy Connector between North and West Buildings showing Deteriorated Conditions*
