## ADDENDUM # 2

**RFP for: Pecan Hill Tree Removal and Sanitary Sewer Retrofit**

**RE: Foundation Movement Study  
Pecan Hill Apartments  
1600 West Lawndale  
San Antonio, Texas**

**FOUNDATION MOVEMENT STUDY**

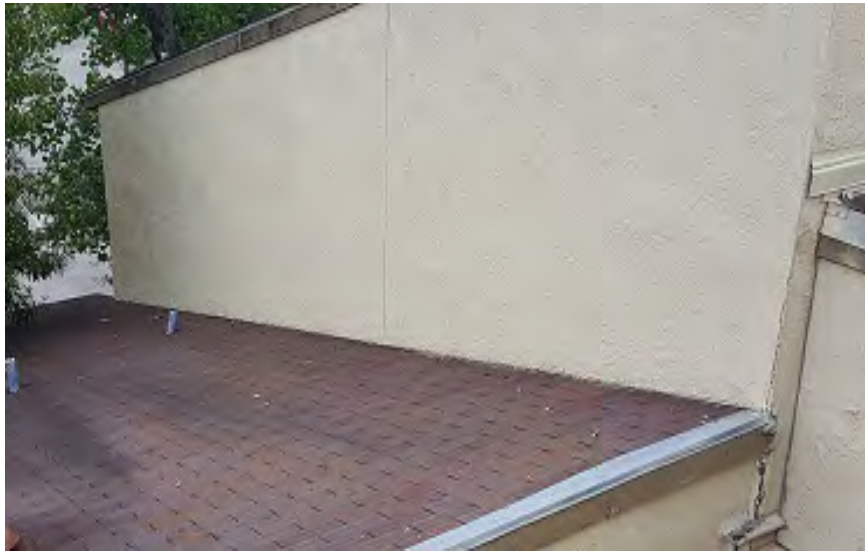
*Photo 85 – North Building Roof: West End showing Facade Cracks*

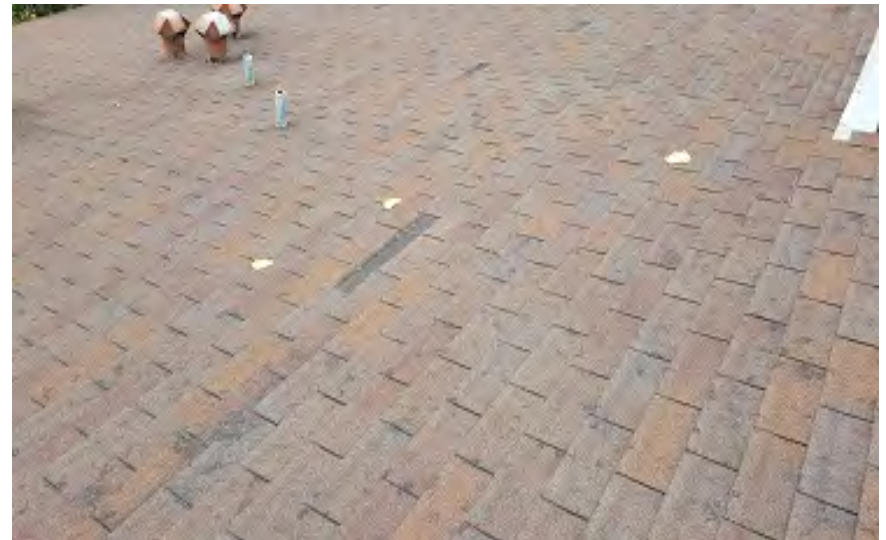
*Photo 86 – West Building Roof showing Hail Damage (Looking North)*

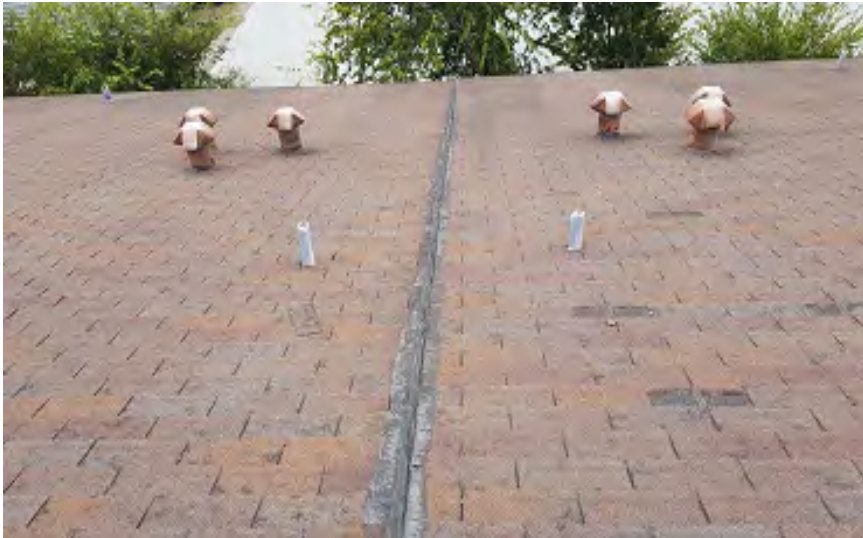
*Photo 89 – West Building showing Deteriorated Northern Roof Expansion Joint*

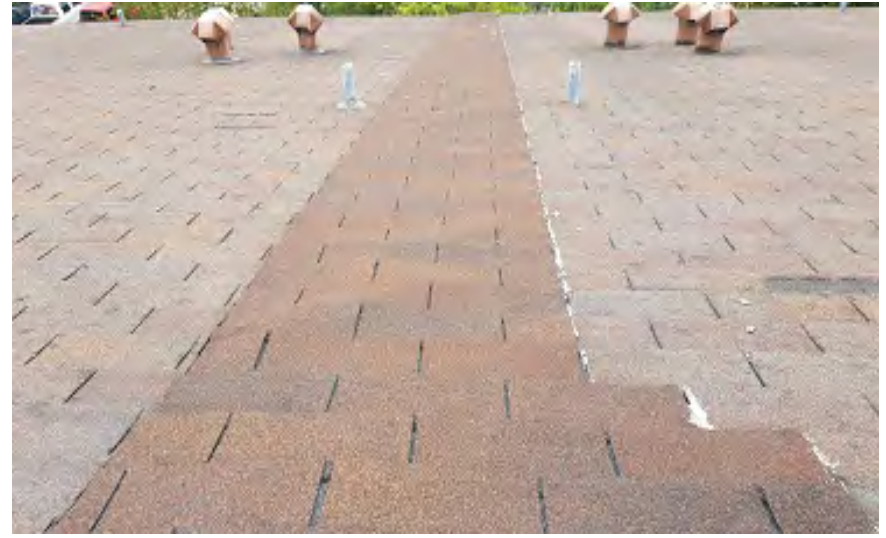
*Photo 90 – West Building Southern Roof Expansion Joint Improperly Covered with a Shingle Patch*

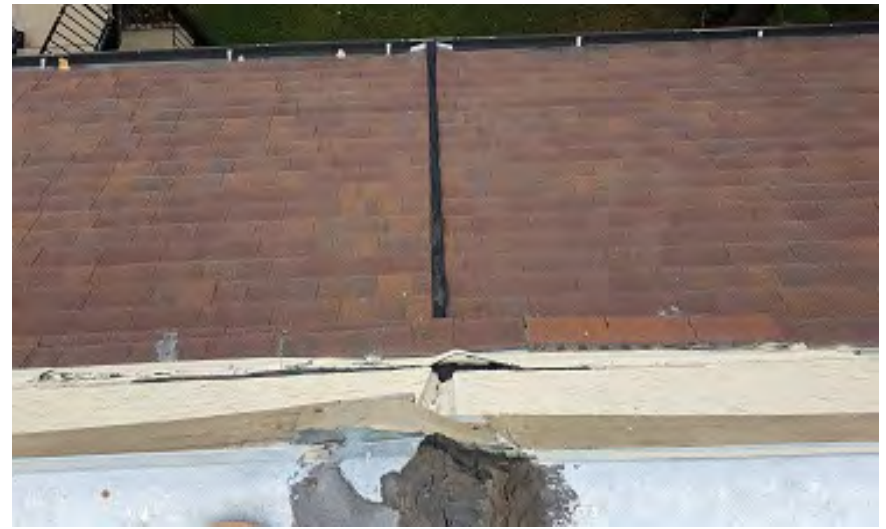
*Photo 92 – West Building: Southern Deteriorated Expansion Joint at Walkway Canopy Roof*

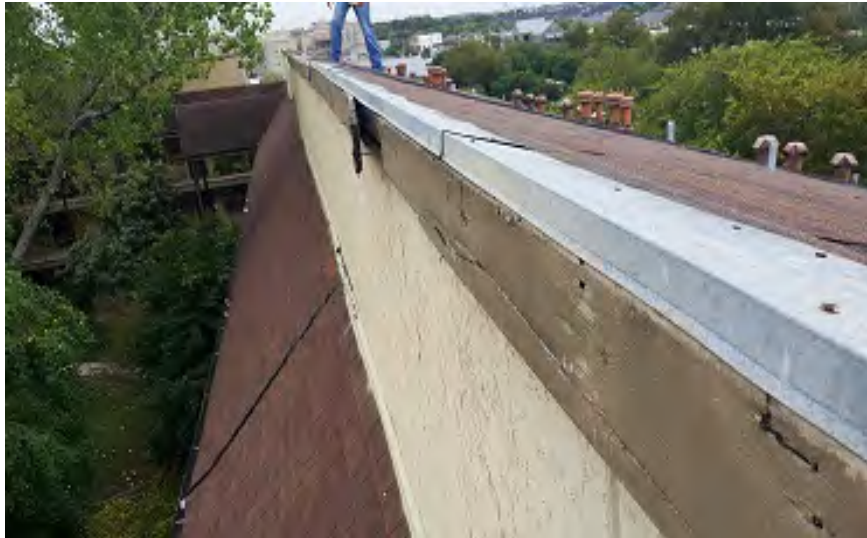
*Photo 93 – West Building: Deteriorated Ridge Flashing and Canopy Roof (Looking South)*

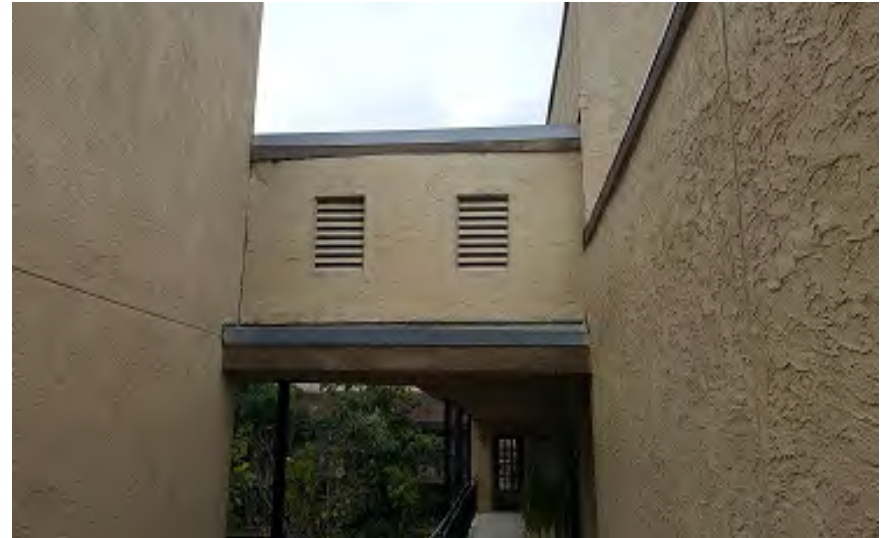
*Photo 94 – Walkway Canopy Connector between North and East Buildings showing Deteriorated Conditions*

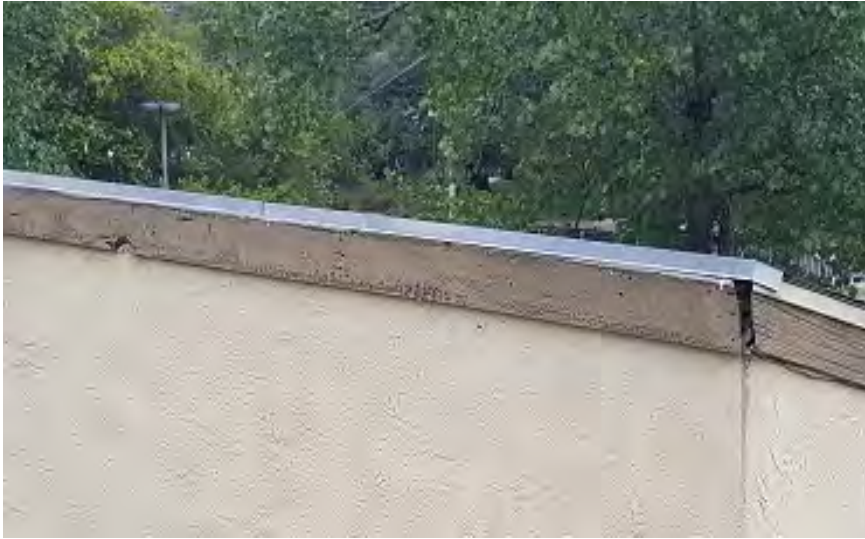
*Photo 97 – North Building: Deteriorated Ridge and Rake Flashing*

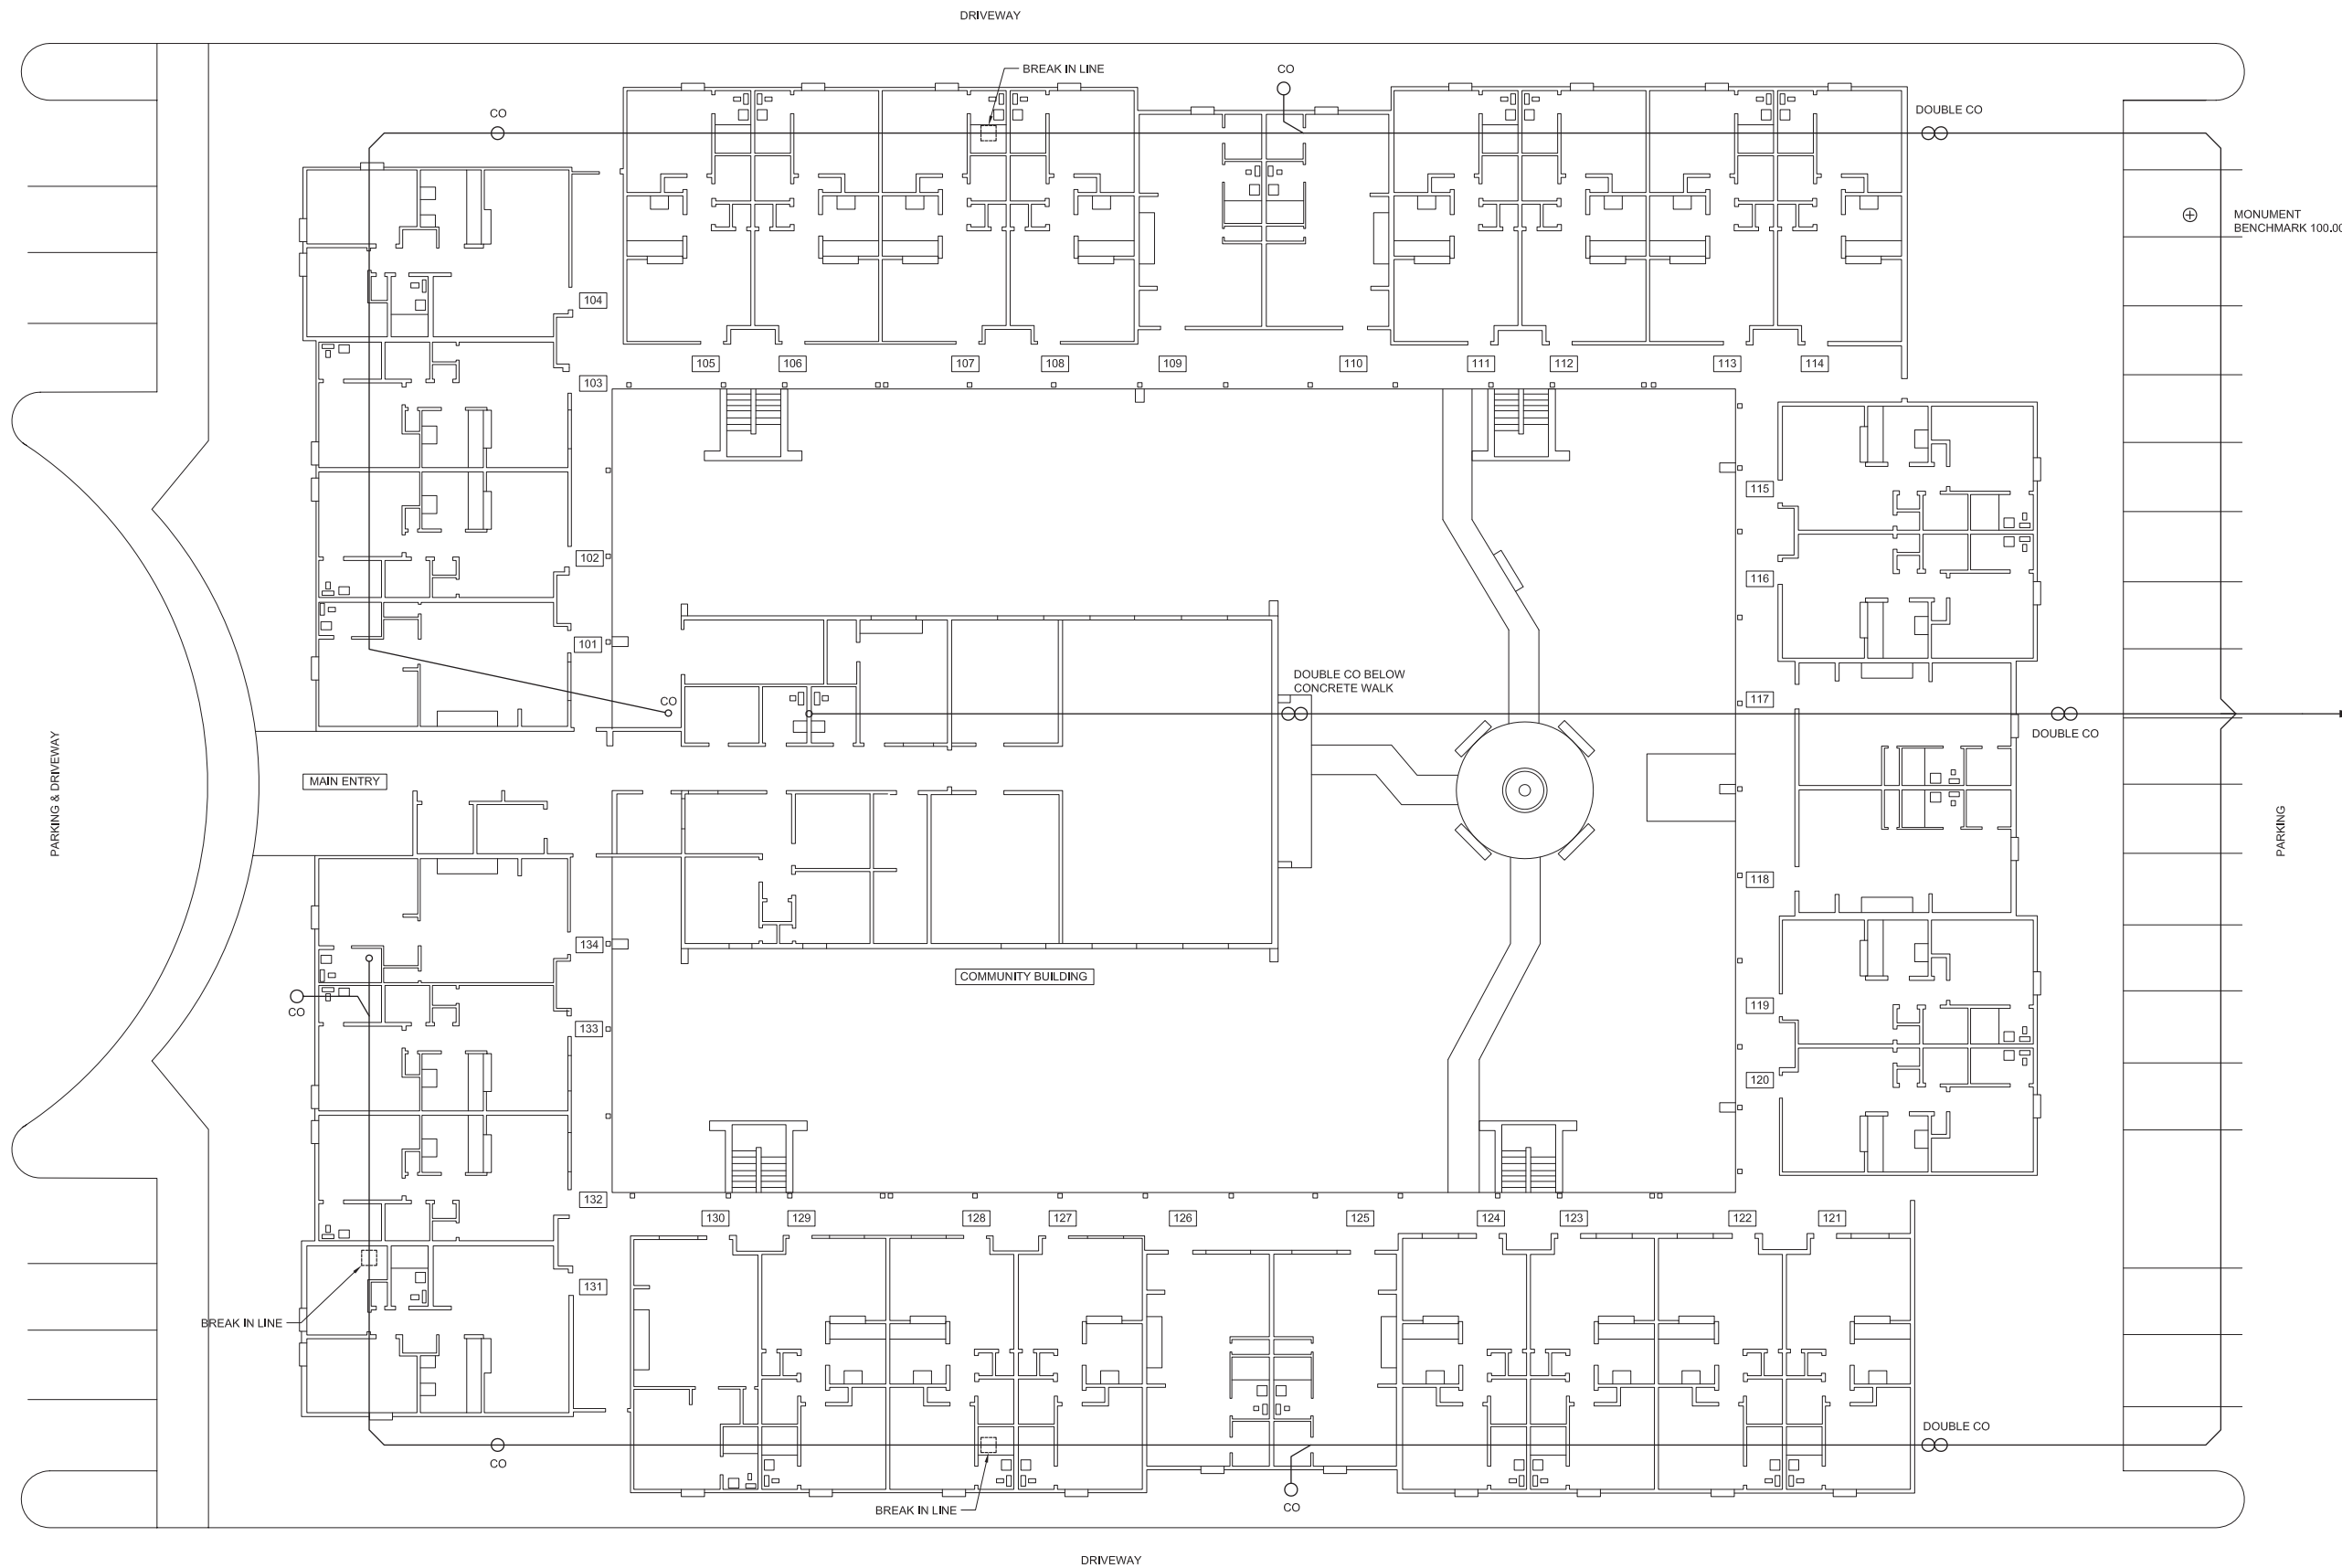
**1** FIRST LEVEL - UNDERGROUND  
SANITARY SEWER  
SCALE: 3/32" = 1'-0"

Since major breaks in the sanitary sewer mains were discovered, static testing of the sanitary sewer was not conducted. Branch lines smaller than 4" including those extending to kitchen areas were not inspected. Similarly, hydrostatic testing of the domestic water lines was not conducted since no water lines traverse below the building foundation except at the solitary entrance to the hot water boiler room in the Community Building. Refer to Appendix C for Bryco Plumbing's report.

NOTE: SANITARY SEWER DEPICTS AS-BUILT AND EXISTING CONDITIONS AS DETERMINED FROM CAMERA OBSERVATIONS CONDUCTED BY BRYCO PLUMBING CO. INC. ON DECEMBER 1, 2016.
