# Aladdin Environmental LLC

Re: 139 Villa Grande, San Antonio, TX

Aladdin Environmental is pleased to submit this limited environmental evaluation on the above residence located at 139 Villa Grande, San Antonio, TX. This limited evaluation was performed on August 12<sup>th</sup>, 2008. We have observed the standard of care generally exercised by the profession under similar circumstances and conditions to complete this report.

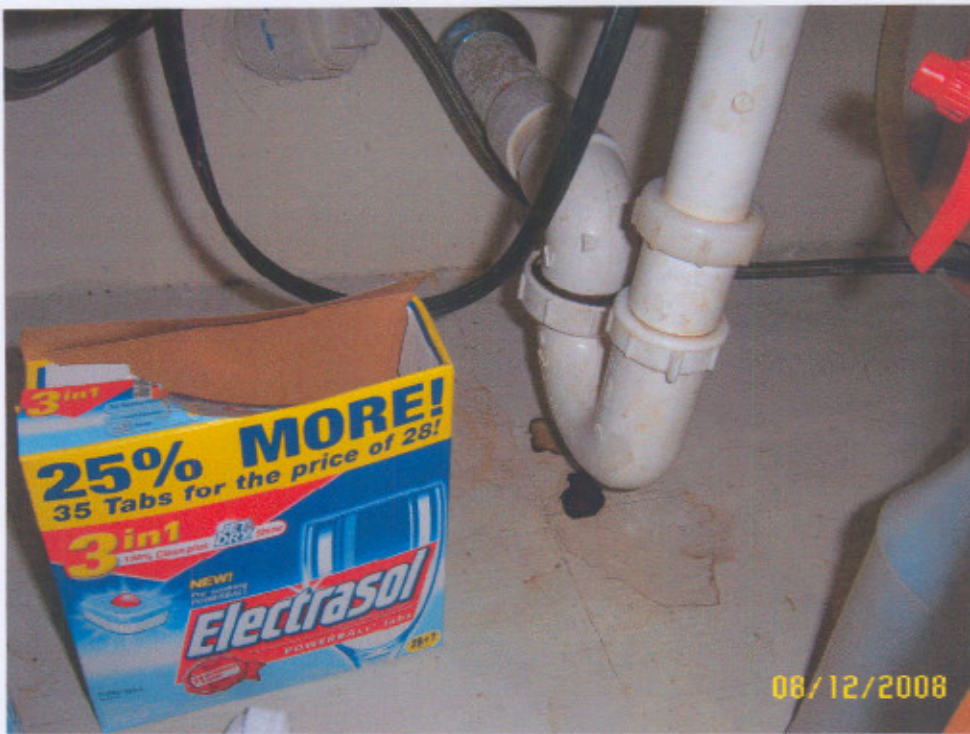
- Kitchen – The shelf below the sink showed indications of water spots. There was water presently on the drain connection. There was no visible microbial growth.

Kitchen - shelf below sink with water present on drain connection

- Recommend repairing the leak to prevent further damage.
  - Recommend cleaning the sink shelf.
- Living – It appears the HVAC unit is new with new ductwork throughout. The A/C return had some dust buildup.

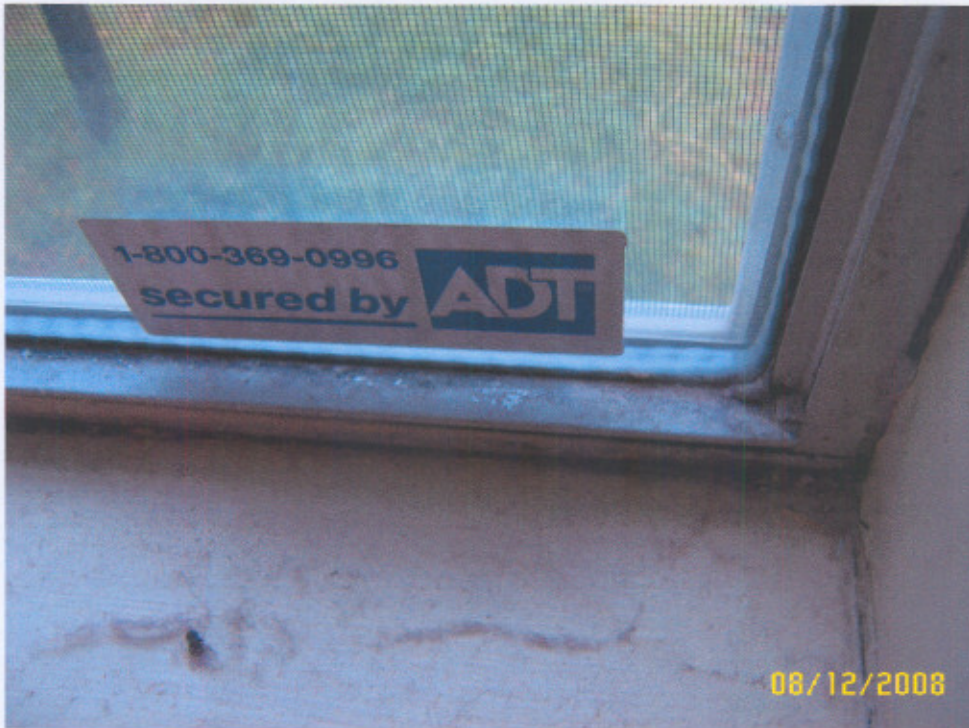
- Recommend the window & sill be part of a regular cleaning routine.
- Master Bedroom – The windows had a build-up of dirt/debris.
  - Recommend the window & sill be part of regular cleaning routine.

Master Bedroom window

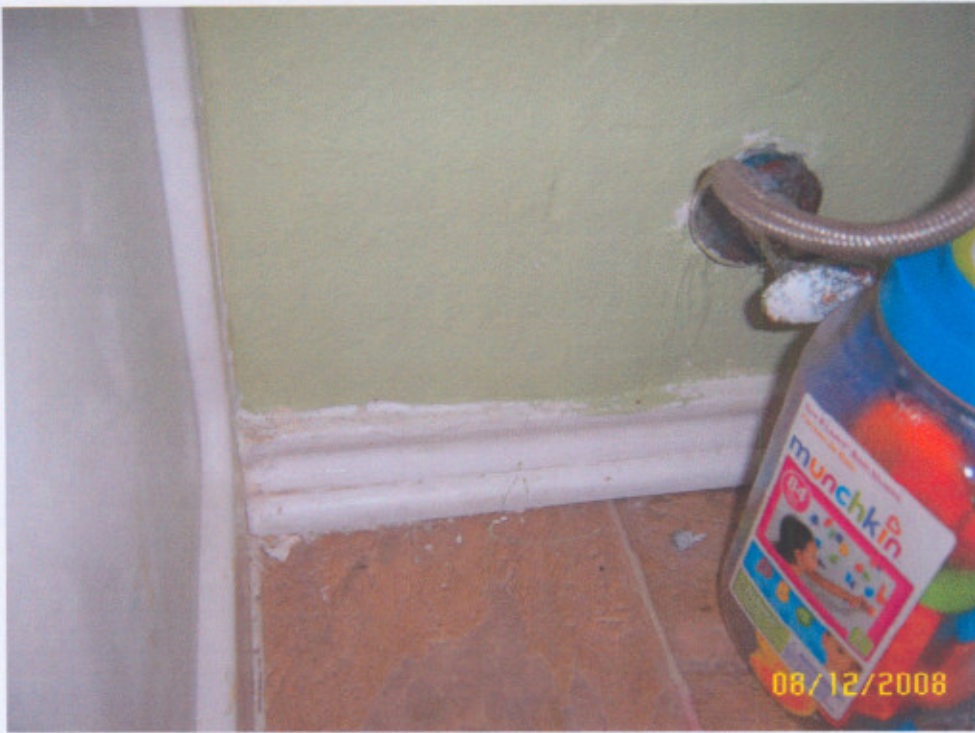
- Hall Bath – Sheetrock behind toilet appears to have had some repairs, but no apparent damage. Moisture readings were normal.
- Bedrooms – The 2 bedrooms appear to have had the windows recently replaced. The window sills had a normal amount dirt/debris.

Hall Bath - sheetrock behind toilet

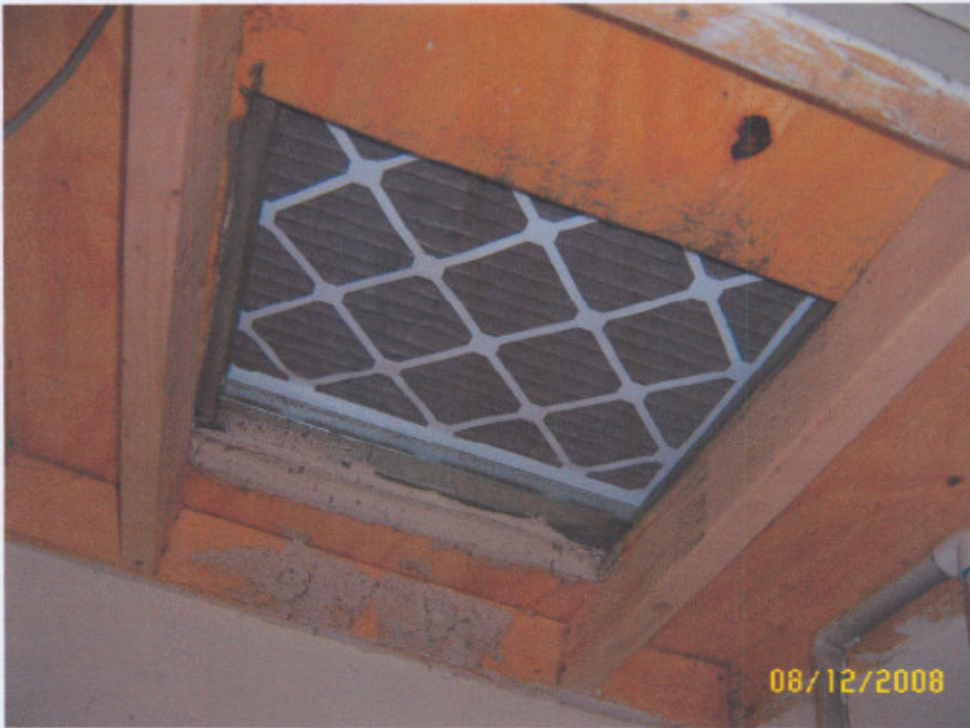
A/C return

- Recommend the A/C return be vacuumed when the A/C filter is changed as part of a regular cleaning routine.
  - Recommend the window & sill be part of regular cleaning routine.
