Environmental Services Inc.  
Environmental Scientists and Engineers

May 28, 2007

RE: Report of Limited Indoor Air Quality Investigation of 442 Matthews Avenue, San Antonio, Texas, 78237  
STC Project 27314R3

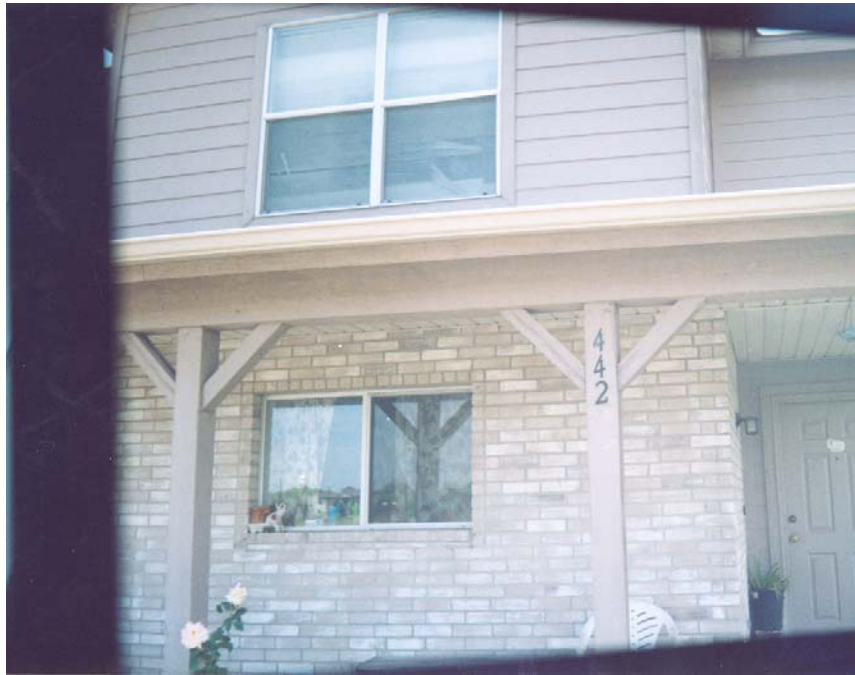
This residence is a two (2) story wooden frame structure constructed on a slab on grade foundation (See Photo 1). The indoor air quality investigation consisted of a visual inspection of the HVAC system and ducts and a visual inspection of the areas where water pipes are located. Samples were collected based on the visual inspection. The results of this assessment depict the indoor air quality conditions on the day of the assessment. Previous mold level conditions or future conditions may vary from the conditions identified on May 17, 2007 as a result of water leaks or other conditions that could result in water intrusion.

**PHOTO 1:** View of the front of the residence.

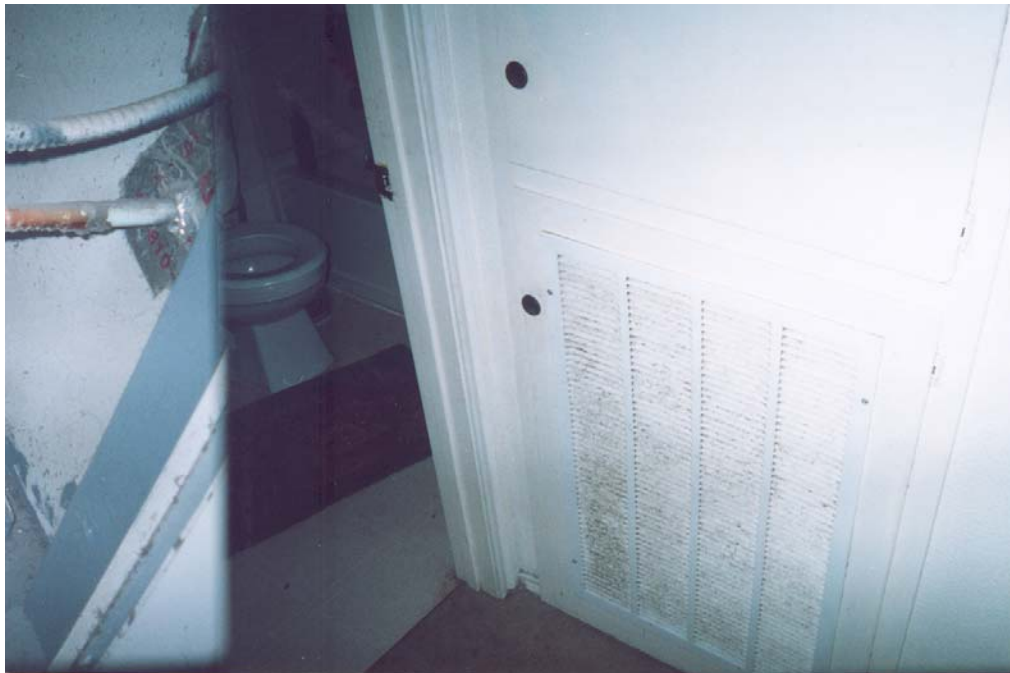
Upon arrival, STC inspected the HVAC system and ducts. There was significant buildup of dust on the return air vent grill (See Photo 2). In addition, there is significant dust buildup on and around several HVAC outlets (See Photos 3 and 4). Inspection of the bathrooms noted some buildup on the walls and in the corners (See Photo 5). There also was evidence of moisture between the tub and stool (See Photo 6). Significant dust was noted in the return air duct around the water heater (See Photo 7). The HVAC closet was generally cleaned (See Photo 8).

**PHOTO 2:** View of buildup on HVAC return vent.

- The HVAC outlet and return air vents should be cleaned.

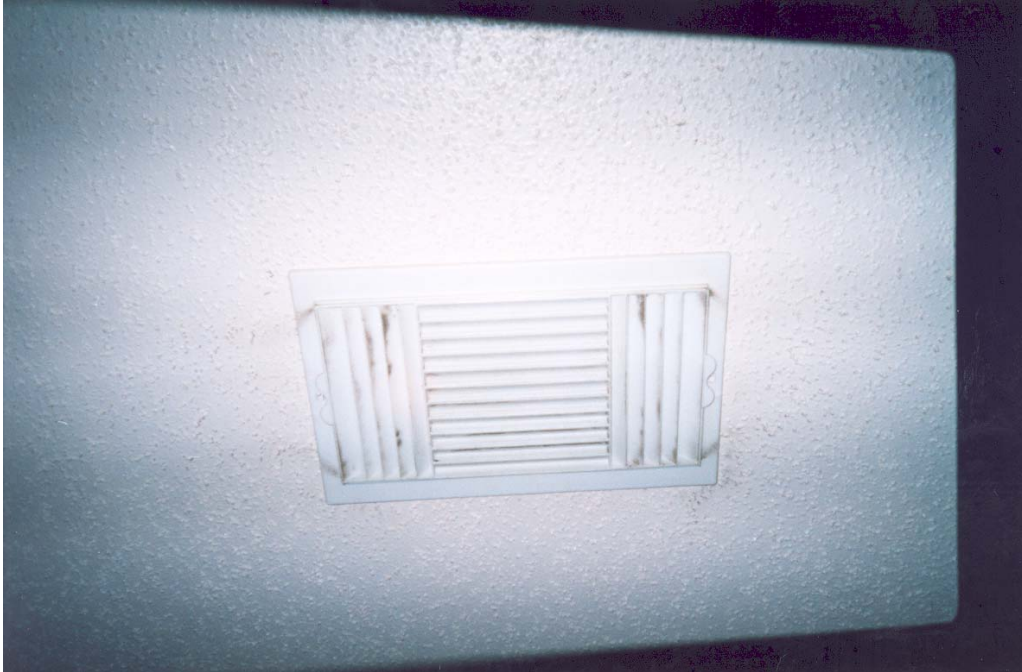
**PHOTO 3:** View of buildup on HVAC outlet.

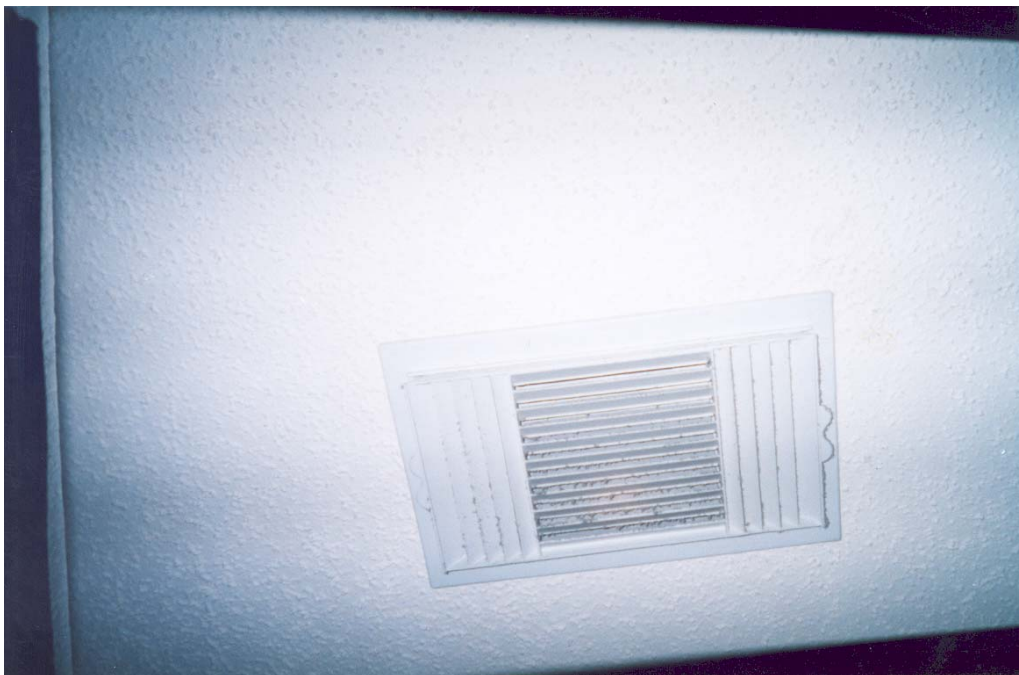
**PHOTO 4:** Additional view of buildup on an HVAC outlet vent.

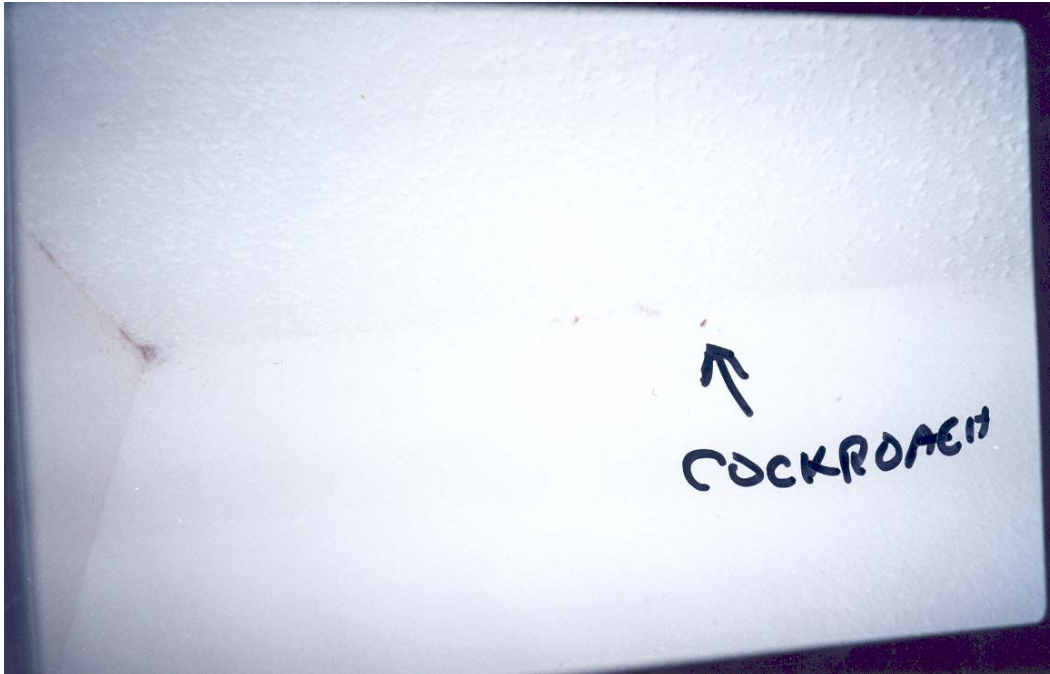
The tape sample collected from wall of the small bathroom identified one (1) species present. The species identified was Unidentifiable spores. This species was identified at concentration of “Rare” which means that 1 to 10 counts were identified. The species identified is found normally in both indoor and outdoor environments. For this species there is **NO** specified level that this mold species is considered harmful to humans. Everyone has an individual sensitivity to these species depending on each individual’s immune system.

As an additional observation, this residence was extremely dirty. Normal housekeeping efforts appeared to be lacking. In addition to the dirty HVAC outlets and return air vent, the carpet throughout the residence was extremely soiled. There also appears to be a cockroach infestation present as cockroaches were noted when the tape sample was collected from the buildup in the bathroom, a cockroach crawled out of the material (See Photo 5). This material is from cockroaches and is not mold as evident by the tape sample results.

**PHOTO 5:** View of buildup in bathroom. What was suspected as mold is from cockroaches. Note visible cockroach that exited the material.

- The house should be inspected by a licensed pest control agent who follows the Integrated Pest Management (IPM) method rather than the old methods of bug sprays, foggers and bombs. These old methods drive away the roaches for awhile but then they return. The IPM method follows the following approach.

- This residence should be thoroughly cleaned to get rid of the roach debris and dust mites. For roaches to be defeated, it requires cooperation of public housing management, maintenance staff and the tenants.

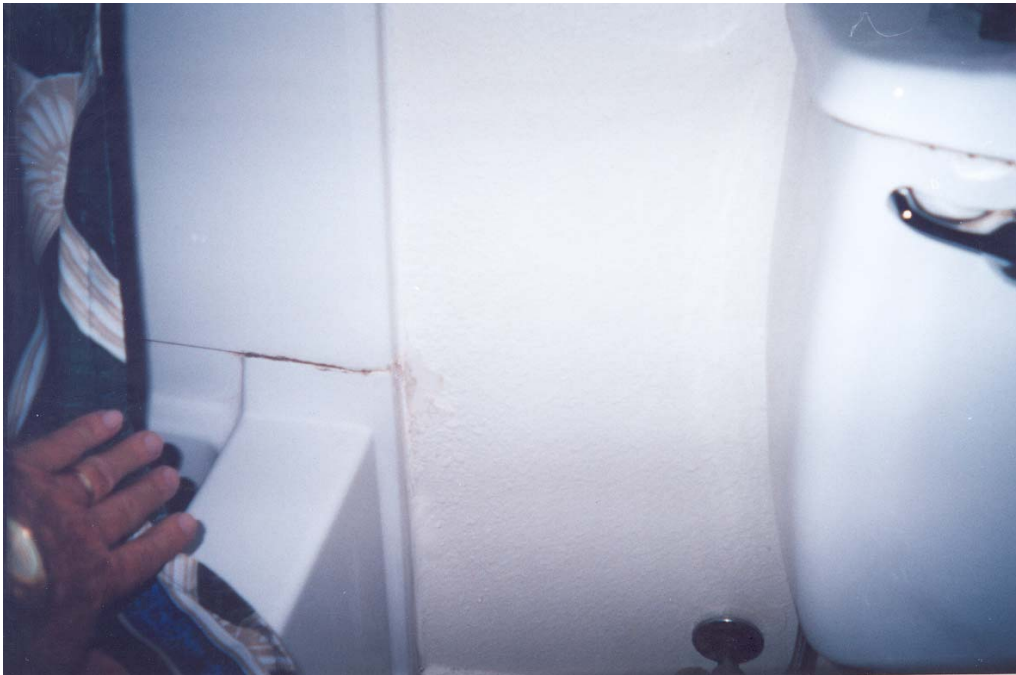
As a result of the moisture on the sheetrock wall between the shower/tub and stool, the area was tested for moisture. The testing was completed with the use of a BD-2100 Delmhorst Instrument. This instrument measures moisture in sheetrock over a range of 0.1% to 50.0%. Moisture levels in sheetrock between 0.1% and 0.4% are considered normal. Moisture levels between 0.5% and 1.0% are considered borderline. Moisture levels in sheetrock above 1.0% are considered to be too wet for painting or for wallpaper. The moisture content of the sheetrock wall in bathrooms ranged from 1.4% to 3.1%. This level is considered elevated.

**PHOTO 6:** View of area where moisture is present in the sheetrock.

- The wet sheetrock between the tub and stool should be replaced as water damage. This can be completed as regular maintenance of water damaged areas and does not require mold remediation unless visible mold is discovered inside the wall during repairs.

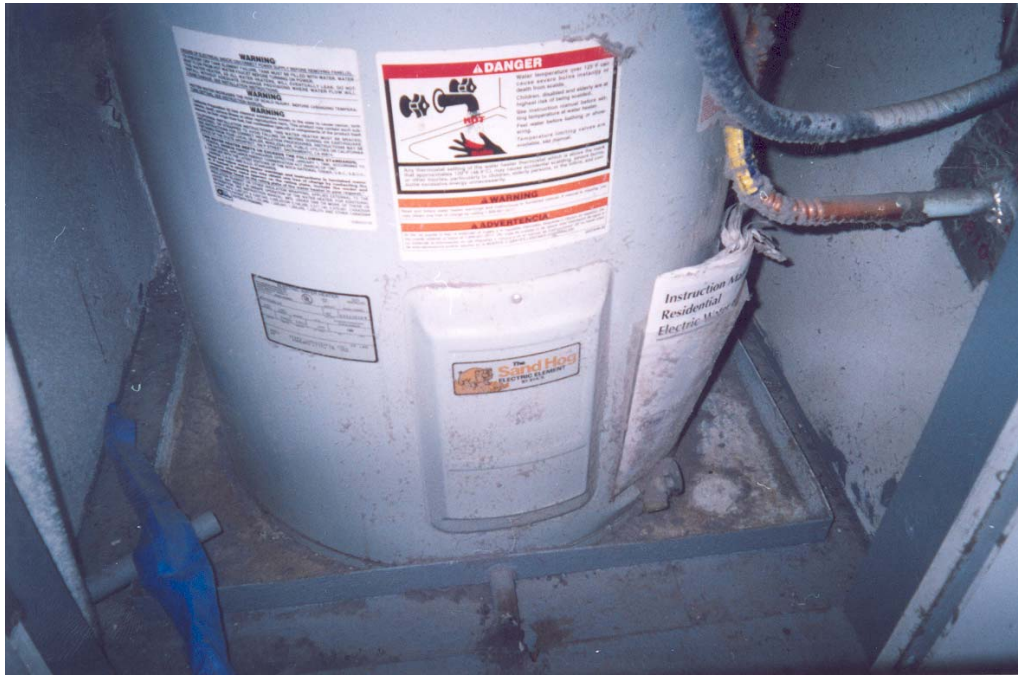
**PHOTO 7:** View of dusty return air closet with water heater.

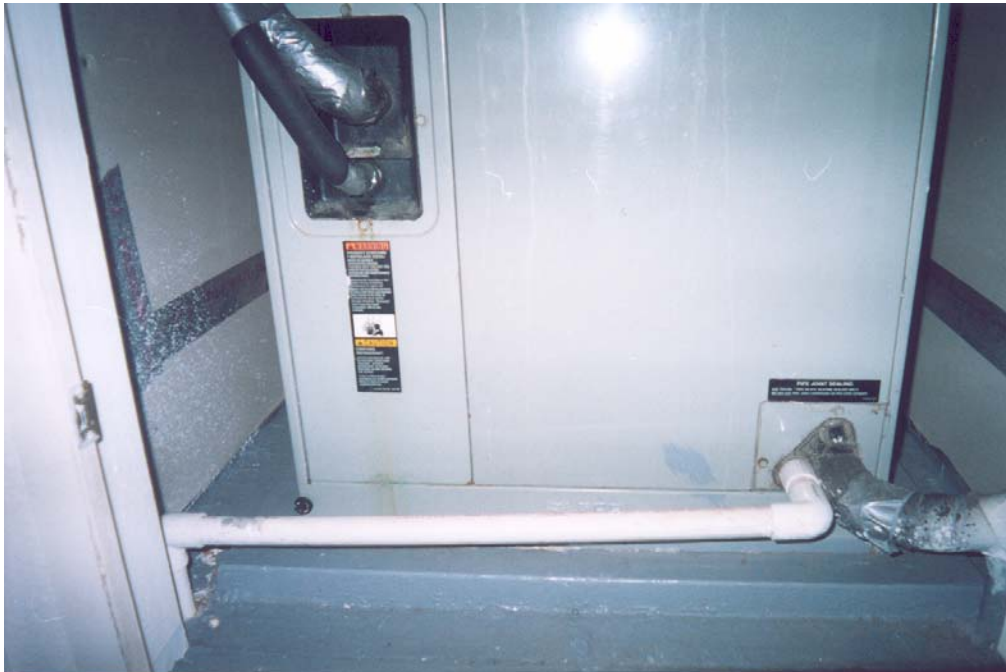
**PHOTO 8:** View of generally clean HVAC unit closet.
