# Aladdin Environmental LLC

Re: SAHA, Mirasol Task Force, 462 Precious, San Antonio, TX

Aladdin Environmental LLC is pleased to submit this report for the Post Remediation Assessment for the above house on May 20<sup>th</sup>, 2008. This report applies to the Master Bath, Bedroom, Closet & Hallway as detailed in the Mold Remediation Protocol dated May 12<sup>th</sup>, 2008. We have observed the standard of care generally exercised by the profession under similar circumstances and conditions to complete this report.

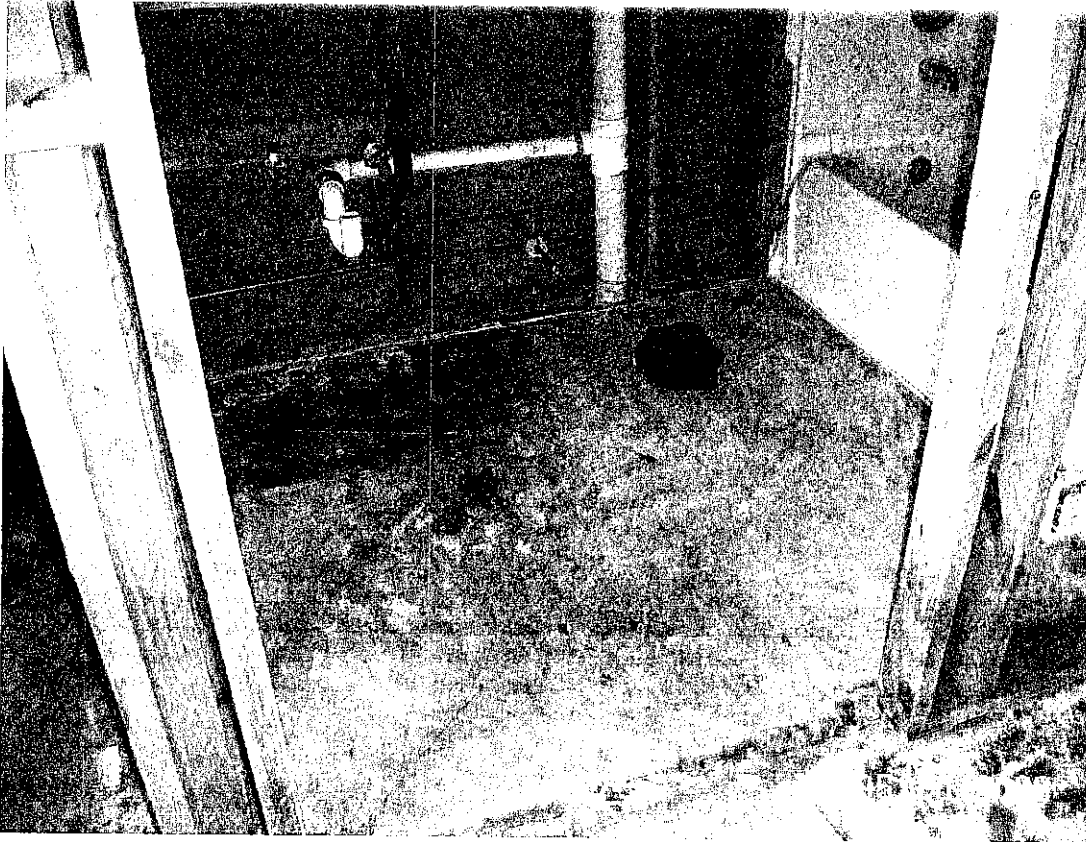
**Master Bath**

S1 – Master Bath – baseplate: Lab results indicate "Rare" on the microscopic screen. This is within the guidelines set forth in the Mold Remediation Protocol. Based on the type of spores being *Chaetomium*, additional cleaning of the wood framing in the bathroom area is recommended. Re-testing is not necessary based on the count being "rare".

Moisture Readings on exposed wood framing tested dry.
