# Aladdin Environmental LLC

Re: 514 Precious, San Antonio, TX

Aladdin Environmental is pleased to submit this environmental evaluation on the above residence located at 514 Precious, San Antonio, TX. This limited evaluation was performed on May 21<sup>st</sup>, 2008. We have observed the standard of care generally exercised by the profession under similar circumstances and conditions to complete this report.

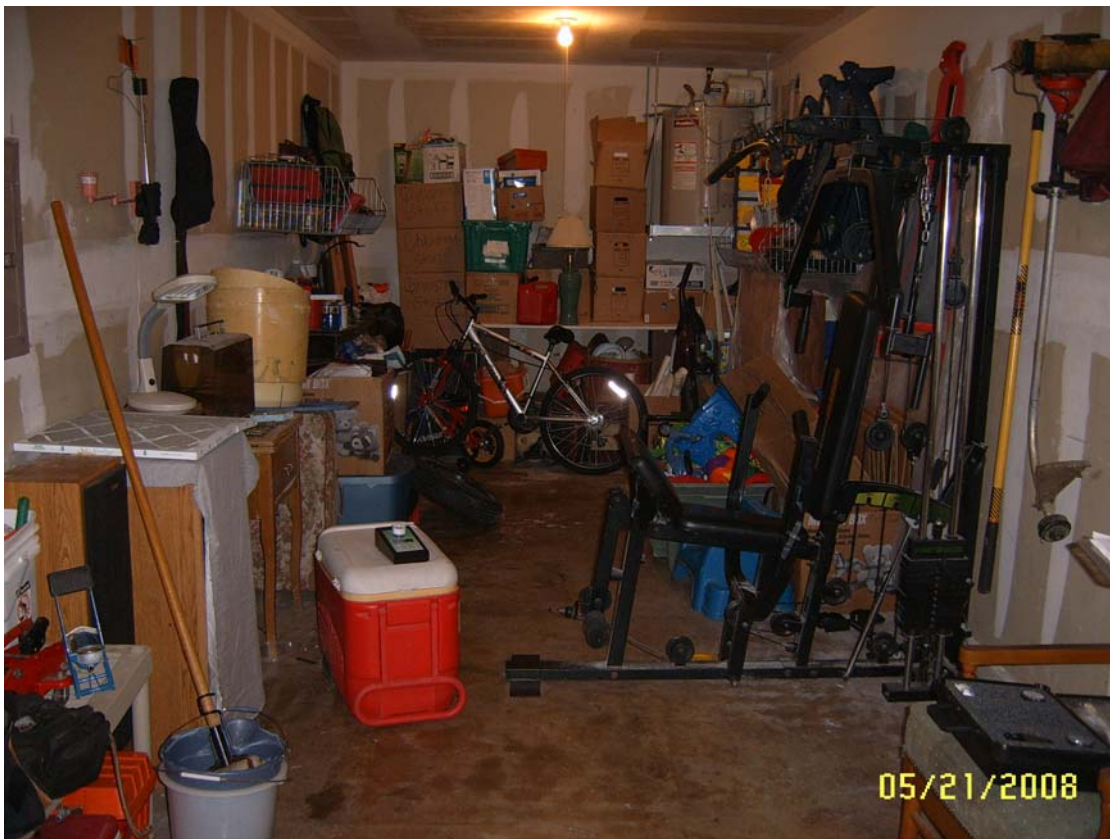
**Garage**

- Lab results show counts of various types of mold, similar to outside, with elevated counts of *Aspergillus/Penicillium* and the presence of *Chaetomium*. This requires action to be taken as described below.

- Inspected areas throughout the house but primarily in the Garage area. The house was considered visually clean.
  - It was reported that this house had previously undergone a Mold Remediation. The clearance report is dated March 18, 2008. Additional sampling was performed by ETC on April 30<sup>th</sup>, 2008 (report dated May 9, 2008) of the Garage & found elevated counts.

- Moisture readings were taken in various areas (as accessible in the garage) using a moisture meter and all readings were normal.
  - There was no visible microbial growth observed during this visit.

- The HVAC unit, supply ductwork and registers appear to have recently been replaced.
  - Garage –
    - Recommend removing all contents, cleaning based on the following cleaning procedures, cleaning of all surfaces in the garage (ceiling, walls, floor) and replace contents in garage. Any items found with visible microbial growth should be thoroughly cleaned if possible or discarded.

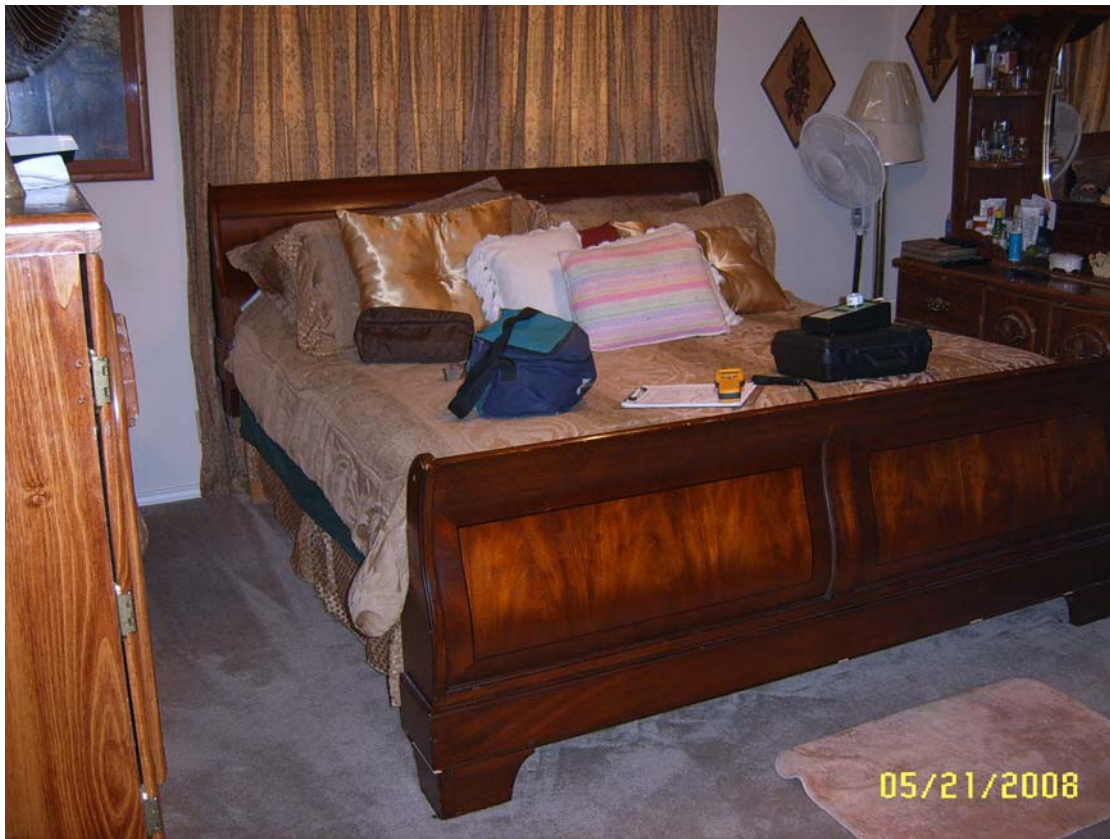
**Master Bedroom**

- Lab results show counts of various types of mold, similar to outside or within a reasonable variance. *Bipolaris* is present in this sample while not present in the outside sample. Recommended action described below.

- Master Bedroom –
    - Recommend cleaning the ceiling fan, the bathroom exhaust fan and HEPA vacuum the comforter and carpet.
  - Upstairs hall @ back Bedrooms -

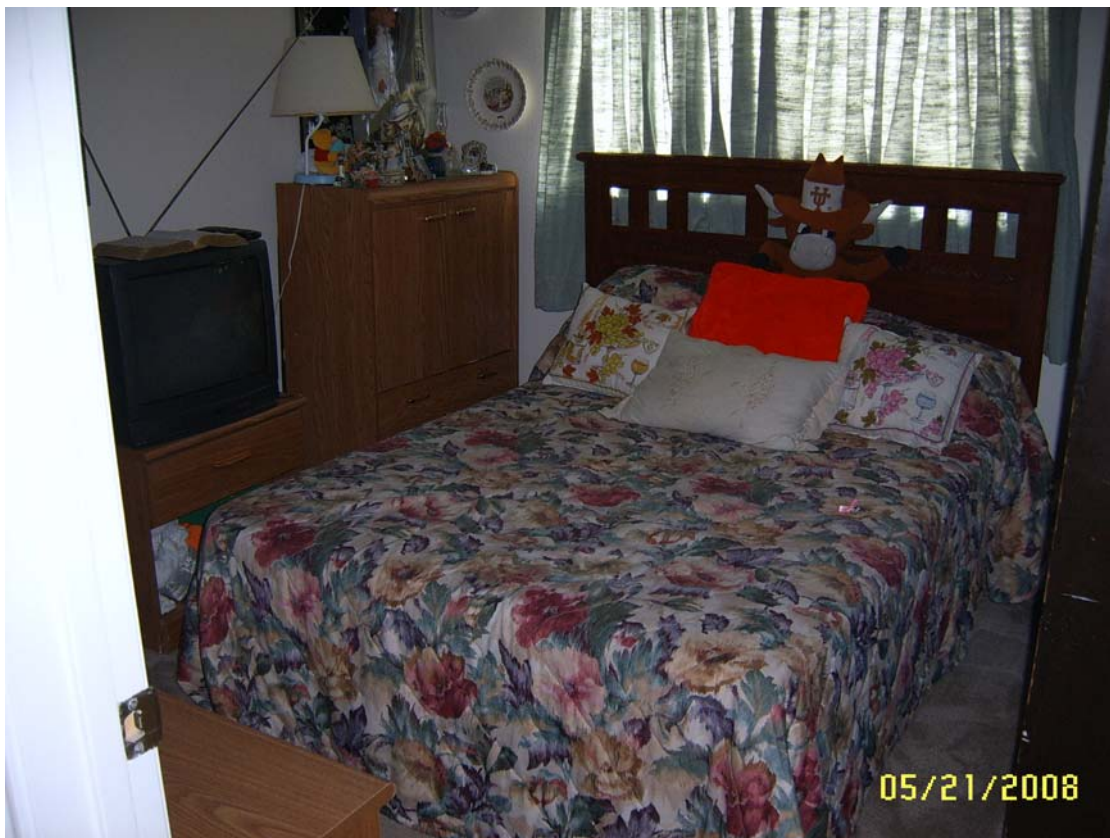
**Upstairs Back Bedroom (next to bath)**

- Lab results show counts of various types of mold, similar to outside, with elevated counts of *Aspergillus/Penicillium* and the presence of *Chaetomium*. This requires action to be taken as described below.

- Recommend HEPA vacuum of upstairs hall carpet, return area of A/C and comforter & carpet of back corner bedroom (closest to Bathroom).
  - Living Room –
