APPRAISAL OF REAL PROPERTY

1607 NW 26th Street
NCB 8888 BLK 9 LOT 6 (Blueridge Subd)
San Antonio , TX 78228-6327

Uniform Residential Appraisal Report

File # CS071041B

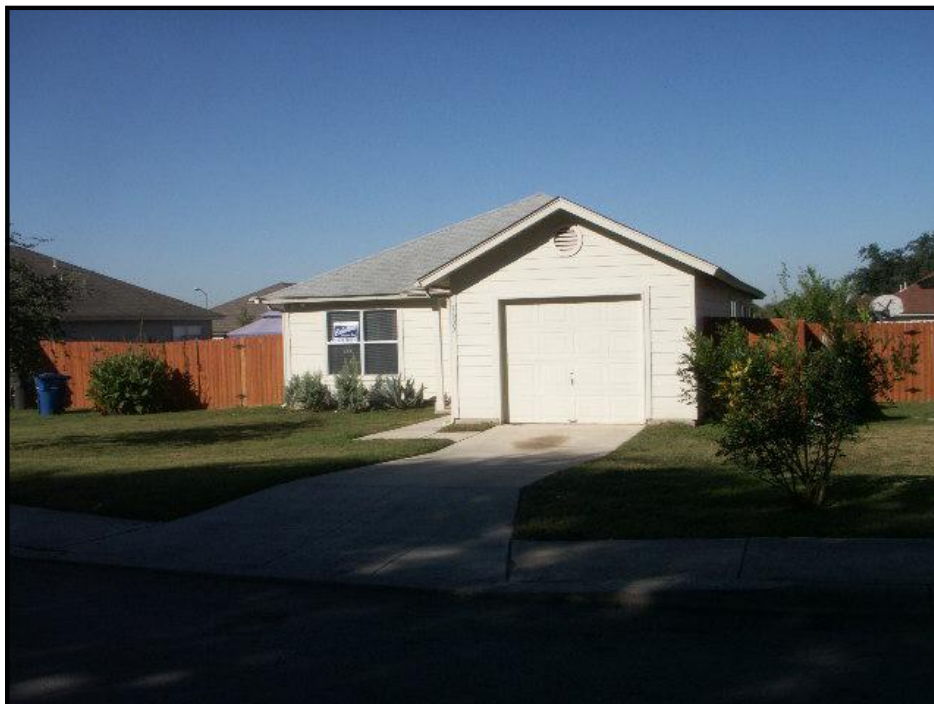
Subject Front

1607 NW 26th Street
 Sales Price N/A
 Gross Living Area 1,221
 Total Rooms 6
 Total Bedrooms 3
 Total Bathrooms 2
 Location Suburban
 View Typical
 Site 5,097 Sq.Ft.
 Quality Average
 Age 7

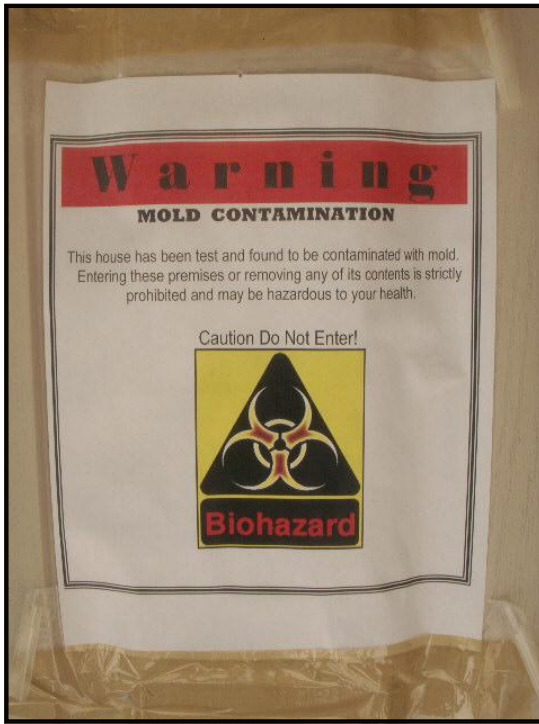
The subject property has three 1ft x 1ft holes that need to be repaired. Cost to cure is approximately \$300. Carpet needs to be installed in the three bedrooms and closets. Cost to cure is approximately \$2,500. There is a sign posted stating the subject property is contaminated due to some sort of mold. This appraiser was furnished with test results from ETC Informational Services who tested for contaminants in the subject property. This appraiser spoke with a staff member of ETC Informational Services that was familiar with the testing on the subject property. ETC Informational Services did not find any harmful contaminants that would deem the property inhabitable. (See Attached Conclusions & Recommendation from ETC Informational Services, LTD.)

Posted Contamination
