Project No. ASR08-059-00
November 10, 2008

**RE: Consulting Engineering Services
Residential Study
138 Villa Arboles
San Antonio, Texas**

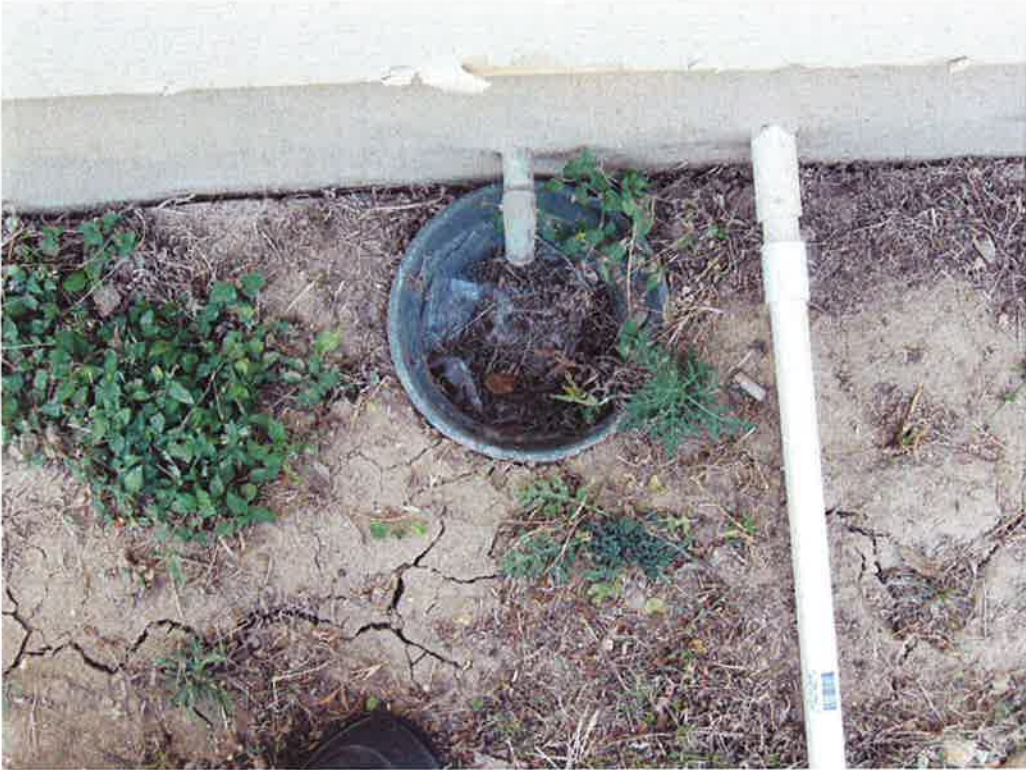
PHOTOGRAPH 8

- The former temperature/pressure relief drain is located about 4-1/2 feet from the back edge of the stoop as shown on Photograph 8.
- The PVC condensate drain line exits the foundation about 4 feet from the back edge of the concrete stoop and extends about 5-ft into the right yard as shown on Photograph 8.
- There is some drying of the soils along the perimeter beam as shown on Photograph 9.
- The surface drainage is considered to be good along the right side of the home as shown on Photograph 2, with the exception of a low spot between the grade beam and the front edge of the concrete stoop as shown on Photograph 10.
- A drip line has formed on the ground surface below the edge of the roof eave.
- The fiber board between the grade beam and the concrete stoop has collapsed into the joint.

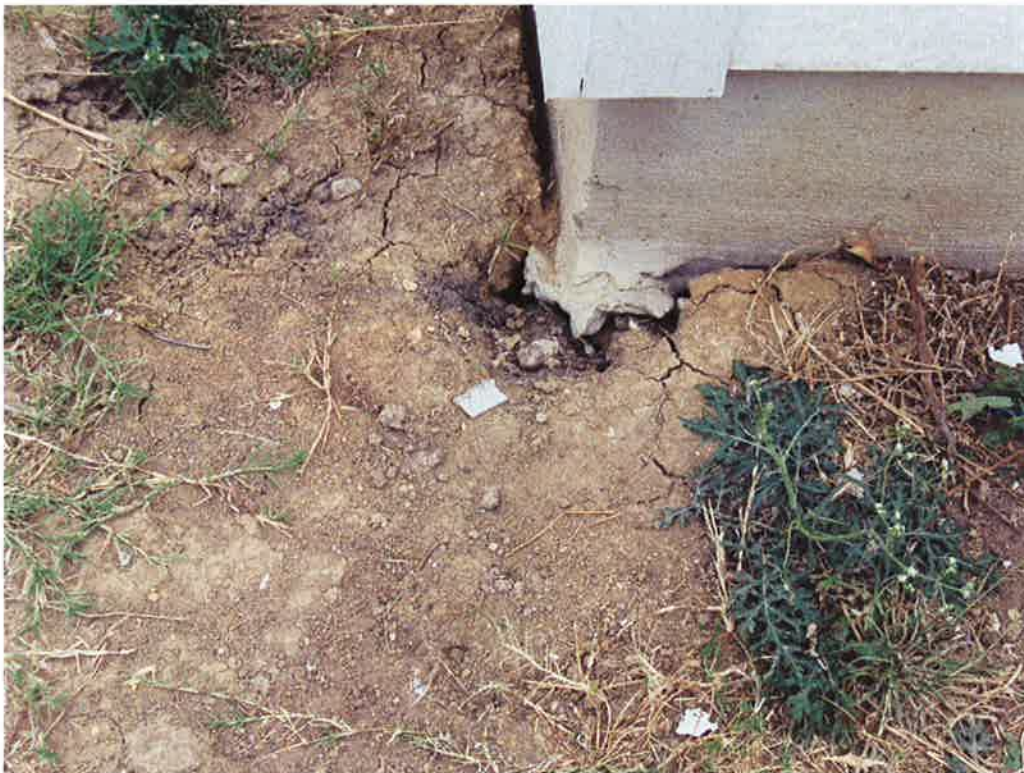
PHOTOGRAPH 11

- The surface drainage is considered to be poor with the ground surface sloping toward the foundation as shown on Photograph 11. There is a slight swale that extends from left to right across the yard; however it is not well defined.
- The coil and fan unit is located adjacent to the perimeter grade beam.
- There is some drying of the soils along the perimeter beam as shown on Photographs 12 and 13.
- There is a 2-ft diameter tree stump located about 15-ft to the rear of the right-rear corner of the home as shown on Photograph 14.
- A drip line has formed on the ground surface below the edge of the roof eave.
