Project No. ASR08-044-00  
September 22, 2008

**RE: Consulting Engineering Services  
Residential Study  
402 Precious Drive  
San Antonio, Texas**

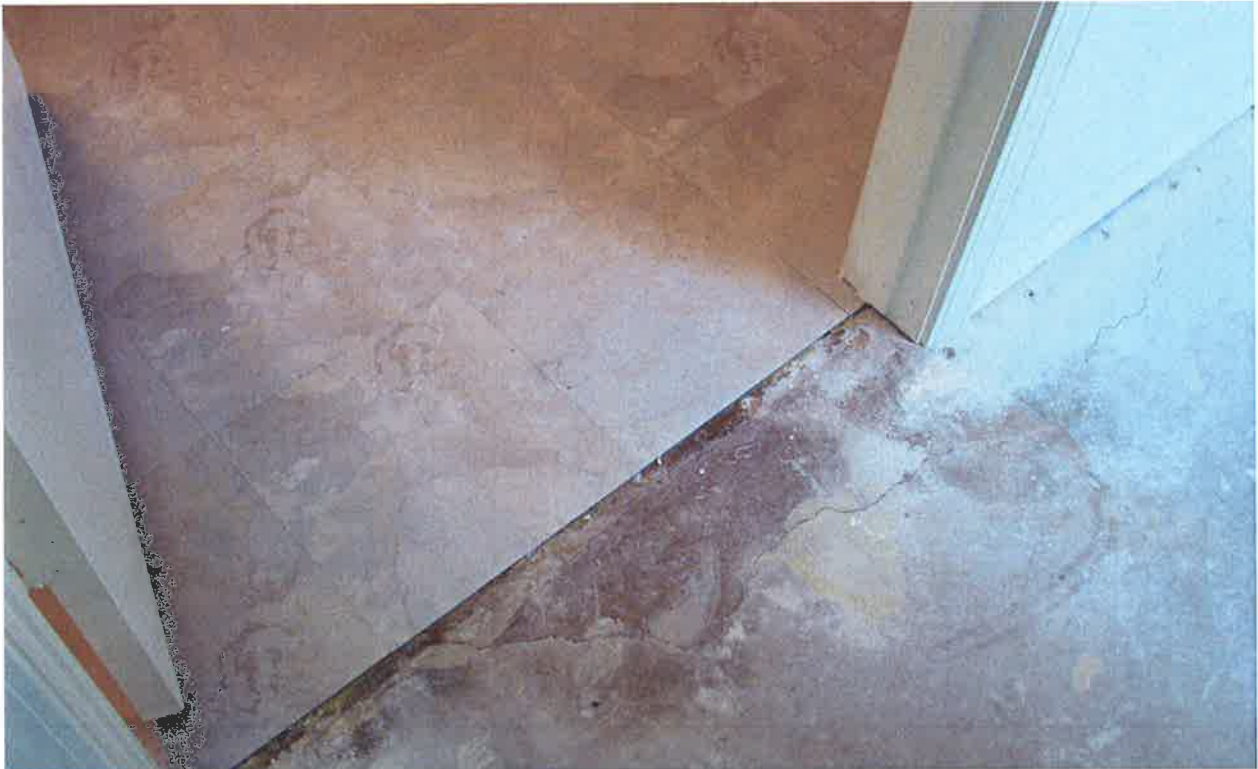
**PHOTOGRAPH 16**

- We noted cracks in the concrete floor slab along the right side of the hallway, as shown on Photographs 12 and 13 in Attachment B.
- Several random plastic shrinkage cracks were observed on the surface of the living room floor slab as shown on Photographs 14, 15, and 16 in Attachment B.
- We also noticed a concrete crack near the hallway bathroom as shown on Photograph 17 in Attachment B. Since there is vinyl floor covering within the bathroom, we do not know where this crack extends in the bathroom.
- Within the master bedroom, there are several random cracks in the floor slab as shown on Photograph 18 in Attachment B.
- We did not note any cracks in the sheetrock covered walls or ceilings throughout the home.

- The cracks in the concrete foundation are plastic shrinkage and dry shrinkage cracking and crack widths are related to soil movements supporting the foundation and will not impact good long term performance of the foundation.

- The movements are not associated with plumbing leaks; however, this should be confirmed by performing plumbing leak testing.
- The foundation cracks are minor in nature, with crack widths of less than 1/16-inch, and the foundation supporting the home and the wood frame are considered structurally adequate.
- The foundation and frame do not demonstrate structural failure cracking conditions.
- The concrete foundation does not demonstrate materials weakness or construction deficiencies.
- The concrete foundation supporting the home and the wood frame is considered structurally adequate.
