**AccuTech
Consultants, LLC**

Structural Report

**San Antonio Housing Authority
Single Family Housing Design/Build Project
San Antonio, Texas**

June 2007
Project CTR001-F

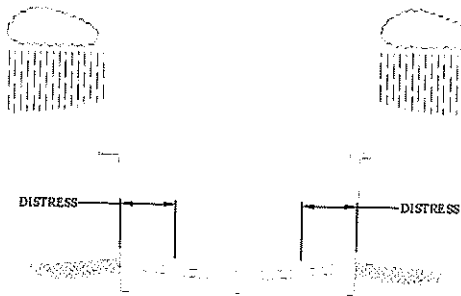
FIGURE 1

1. Based on our observations, there were no signs of structural damage or distress to any of the structures.
2. Our elevation survey revealed that the foundations had an overall difference in elevation that ranged from 0.8 to 5.9 inches. It has been our experience that newly constructed foundations are never constructed perfectly level. Therefore, it is our opinion that some of the overall differences in elevation of these structures may possibly be as-built conditions.
3. The soils information indicated that the homes overlie expansive clay soils. Therefore, when moisture increases along the building perimeter, it can cause the underlying soils to swell and raise the perimeter (edges) of the foundation (See Figure 1). On the other hand, as the moisture contained in the soil around the foundation's perimeter decreases (dries

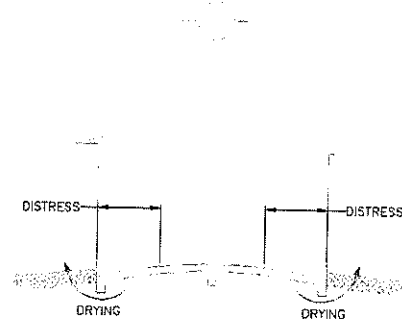
FIGURE 2

out), the perimeter of the foundation can move in a downward direction (See Figure 2). The drying out effect can be caused by the natural loss of moisture through evaporation, or this drying may be significantly increased by the effect of vegetation located near the foundation. These movements can cause walls and ceilings to crack, and doors to stick throughout the structure.

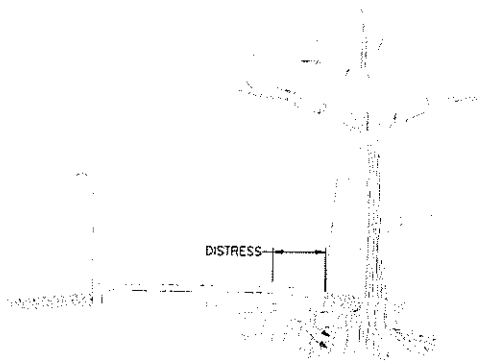
FIGURE 3

4. Due to the expansive nature of the underlying clay soils, water maintenance of the soil along the perimeter of the foundation can affect foundation performance. Therefore, the possibility exists that some of the differential foundation movement and resulting distress may be a result of inadequate water maintenance.
5. At a few of the homes (houses #12, #17, #21, #25), the affects of seasonal moisture changes have been compounded by trees and other vegetation near the foundation (See Figure 3), which tend to decrease the moisture of the underlying soils at the perimeter of the foundation at a faster rate. In these instances, our elevation survey revealed generally lower foundation elevations in the vicinity of trees that were located in close proximity to the foundation.

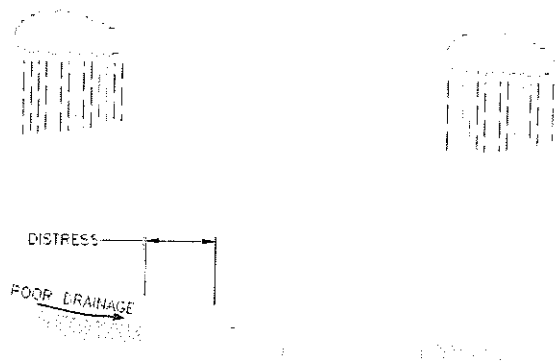
FIGURE 4

6. At several of the homes (houses #3, #5, #8, #9, #10, #11, #14, #15, #23, #26, #27), higher foundation elevations were found along the perimeter of the structure where the drainage appeared to be inadequate. In these cases, the affects of seasonal moisture changes have been compounded due to poor drainage (See Figure 4).

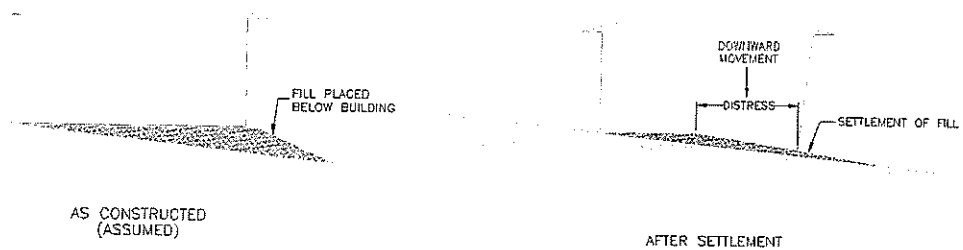
FIGURE 5

7. Based on our observations and our elevation surveys, some of the slopes of the foundations (houses #3, #5, #8, #9, #10, #11, #14, #15, #23, #26, #27) generally followed the slope of the site. In these instances, some of the foundation slope may have been an "as-built" condition or possibly the result of the foundation being constructed on a fill site. This movement is a result of initial settlement of the foundation and typical for foundation constructed on fill sites. (See Figure 5)

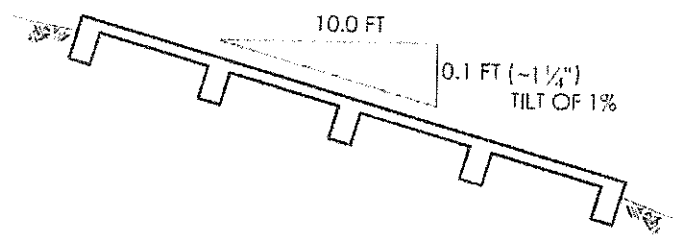
FIGURE 6 – Tilt Schematic

9. Our elevation surveys revealed that the foundation of the structure located at 142 Villa Grande (house #14) had an overall difference in elevation of approximately 5.9 inches. However, we found little to no distress in the interior or exterior finishes. It is therefore our opinion that the foundation has undergone a uniform tilt (See Figure 6). This occurs when the foundation moves uniformly as a unit. Due to the floor slope, we would recommend that this condition be brought to the builders attention for the purpose of addressing the possible need for leveling.
