## ADDENDUM # 2

**RFP for: Pecan Hill Tree Removal and Sanitary Sewer Retrofit**

**RE: Foundation Movement Study  
Pecan Hill Apartments  
1600 West Lawndale  
San Antonio, Texas**

**FOUNDATION MOVEMENT STUDY**

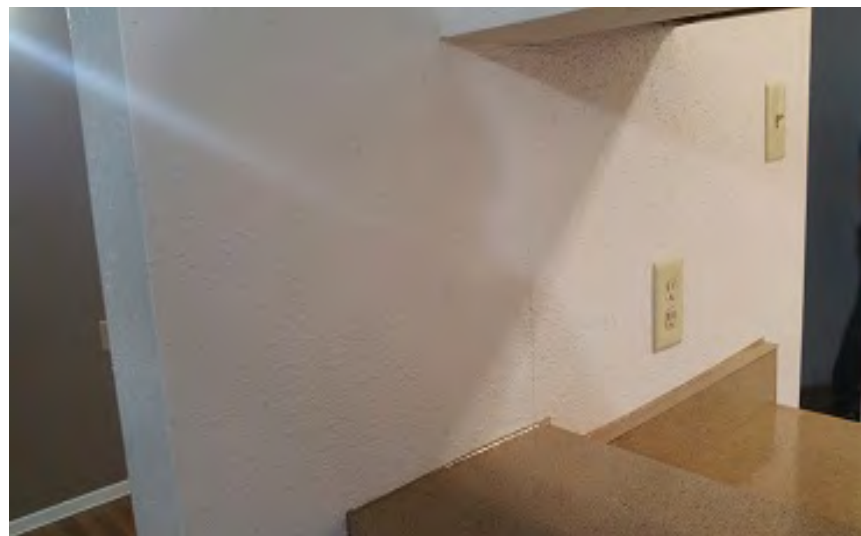
*Photo 12 – Unit 112: Crack near Kitchen Counter*

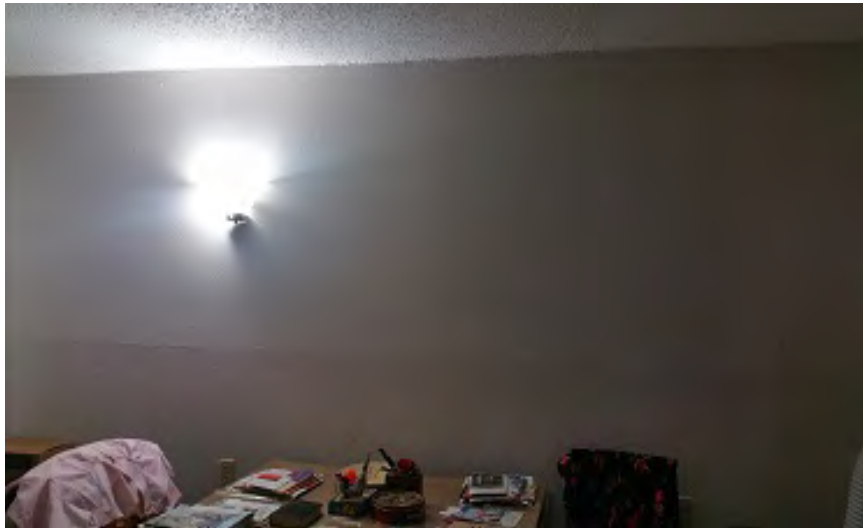
*Photo 21 – Unit 103: Crack in Living Room*

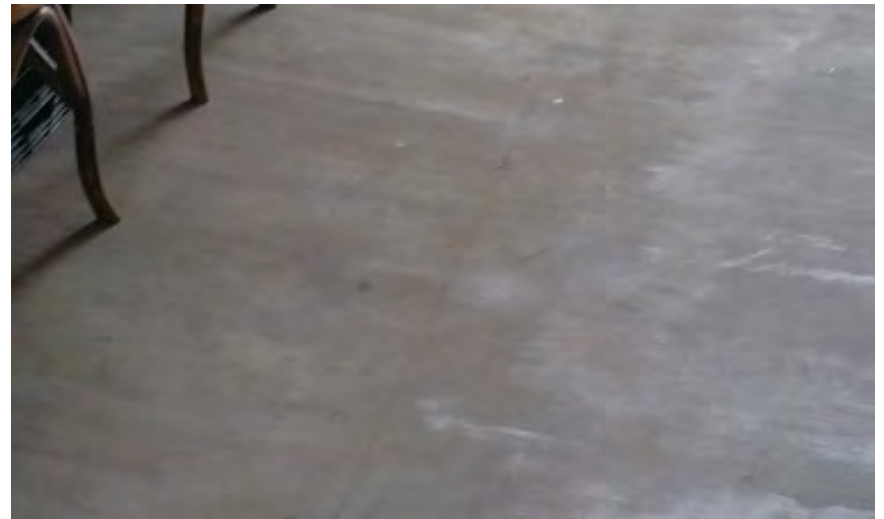
*Photo 26 – Walkway Crack near NW Community Exit*

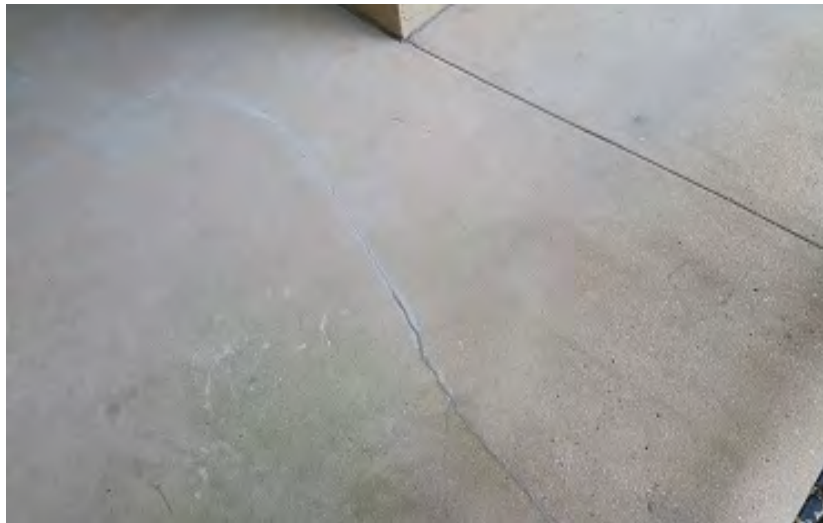
*Photo 29 – 2<sup>nd</sup> Floor: Walkway Crack*

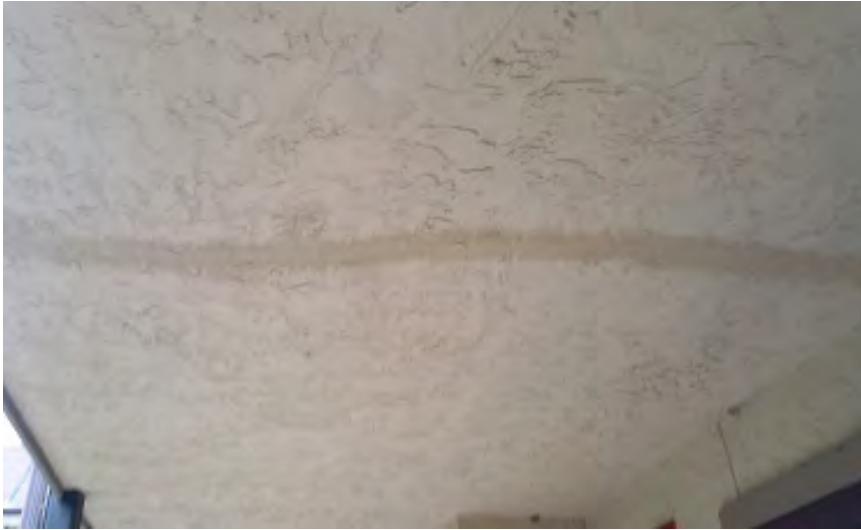
*Photo 30 – 2<sup>nd</sup> Floor: Walkway Ceiling Crack*

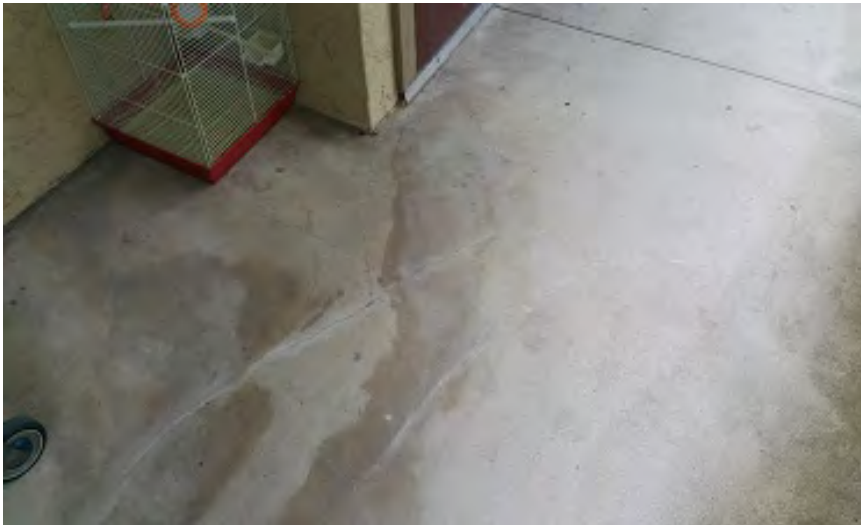
*Photo 32 – 2<sup>nd</sup> Floor: Walkway Crack*

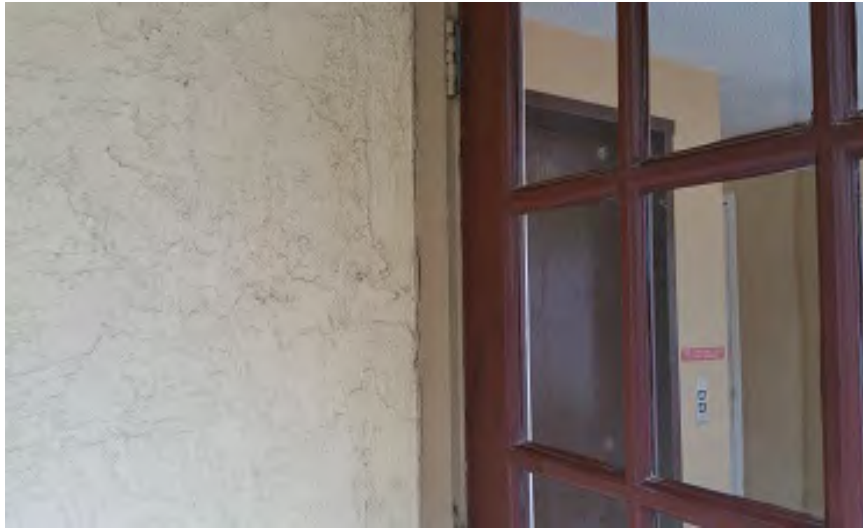
*Photo 34 – 2<sup>nd</sup> Floor: Wall Crack near Elevator Lobby*

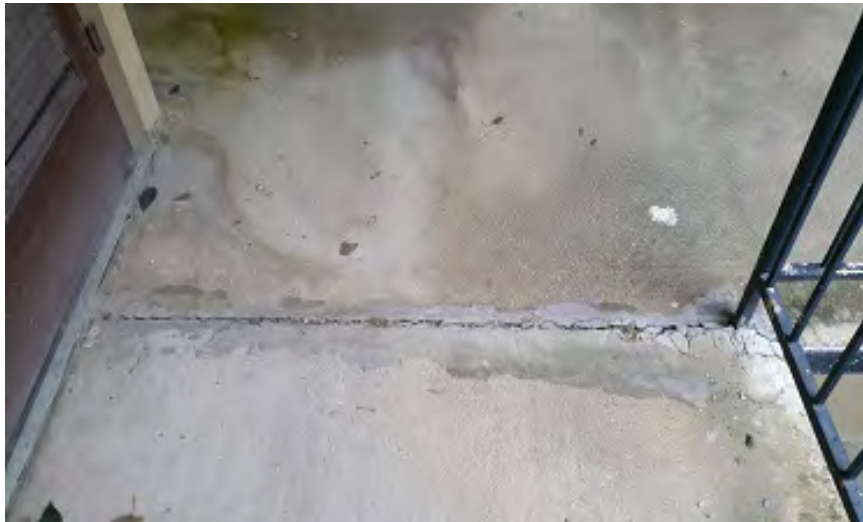
*Photo 36 – 2<sup>nd</sup> Floor: Walkway Crack*

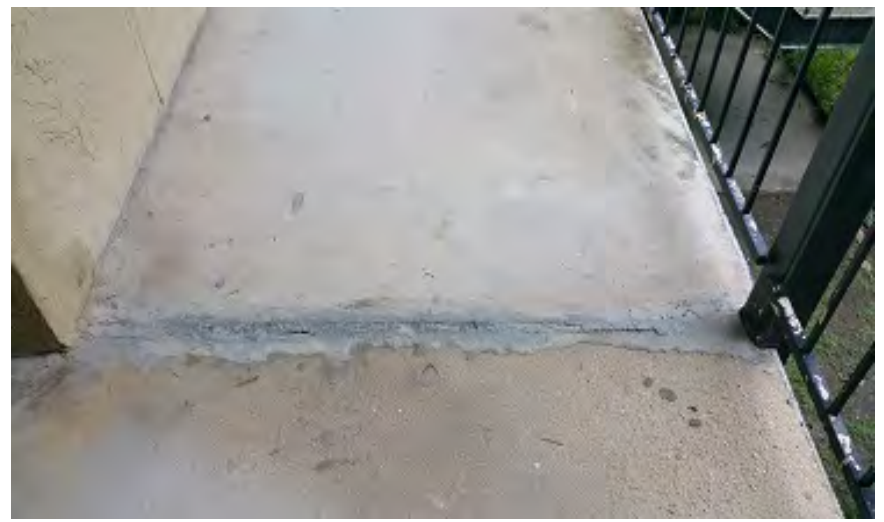
*Photo 37 – 2<sup>nd</sup> Floor: Walkway Crack*

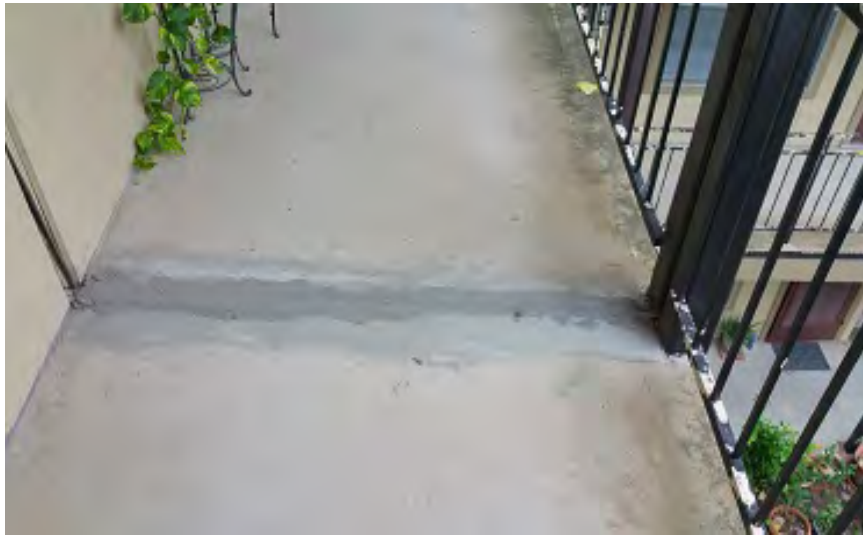
*Photo 38 – 3<sup>rd</sup> Floor: Walkway Crack*

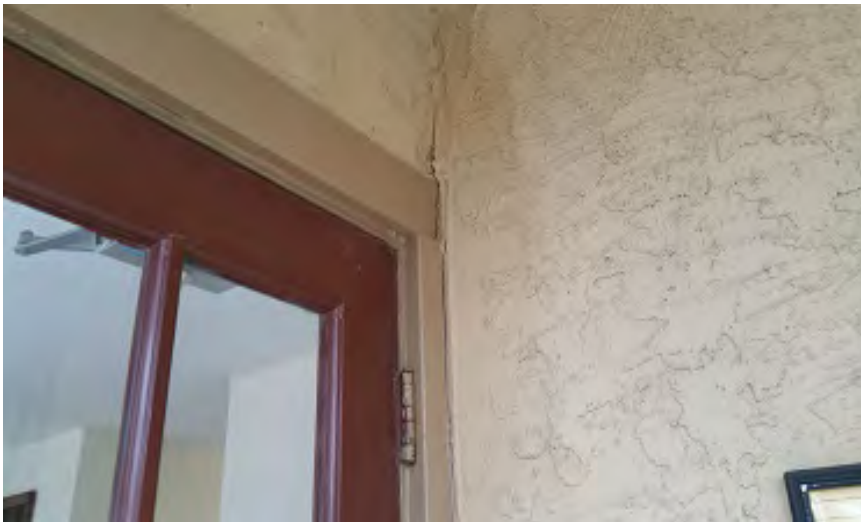
*Photo 44 – 3<sup>rd</sup> Floor: Crack at Door Frame near Elevator Lobby*

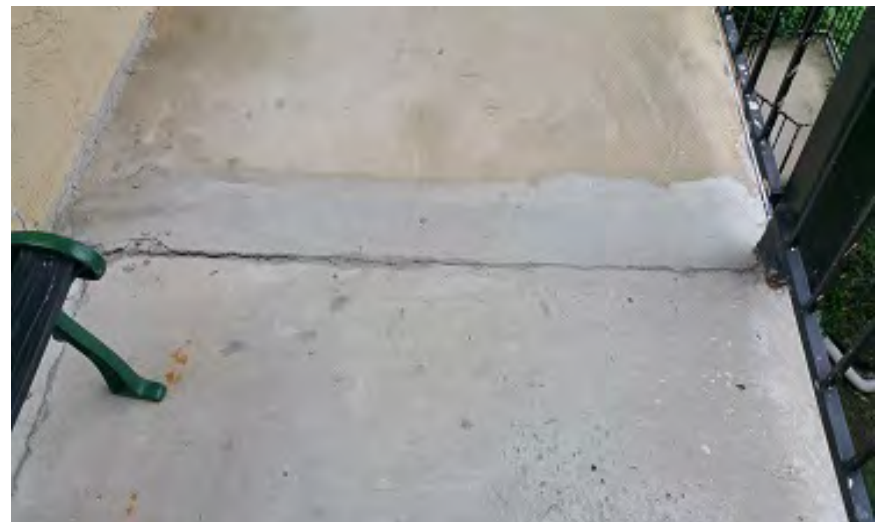
*Photo 45 – 3<sup>rd</sup> Floor: Walkway Crack*

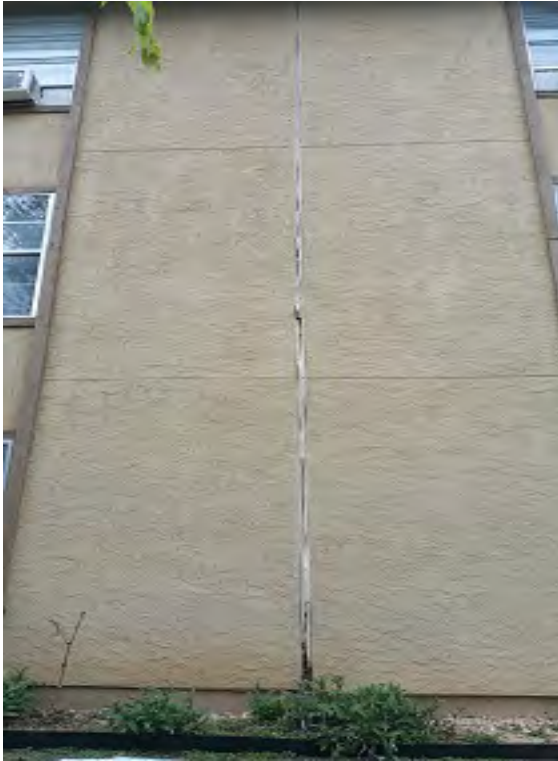
*Photo 47 – West Building: Deteriorated North Expansion Joint*

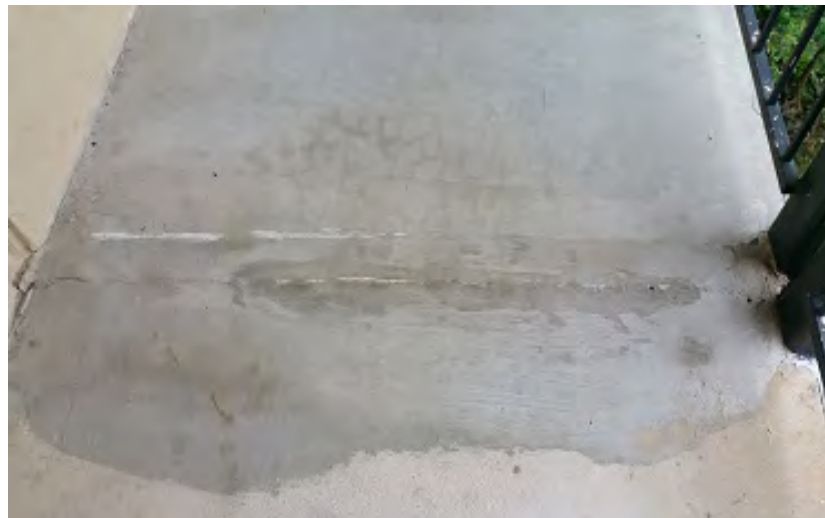
*Photo 46 – 3<sup>rd</sup> Floor: Walkway Crack*

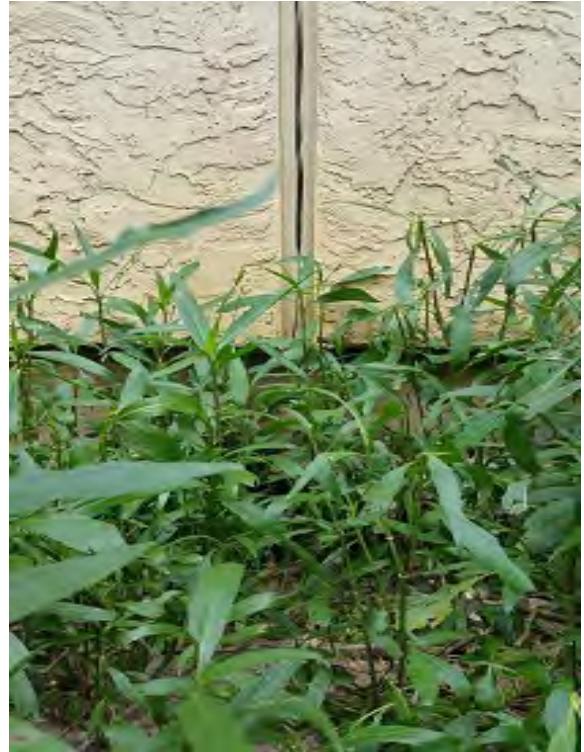
*Photo 50 – West Building: Deteriorated South Expansion Joint at Base*

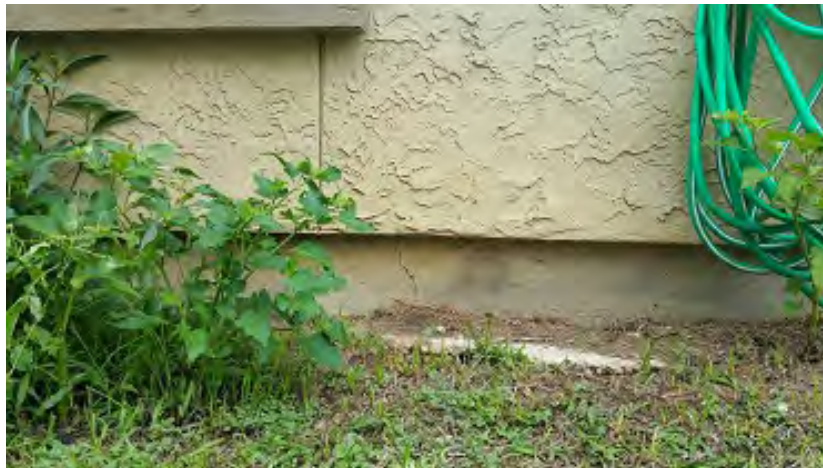
*Photo 51 – West Building Foundation Crack*

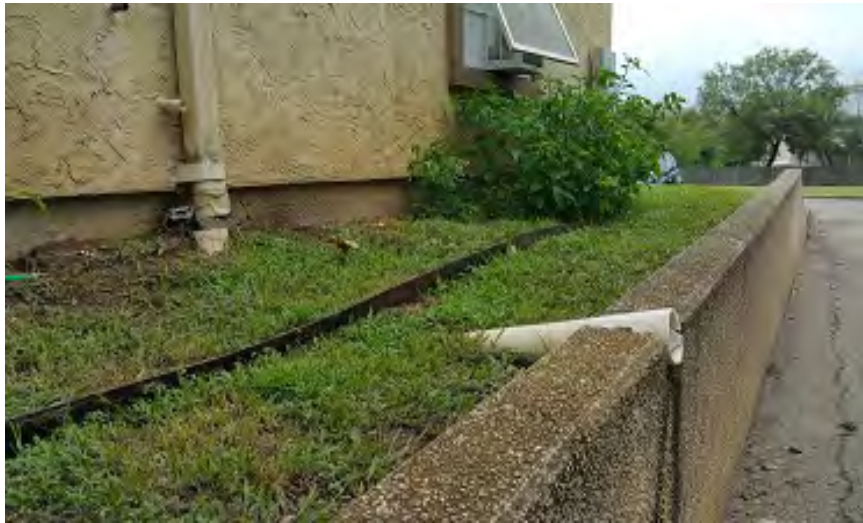
*Photo 52 – West Building: Improper Drainage (Looking South)*

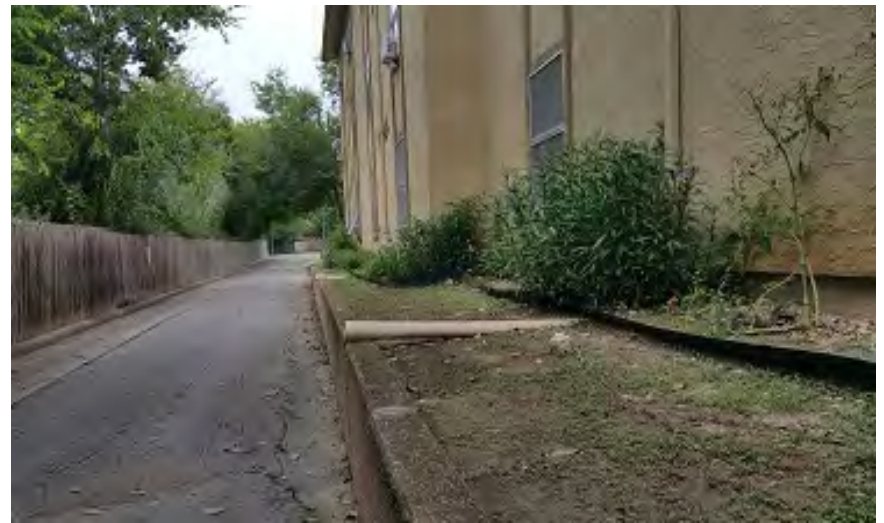
*Photo 53 – West Building: Improper Drainage (Looking North)*

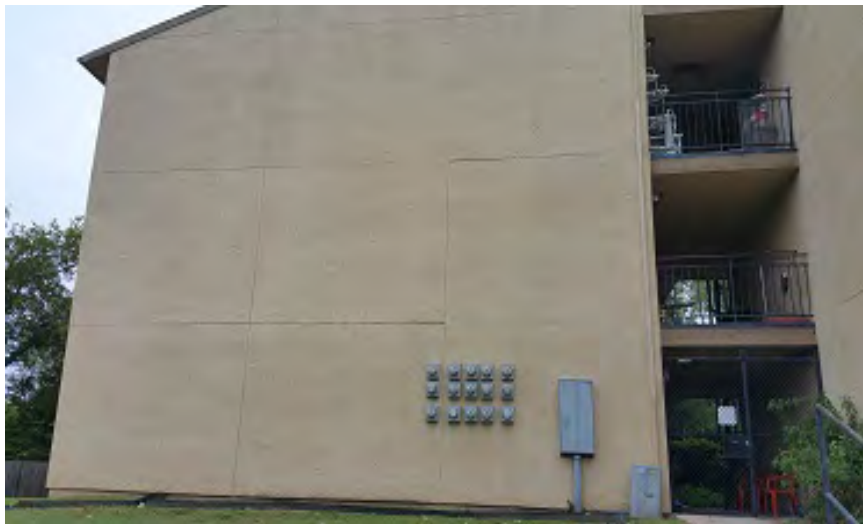
*Photo 54 – West Building: South Façade Joint Separation*

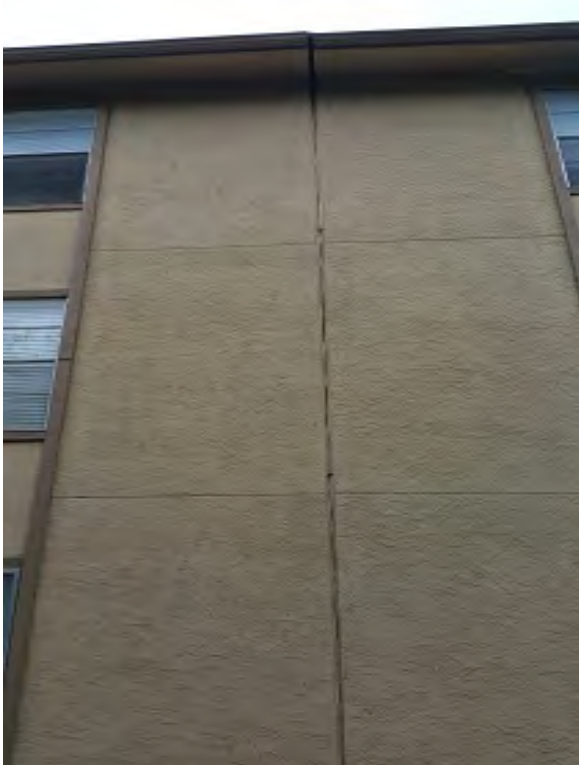
*Photo 56 – East Building: Deteriorated South Expansion Joint*

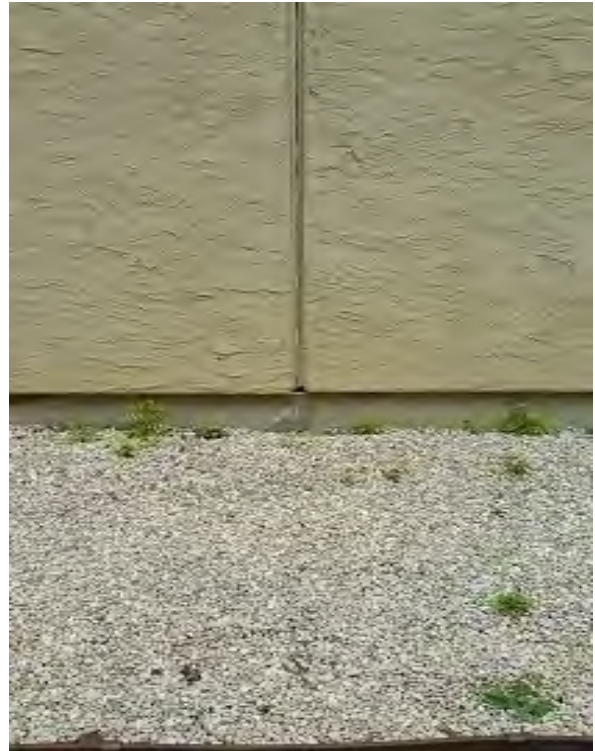
*Photo 57 – East Building: Deteriorated South Expansion Joint at Base*

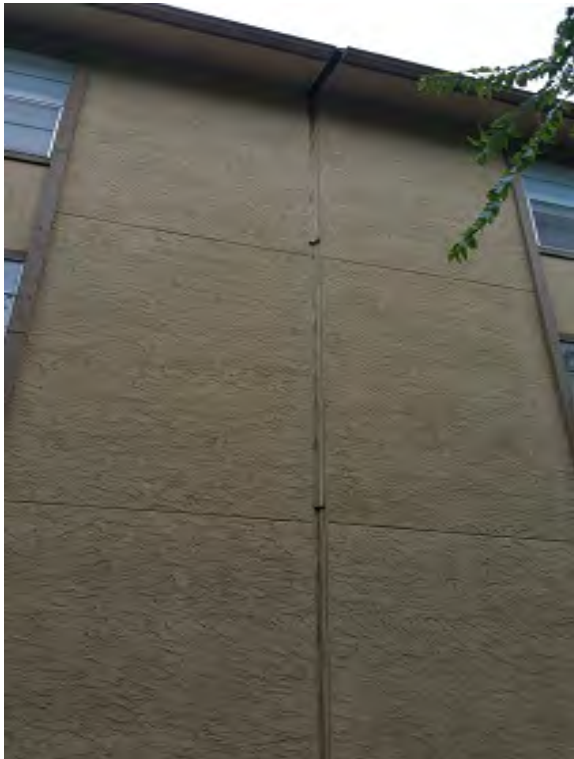
*Photo 58 - East Building: Deteriorated North Expansion Joint*

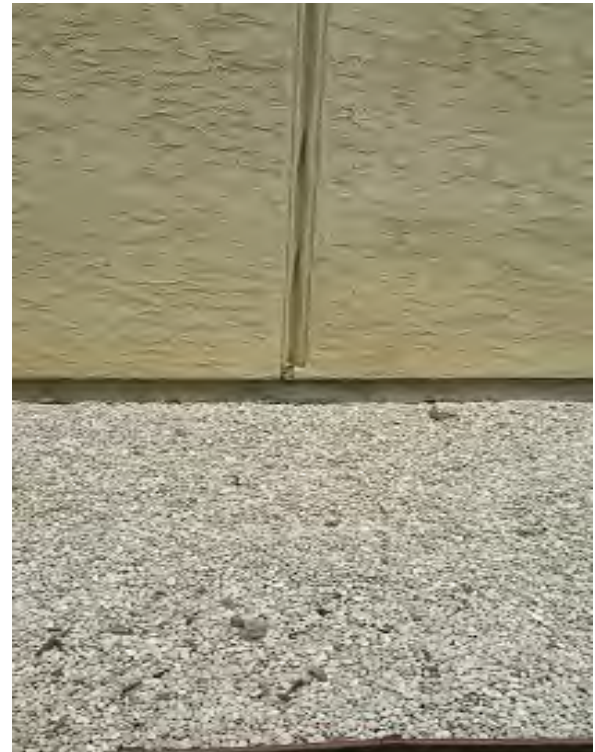
*Photo 59 - East Building: Deteriorated North Expansion Joint at Base*

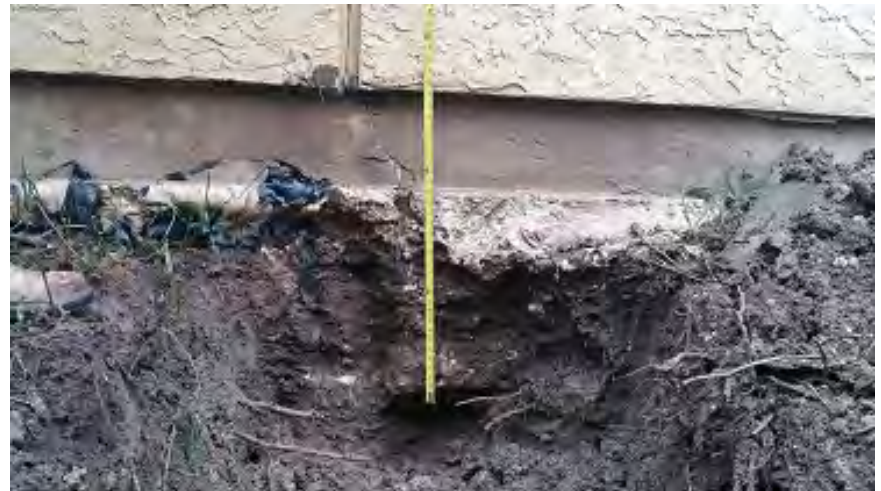
Two test pits were dug by GeoTest at the site under the observation of Robert Raffle, P.E. from RKCI. Test Pit 1 was located directly below the southern building expansion joint of the West Building and Test Pit 2 was located directly below the southern building expansion joint of the East Building. Reference is made to Appendix A, Photos 68 and 69, respectively and Appendix B - Drawing C 1.2. Cracks in the perimeter foundation beams were noted to extend through the members but there was no differential movement on either side of the cracks. The concrete foundation beams and the portion of drilled piers that were visible appeared solid with no deterioration, spalling or exposed reinforcement. The drilled pier at Test Pit 1 was just north of the beam crack while the drilled pier at Test Pit 2 was directly below the beam crack.

*Photo 68 –West Building: Test Pit 1*

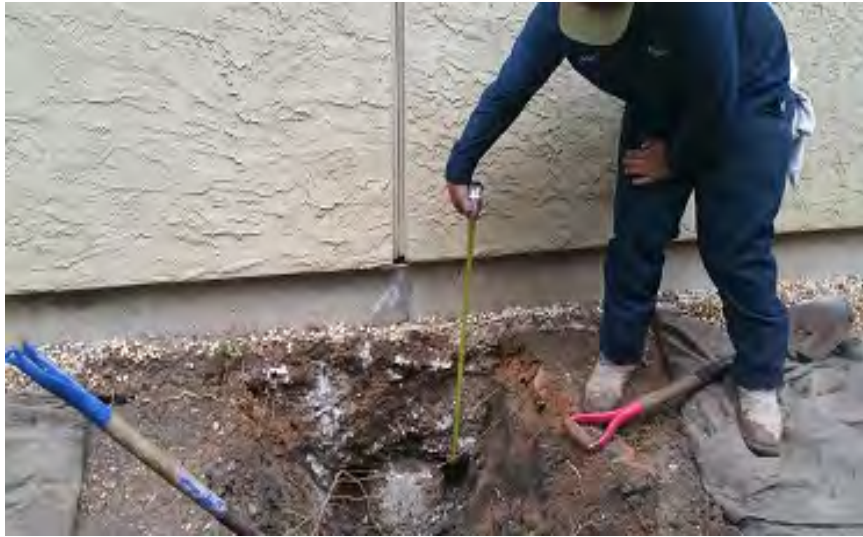
*Photo 69 – East Building: Test Pit 2*

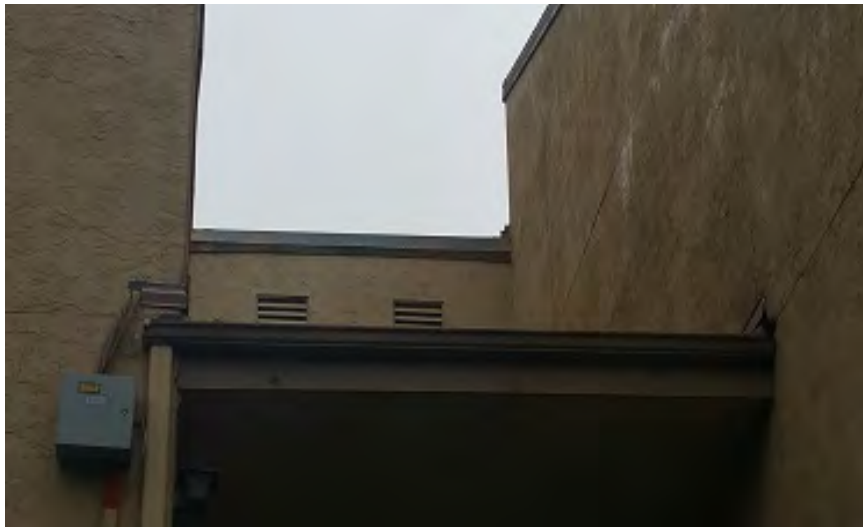
*Photo 71 – 3<sup>rd</sup> Floor Deteriorated Walkway Canopy Façade between North and West Buildings*

Crack repairs were evidenced throughout the apartment complex in various interior and exterior assemblies. These repairs will need to continue as required; however, their extent and severity should diminish as major repairs recommended above are completed. Of immediate importance will be the replacement of sheathing, stucco veneer and related insulation and flashing at the 3<sup>rd</sup> floor walkway canopy facades between the North and East Building and the North and West Building (Refer to Appendix A, Photos 70, 71, 83 and 94).

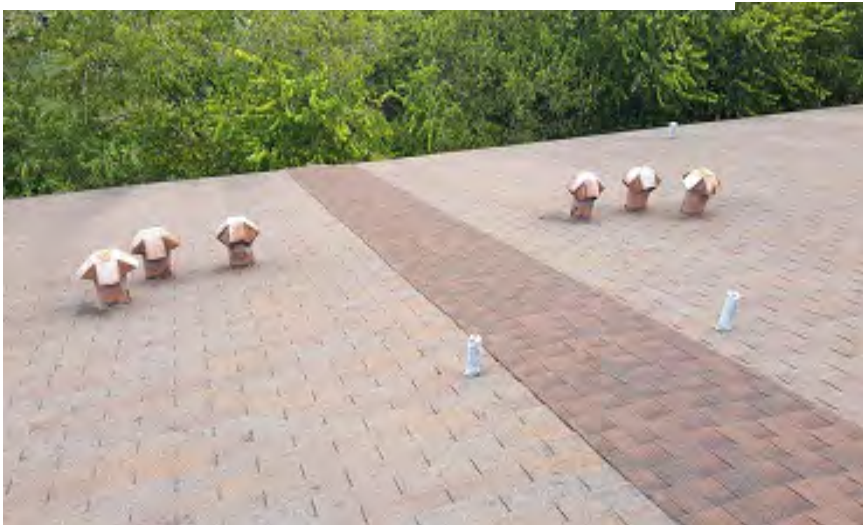
*Photo 75 – East Building: Northern Roof Expansion Joint Improperly Covered with a Shingle Patch*

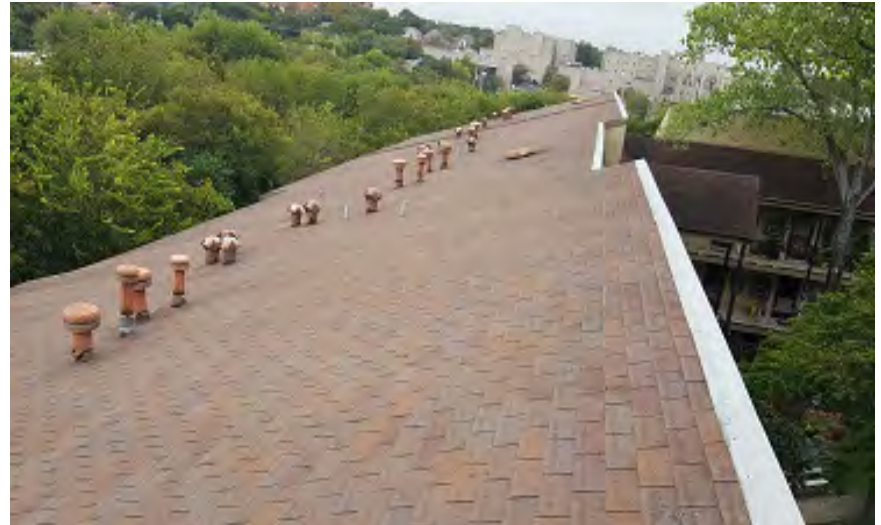
*Photo 76 – East Building Roof showing Deteriorated Vents, Penetrations, and Flashings (Looking South)*

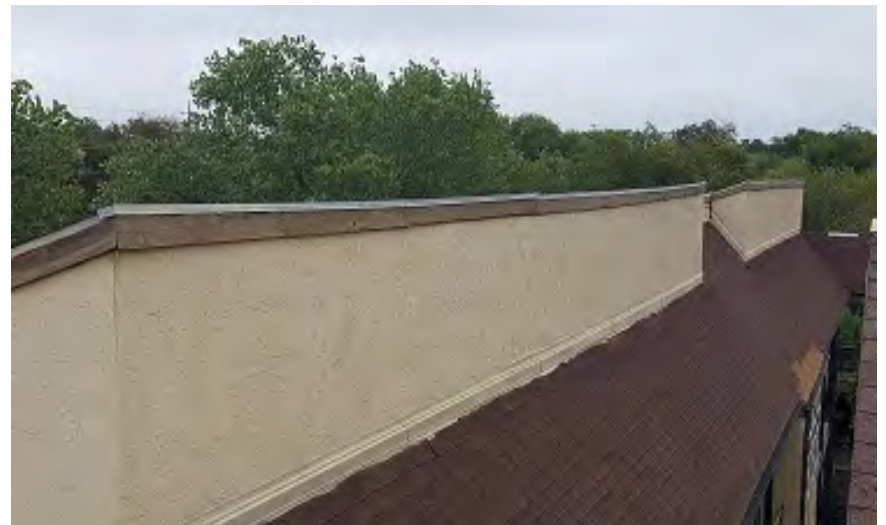
*Photo 84 – North Building: Walkway Canopy Roof (Looking East)*

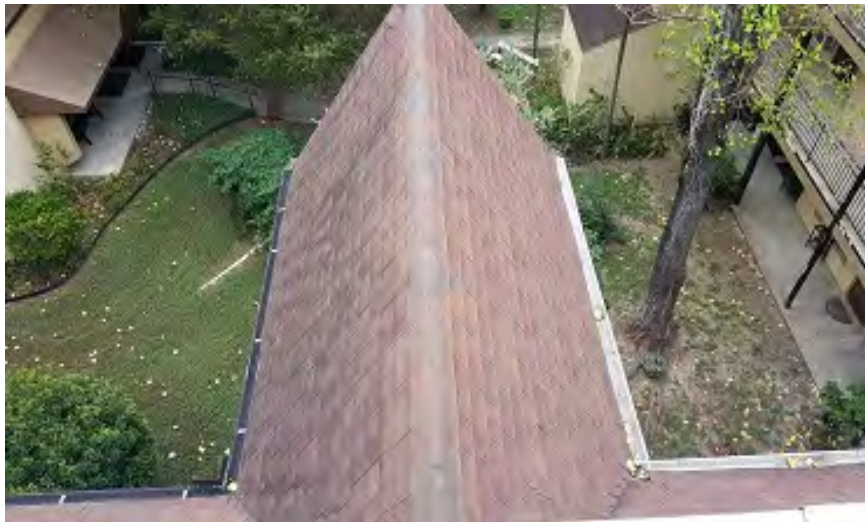
*Photo 86 – West Building Roof showing Hail Damage (Looking North)*

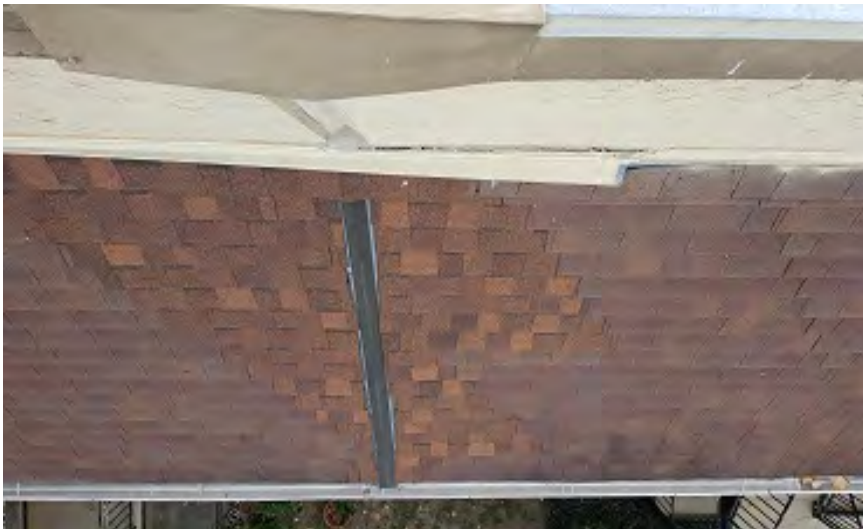
*Photo 90 – West Building Southern Roof Expansion Joint Improperly Covered with a Shingle Patch*

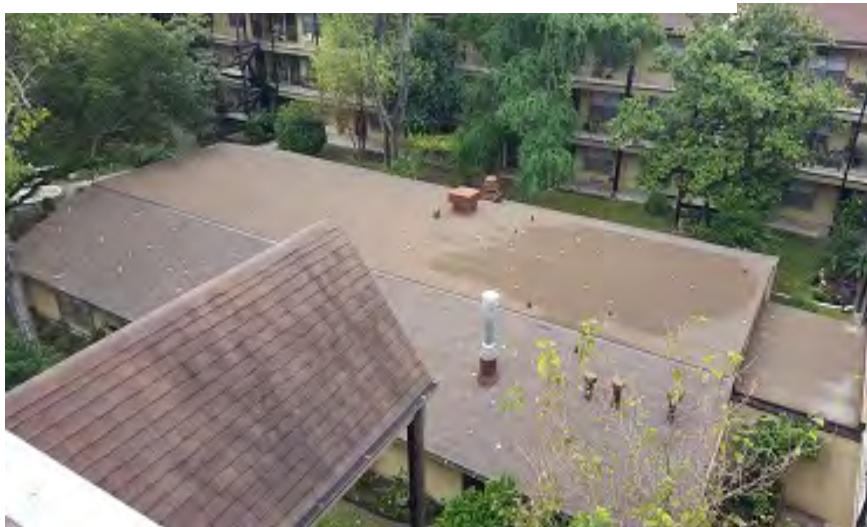
*Photo 94 – Walkway Canopy Connector between North and East Buildings showing Deteriorated Conditions*
