Aladdin Environmental LLC

Re: 303 Villa Rosa, San Antonio, TX

Aladdin Environmental is pleased to submit this environmental evaluation on the above residence located at 303 Villa Rosa, San Antonio, TX. This limited evaluation was performed on March 25th, 2008. We have observed the standard of care generally exercised by the profession under similar circumstances and conditions to complete this report.

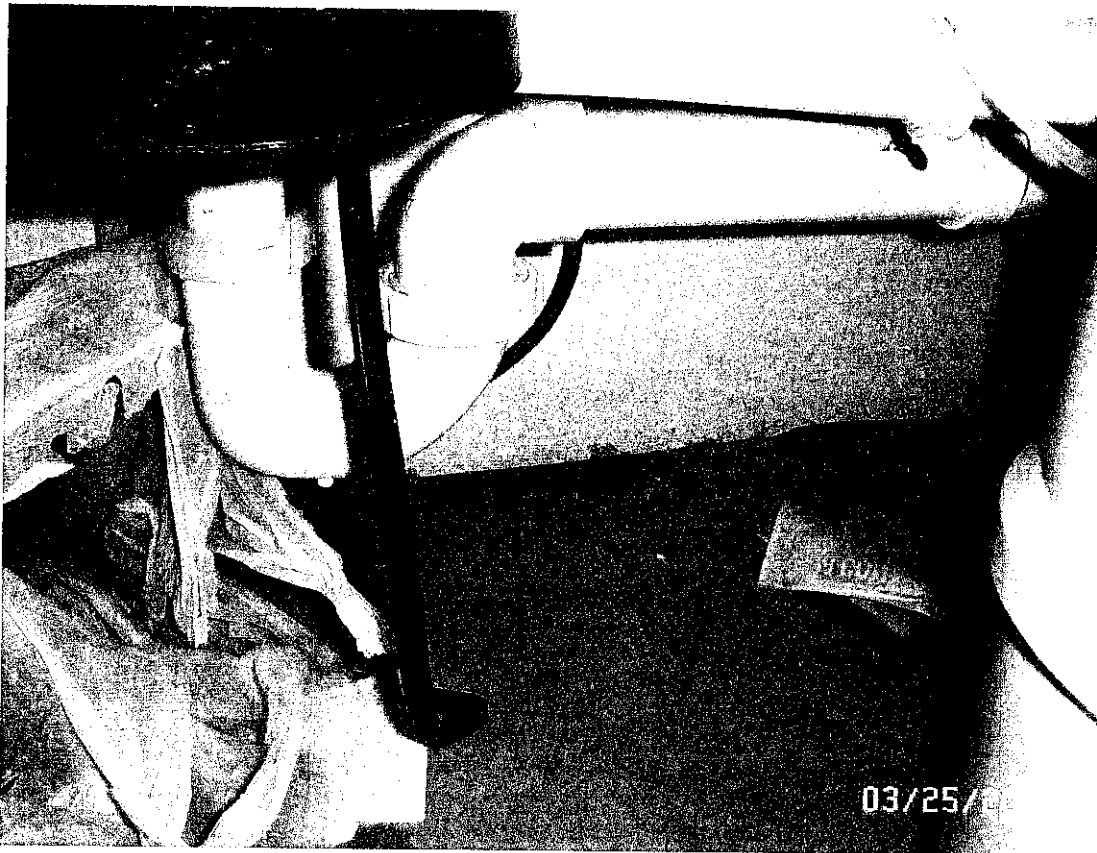
- The HVAC unit, supply ductwork and registers had recently been replaced.
- Kitchen – door threshold around back door showed signs of excess caulk. The base shelf below the sink showed signs of discoloration most likely from items placed there. The window showed signs of excess caulk from what appears to be poor caulking.

Kitchen - sink base shelf

- Recommend the door threshold be inspected and caulk be replaced as necessary.
 - Recommend the sink base shelf be replaced.
 - Recommend replace the caulk around the window.

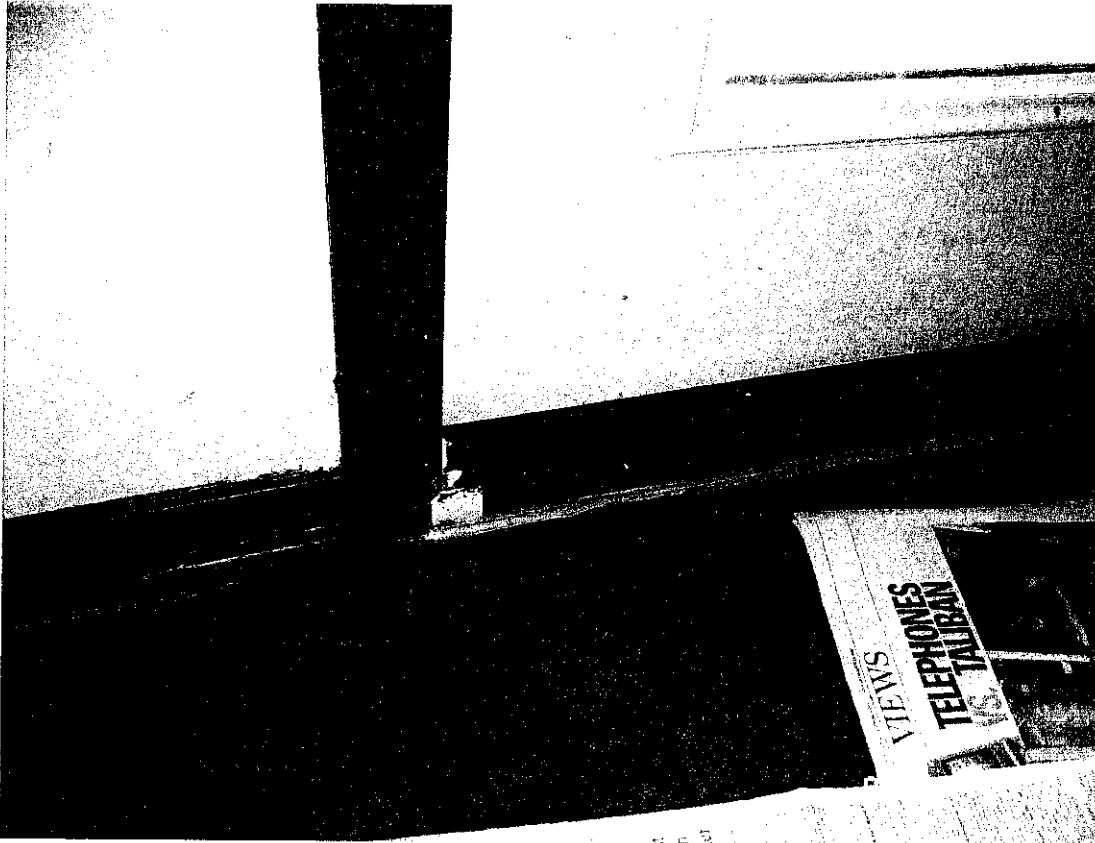
Kitchen - back door

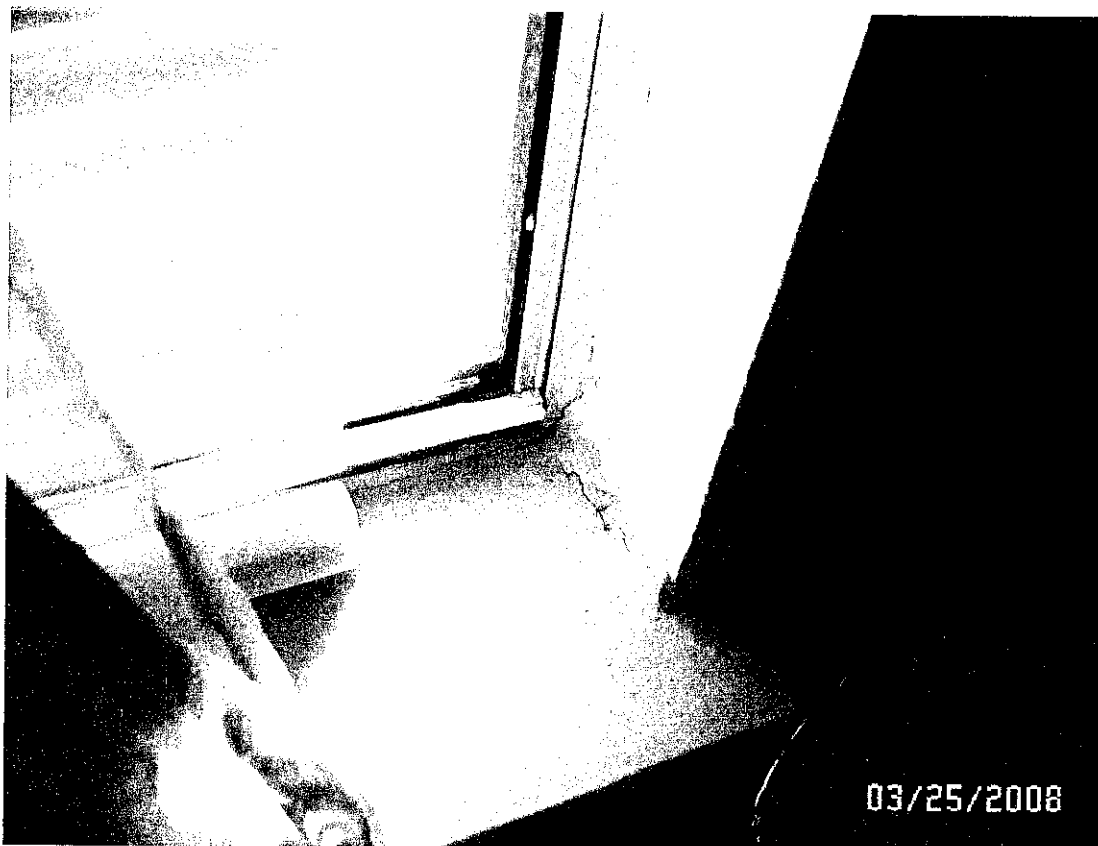
- Master Bedroom – The window showed signs of excess caulk from what appears to be poor caulking.
 - Recommend the window be cleaned & sanitized and the caulk replaced properly.

Master Bedroom - window

- Recommend the window area be part of routine cleaning to prevent debris buildup.
- Master Bath – The edge of the tub at the floor had signs of excess caulk from what appears to be poor caulking.
